## Profile/Photo Observation Report

Street:	<b>South Lake Park</b>	Flow Control:	<b>Not Controlled</b>
City:	<b>Hobart, IN</b>	Year Renewed:	
Location:	<b>Light Highway</b>	Tape/Media #:	<b>DEP297</b>
Purpose:	<b>Routine Assessment</b>	Dia/Height:	<b>18"</b>
Use:	<b>Sanitary</b>	Material:	<b>VCP</b>
Drain Area:		Lining:	
Category:	<b>NA</b>		
Comment:	<b>5-21-2018</b>

Location Details:		Direction of Survey:	<b>Upstream</b>
US MH:	<b>M-606-005</b>	DS MH:	<b>M-606-006</b>
		Total Length Surveyed (ft):	<b>64.5</b>

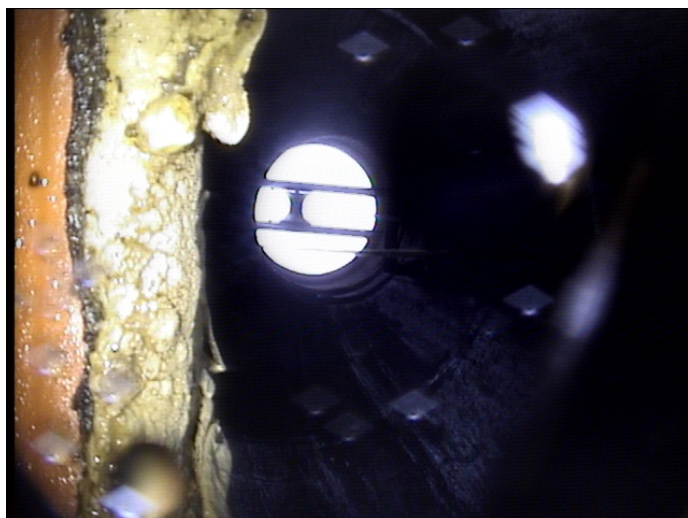
Code: **AMH**  
Description: **Manhole**

Distance (ft): **.0**  
Structural Grade: **0**  
O&M Grade: **0**  
Clock Start/From:  
Clock To:  
1st Value:  
2nd Value:  
Value Percent:  
Continuous Index:  
Within 8" of Joint: **NO**  
Remarks: **M-606-006**

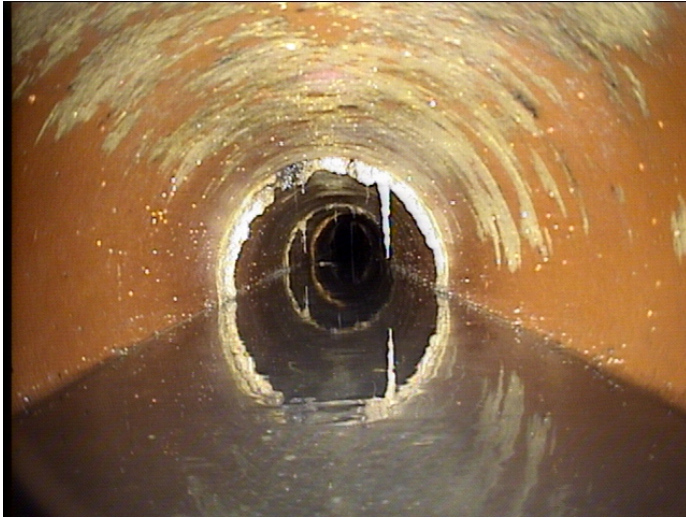
Code: **MWL**  
Description: **Water Level**

Distance (ft): **.0**  
Structural Grade: **0**  
O&M Grade: **0**  
Clock Start/From:  
Clock To:  
1st Value:  
2nd Value:  
Value Percent: **25.000**  
Continuous Index:  
Within 8" of Joint: **NO**  
Remarks:

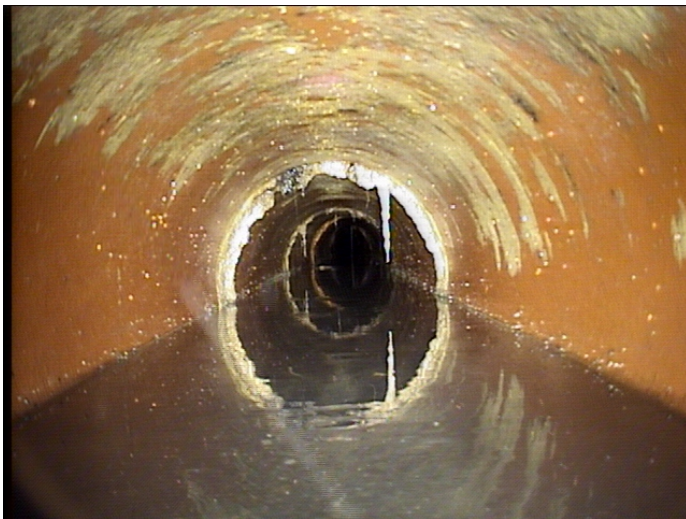
Code: **DSF**  
Description: **Deposits Settled Fine**

Distance (ft): **.0**  
Structural Grade: **0**  
O&M Grade: **3**  
Clock Start/From: **4**  
Clock To: **8**  
1st Value:  
2nd Value:  
Value Percent: **20.000**  
Continuous Index: **S01**  
Within 8" of Joint: **NO**  
Remarks:

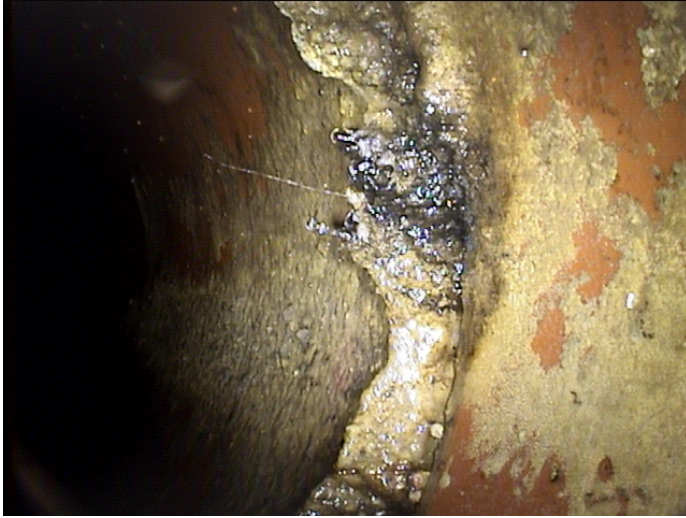
Code:	ID
Description:	Infil Dripper
Distance (ft):	2.0
Structural Grade:	0
O&M Grade:	3
Clock Start/From:	12
Clock To:	
1st Value:	
2nd Value:	
Value Percent:	
Continuous Index:	
Within 8" of Joint:	YES
Remarks:

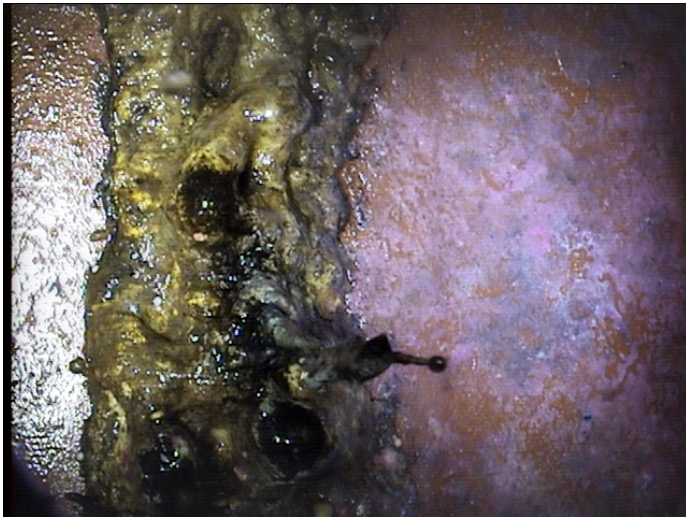
Code:	ID
Description:	Infil Dripper
Distance (ft):	8.4
Structural Grade:	0
O&M Grade:	3
Clock Start/From:	12
Clock To:	
1st Value:	
2nd Value:	
Value Percent:	
Continuous Index:	
Within 8" of Joint:	YES
Remarks:

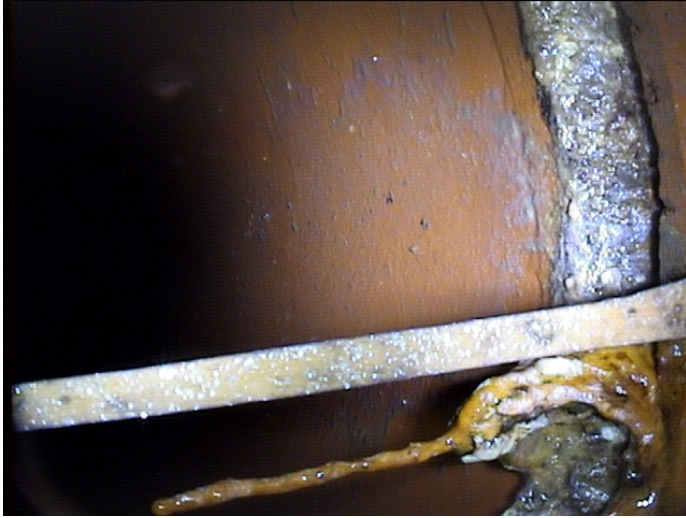
Code:	DAE
Description:	Deposits Attached Encrustation
Distance (ft):	24.4
Structural Grade:	0
O&M Grade:	2
Clock Start/From:	9
Clock To:	3
1st Value:	
2nd Value:	
Value Percent:	5.000
Continuous Index:	
Within 8" of Joint:	YES
Remarks:

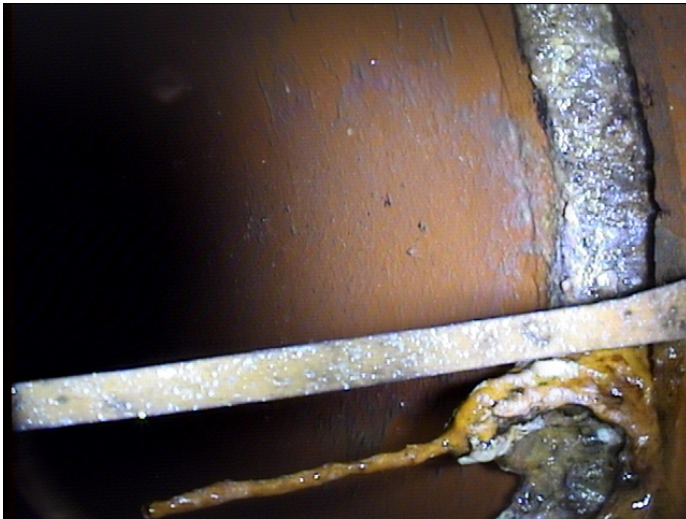
Code:	ID
Description:	Infil Dripper
Distance (ft):	24.4
Structural Grade:	0
O&M Grade:	3
Clock Start/From:	12
Clock To:	
1st Value:	
2nd Value:	
Value Percent:	
Continuous Index:	
Within 8" of Joint:	YES
Remarks:

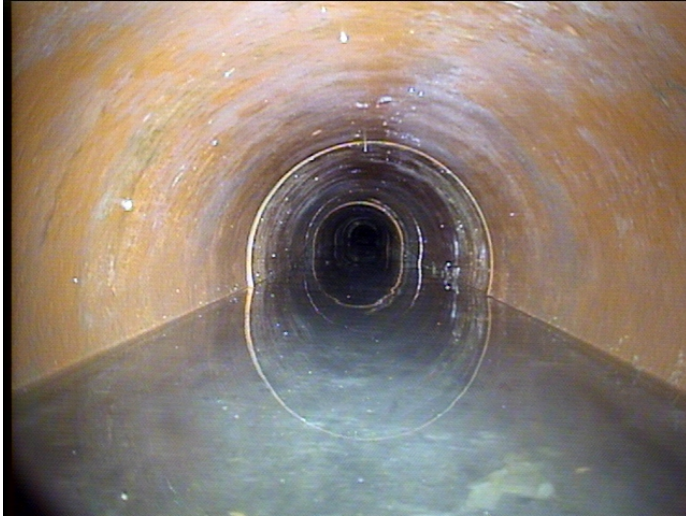
Code: **DSF**  
Description: **Deposits Settled Fine**

Distance (ft): **64.5**  
Structural Grade: **0**  
O&M Grade: **3**  
Clock Start/From: **4**  
Clock To: **8**  
1st Value:  
2nd Value:  
Value Percent: **20.000**  
Continuous Index: **F01**  
Within 8" of Joint: **NO**  
Remarks:

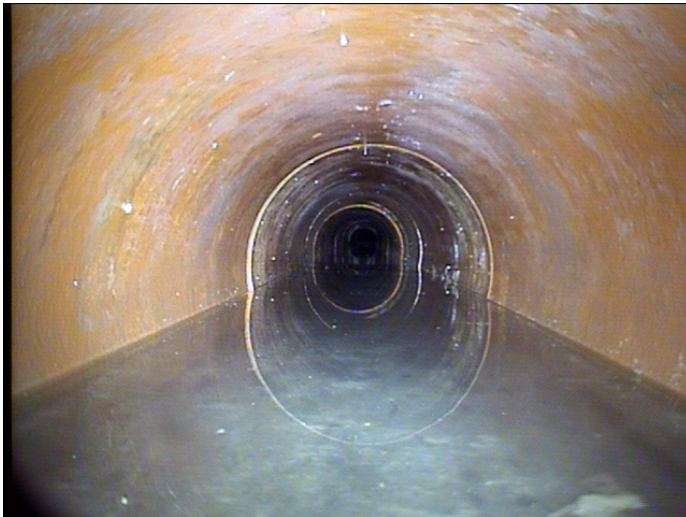
Code: **MSA**  
Description: **Abandoned Survey**

Distance (ft): **64.5**  
Structural Grade: **0**  
O&M Grade: **0**  
Clock Start/From:  
Clock To:  
1st Value:  
2nd Value:  
Value Percent:  
Continuous Index:  
Within 8" of Joint: **NO**  
Remarks: **Heavy sediment**
