Profile/Photo Observation Report

Date:	05/08/2018	Weather:		Coding:	PACP 6.0
Pipe Length (ft):		Owner:	City of Hobart	Pre Clean:	Not Known
P.O.#:	304	Surveyor:	B. Helbling	PSR:	P-606-008-LS001
Customer:	City of Hobart	Clean Date:		Shape:	C

Street:	West 8th Street	Flow Control:	Not Controlled
City:	Hobart, IN	Year Renewed:	
Location:	Light Highway	Tape/Media #:	DEP304
Purpose:	Routine Assessment	Dia/Height:	18"
Use:	Sanitary	Material:	VCP
Drain Area:		Lining:	
Category:	NA		
Comment:	5-21-2018		
Location Details:		Direction of Survey:	Downstream
US MH:	M-606-008	DS MH:	M-606-008
		Total Length Surveyed (ft):	40.7

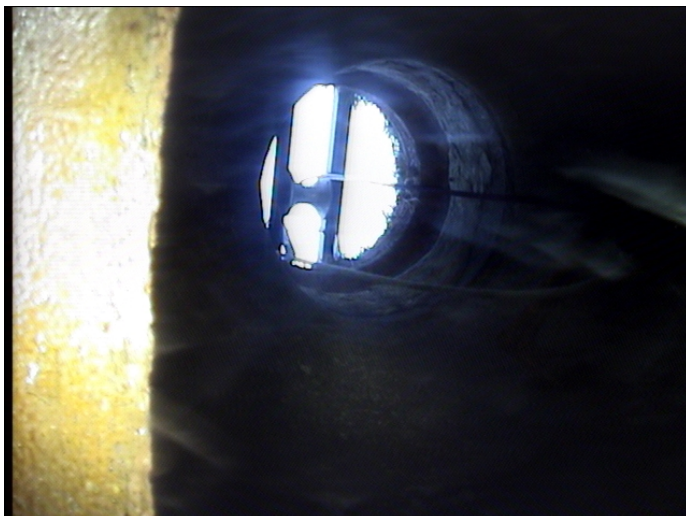
Code: **AMH**
Description: **Manhole**

Distance (ft): **.0**
Structural Grade: **0**
O&M Grade: **0**
Clock Start/From:
Clock To:
1st Value:
2nd Value:
Value Percent:
Continuous Index:
Within 8" of Joint: **NO**
Remarks: **M-606-008**

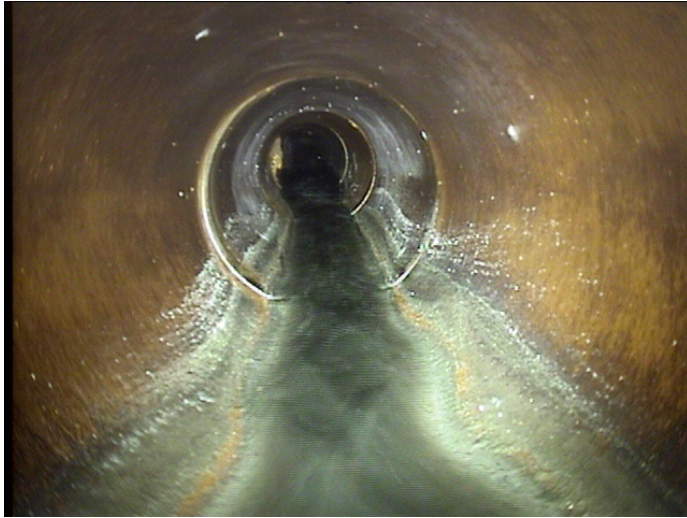
Code:	MWL
Description:	Water Level
Distance (ft):	.0
Structural Grade:	0
O&M Grade:	0
Clock Start/From:	
Clock To:	
1st Value:	
2nd Value:	
Value Percent:	5.000
Continuous Index:	
Within 8" of Joint:	NO
Remarks:

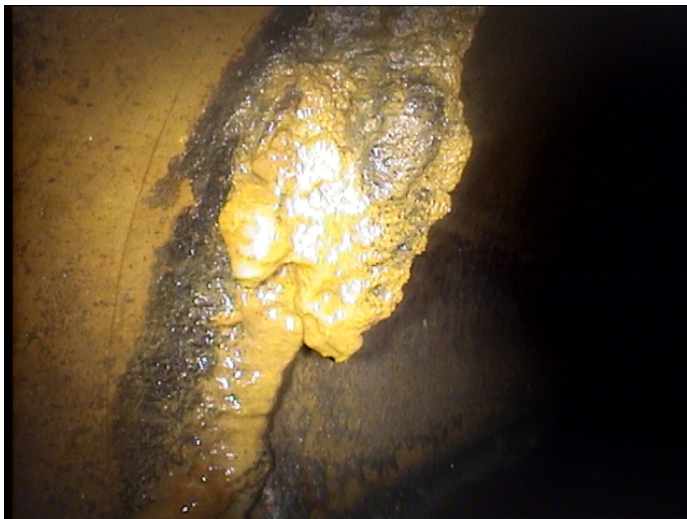
Code:	ID
Description:	Infil Dripper
Distance (ft):	12.1
Structural Grade:	0
O&M Grade:	3
Clock Start/From:	9
Clock To:	
1st Value:	
2nd Value:	
Value Percent:	
Continuous Index:	
Within 8" of Joint:	YES
Remarks:

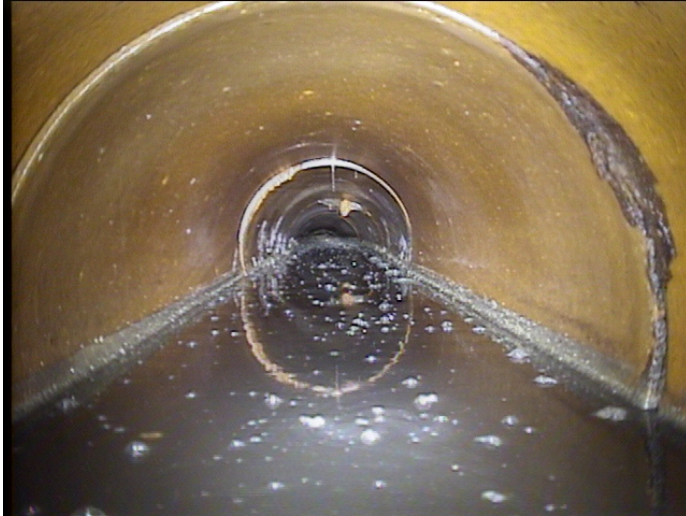
Code:	MWL
Description:	Water Level
Distance (ft):	21.4
Structural Grade:	0
O&M Grade:	0
Clock Start/From:	
Clock To:	
1st Value:	
2nd Value:	
Value Percent:	40.000
Continuous Index:	
Within 8" of Joint:	NO
Remarks:

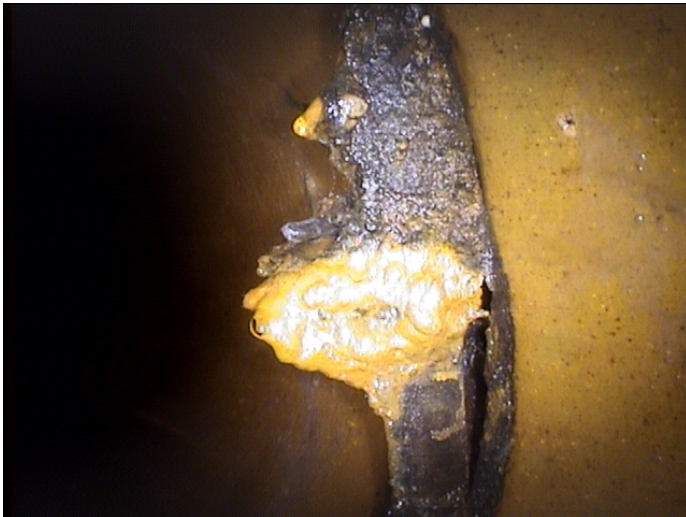
Code:	ID
Description:	Infil Dropper
Distance (ft):	32.5
Structural Grade:	0
O&M Grade:	3
Clock Start/From:	1
Clock To:	
1st Value:	
2nd Value:	
Value Percent:	
Continuous Index:	
Within 8" of Joint:	YES
Remarks:

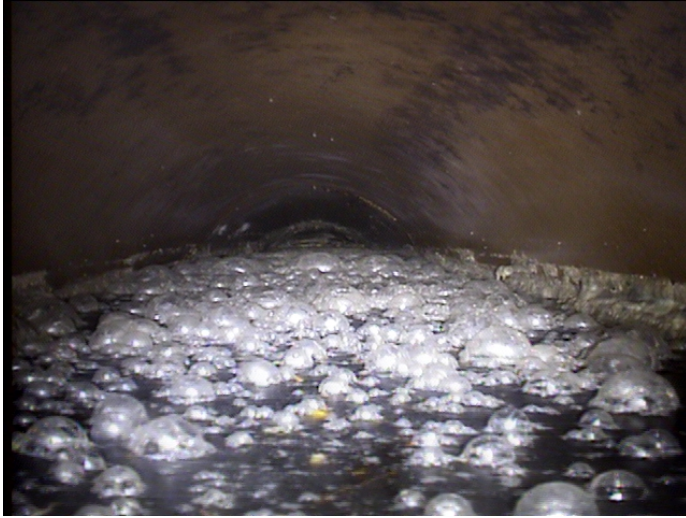
Code: **MWL**
Description: **Water Level**

Distance (ft): **39.0**
Structural Grade: **0**
O&M Grade: **0**
Clock Start/From:
Clock To:
1st Value:
2nd Value:
Value Percent: **65.000**
Continuous Index:
Within 8" of Joint: **NO**
Remarks:

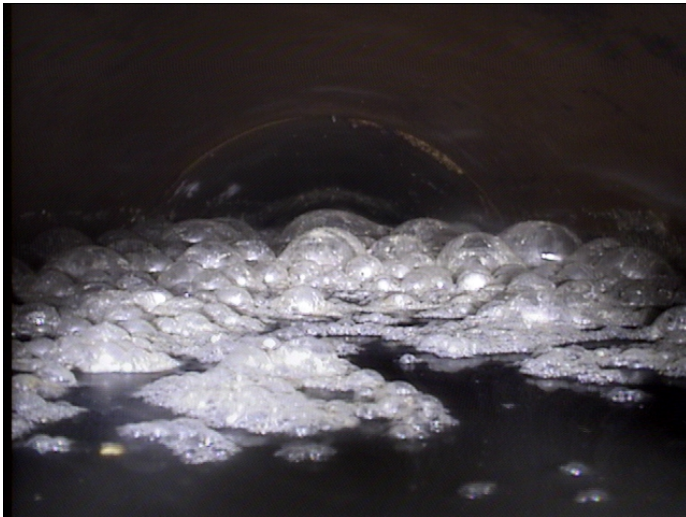
Code: **MSA**
Description: **Abandoned Survey**

Distance (ft): **40.7**
Structural Grade: **0**
O&M Grade: **0**
Clock Start/From:
Clock To:
1st Value:
2nd Value:
Value Percent:
Continuous Index:
Within 8" of Joint: **NO**
Remarks: **Surcharged before Lift Station**
