Profile/Photo Observation Report

Street:	W 8TH ST & W 8TH PL	Flow Control:	Not Controlled
City:	Hobart, IN	Year Renewed:	
Location:	Yard	Tape/Media #:	
Purpose:	Routine Assessment	Dia/Height:	10"
Use:	Sanitary	Material:	VCP
Drain Area:	NA	Lining:	
Category:	NA		
Comment:	Flow direction is marked wrong.		
Location Details:		Direction of Survey:	Upstream
US MH:	M-606-009	DS MH:	M-606-010
		Total Length Surveyed (ft):	21.5

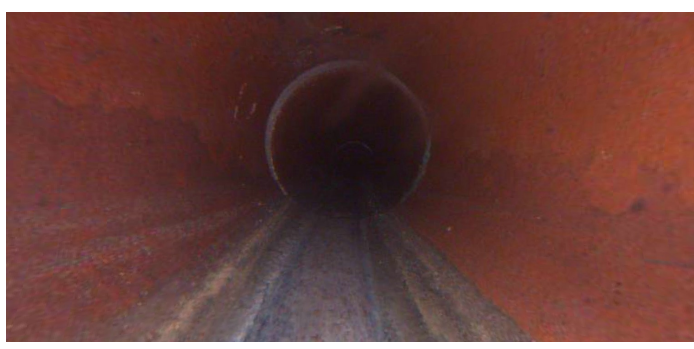
Code: **AMH**
Description: **Manhole**

Distance (ft): **.0**
Structural Grade: **0**
O&M Grade: **0**
Clock Start/From:
Clock To:
1st Value:
2nd Value:
Value Percent:
Continuous Index:
Within 8" of Joint: **NO**
Remarks: **M-606-010**

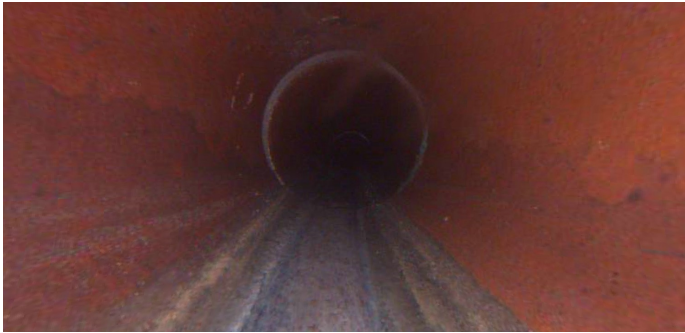
Code:	MWL
Description:	Water Level

Distance (ft):	.0
Structural Grade:	0
O&M Grade:	0
Clock Start/From:	
Clock To:	
1st Value:	
2nd Value:	
Value Percent:	5.000
Continuous Index:	
Within 8" of Joint:	NO
Remarks:

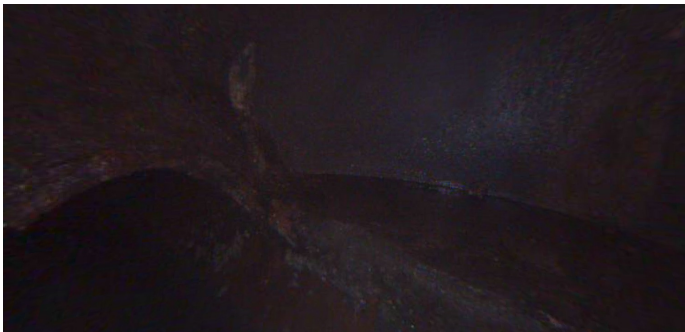
Code:	AMH
Description:	Manhole

Distance (ft):	21.5
Structural Grade:	0
O&M Grade:	0
Clock Start/From:	
Clock To:	
1st Value:	
2nd Value:	
Value Percent:	
Continuous Index:	
Within 8" of Joint:	NO
Remarks:	M-606-009
