## Profile/Photo Observation Report

Date:	<b>04/11/2018</b>	Weather:		Coding:	<b>PACP 6.0</b>
Pipe Length (ft):	<b>230.2</b>	Owner:	<b>NA</b>	Pre Clean:	<b>No Pre-Cleaning</b>
P.O.#:		Surveyor:	<b>Jen Costello</b>	PSR:	<b>P-606-011-010</b>
Customer:		Clean Date:	<b>01/01/1900</b>	Shape:	<b>C</b>

Street:	<b>FOXCROFT STREET</b>	Flow Control:	<b>Not Controlled</b>
City:	<b>Hobart, IN</b>	Year Renewed:	
Location:	<b>Yard</b>	Tape/Media #:	
Purpose:	<b>Routine Assessment</b>	Dia/Height:	<b>10"</b>
Use:	<b>Sanitary</b>	Material:	<b>VCP</b>
Drain Area:	<b>NA</b>	Lining:	
Category:	<b>NA</b>		
Comment:	<b>Flow direction is marked wrong.</b>		
Location Details:		Direction of Survey:	<b>Downstream</b>
US MH:	<b>M-606-010</b>	DS MH:	<b>M-606-011</b>
		Total Length Surveyed (ft):	<b>213.5</b>

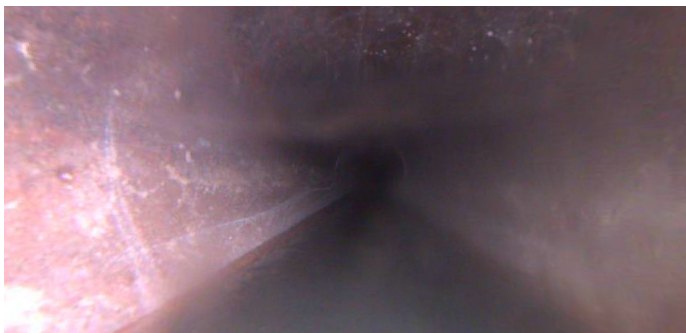
Code: **AMH**  
Description: **Manhole**

Distance (ft): **.0**  
Structural Grade: **0**  
O&M Grade: **0**  
Clock Start/From:  
Clock To:  
1st Value:  
2nd Value:  
Value Percent:  
Continuous Index:  
Within 8" of Joint: **NO**  
Remarks: **M-606-010**

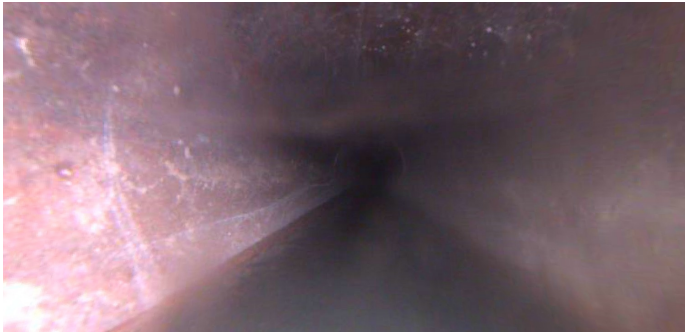
Code:	<b>MWL</b>
Description:	<b>Water Level</b>

Distance (ft):	<b>.0</b>
Structural Grade:	<b>0</b>
O&M Grade:	<b>0</b>
Clock Start/From:	
Clock To:	
1st Value:	
2nd Value:	
Value Percent:	<b>20.000</b>
Continuous Index:	
Within 8" of Joint:	<b>NO</b>
Remarks:

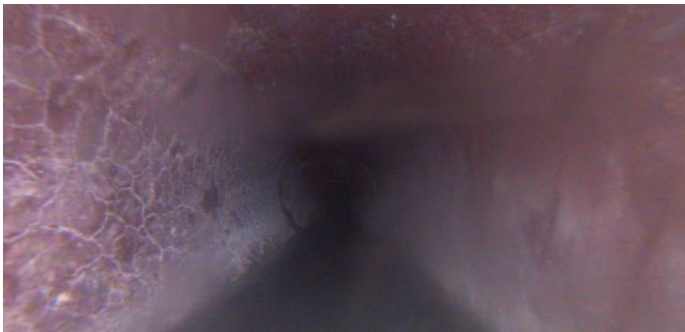
Code:	<b>CM</b>
Description:	<b>Crack Multiple</b>

Distance (ft):	<b>2.7</b>
Structural Grade:	<b>3</b>
O&M Grade:	<b>0</b>
Clock Start/From:	<b>8</b>
Clock To:	<b>4</b>
1st Value:	
2nd Value:	
Value Percent:	
Continuous Index:	
Within 8" of Joint:	<b>YES</b>
Remarks:

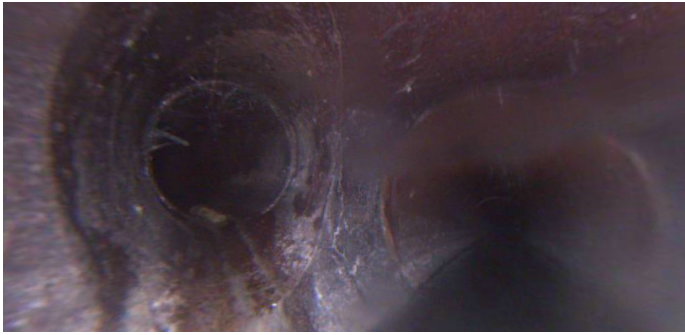
Code: **TF**  
Description: **Tap Factory**

Distance (ft): **4.4**  
Structural Grade: **0**  
O&M Grade: **0**  
Clock Start/From: **9**  
Clock To:  
1st Value: **4.000**  
2nd Value:  
Value Percent:  
Continuous Index:  
Within 8" of Joint:  
Remarks:

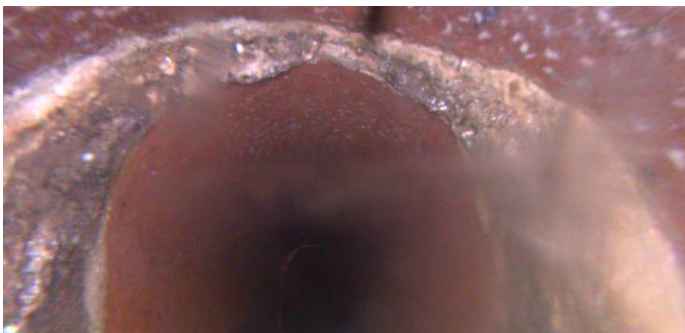
Code: **DAE**  
Description: **Deposits Attached Encrustation**

Distance (ft): **67.0**  
Structural Grade: **0**  
O&M Grade: **2**  
Clock Start/From: **8**  
Clock To: **4**  
1st Value:  
2nd Value:  
Value Percent: **5.000**  
Continuous Index:  
Within 8" of Joint: **YES**  
Remarks:

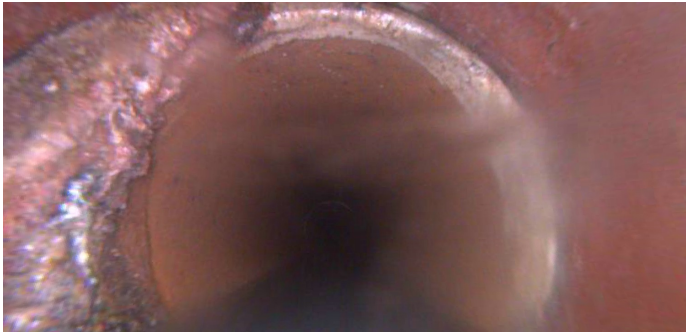
Code: **DAE**  
Description: **Deposits Attached Encrustation**

Distance (ft): **70.9**  
Structural Grade: **0**  
O&M Grade: **2**  
Clock Start/From: **8**  
Clock To: **12**  
1st Value:  
2nd Value:  
Value Percent: **10.000**  
Continuous Index:  
Within 8" of Joint: **YES**  
Remarks:

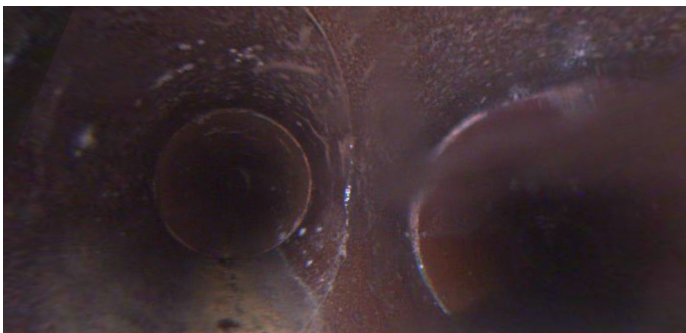
Code: **TFA**  
Description: **Tap Factory Active**

Distance (ft): **85.0**  
Structural Grade: **0**  
O&M Grade: **0**  
Clock Start/From: **9**  
Clock To:  
1st Value: **4.000**  
2nd Value:  
Value Percent:  
Continuous Index:  
Within 8" of Joint:  
Remarks:

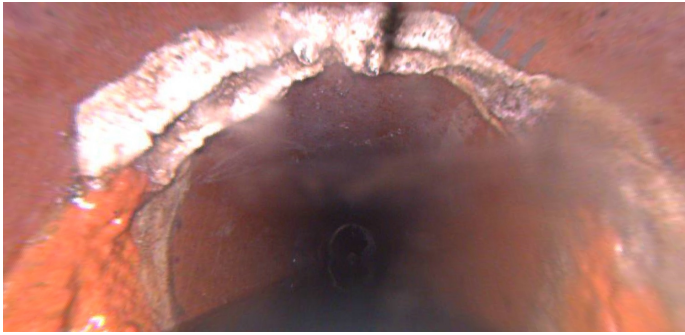
Code: **DAE**  
Description: **Deposits Attached Encrustation**

Distance (ft): **112.8**  
Structural Grade: **0**  
O&M Grade: **2**  
Clock Start/From: **8**  
Clock To: **4**  
1st Value:  
2nd Value:  
Value Percent: **10.000**  
Continuous Index:  
Within 8" of Joint: **YES**  
Remarks:

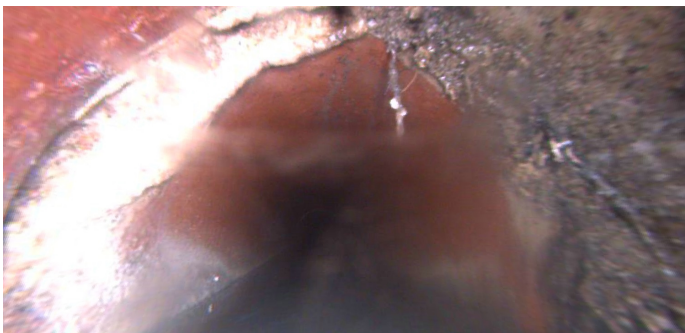
Code: **RFJ**  
Description: **Roots Fine Joint**

Distance (ft): **116.9**  
Structural Grade: **0**  
O&M Grade: **1**  
Clock Start/From: **12**  
Clock To: **3**  
1st Value:  
2nd Value:  
Value Percent:  
Continuous Index:  
Within 8" of Joint: **YES**  
Remarks:

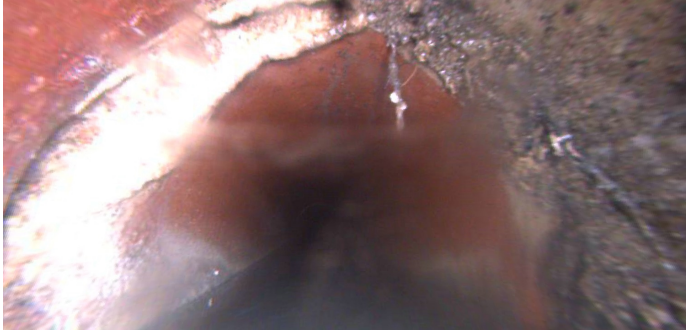
Code: **DAE**  
Description: **Deposits Attached Encrustation**

Distance (ft): **116.9**  
Structural Grade: **0**  
O&M Grade: **2**  
Clock Start/From: **8**  
Clock To: **4**  
1st Value:  
2nd Value:  
Value Percent: **10.000**  
Continuous Index:  
Within 8" of Joint: **YES**  
Remarks:

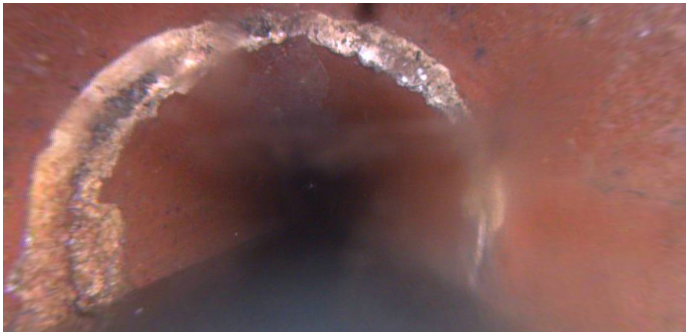
Code: **DAE**  
Description: **Deposits Attached Encrustation**

Distance (ft): **140.1**  
Structural Grade: **0**  
O&M Grade: **2**  
Clock Start/From: **8**  
Clock To: **4**  
1st Value:  
2nd Value:  
Value Percent: **5.000**  
Continuous Index:  
Within 8" of Joint: **YES**  
Remarks:

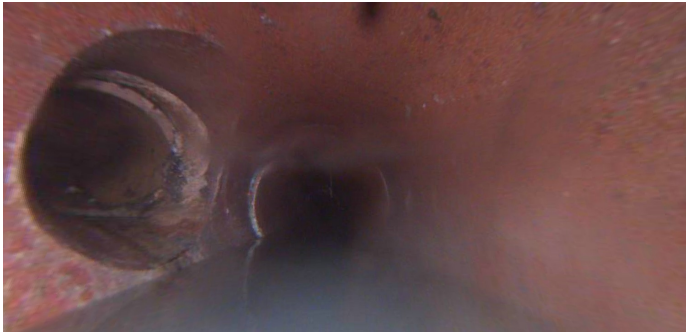
Code: **TF**  
Description: **Tap Factory**

Distance (ft): **153.8**  
Structural Grade: **0**  
O&M Grade: **0**  
Clock Start/From: **9**  
Clock To:  
1st Value: **4.000**  
2nd Value:  
Value Percent:  
Continuous Index:  
Within 8" of Joint:  
Remarks:

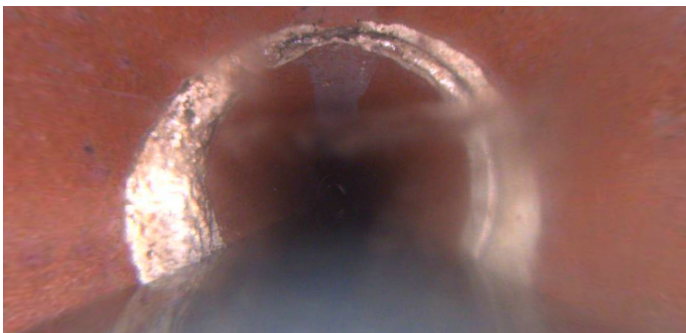
Code: **DAE**  
Description: **Deposits Attached Encrustation**

Distance (ft): **177.9**  
Structural Grade: **0**  
O&M Grade: **2**  
Clock Start/From: **8**  
Clock To: **4**  
1st Value:  
2nd Value:  
Value Percent: **5.000**  
Continuous Index:  
Within 8" of Joint: **YES**  
Remarks:

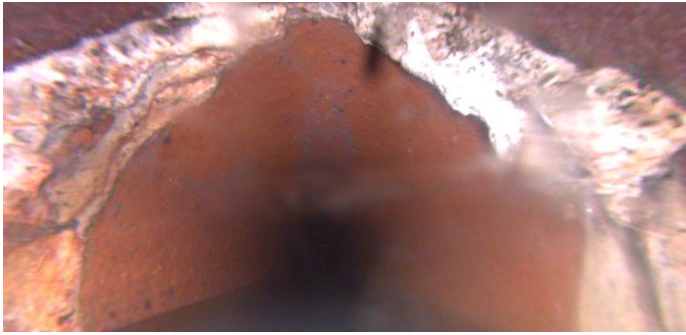
Code: **DAE**  
Description: **Deposits Attached Encrustation**

Distance (ft): **186.0**  
Structural Grade: **0**  
O&M Grade: **2**  
Clock Start/From: **8**  
Clock To: **4**  
1st Value:  
2nd Value:  
Value Percent: **10.000**  
Continuous Index:  
Within 8" of Joint: **YES**  
Remarks:

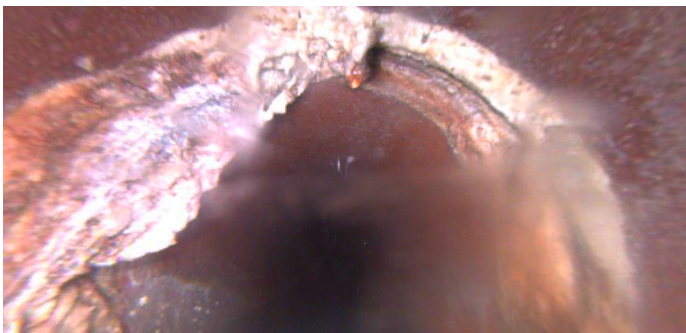
Code: **ID**  
Description: **Infil Dripper**

Distance (ft): **201.5**  
Structural Grade: **0**  
O&M Grade: **3**  
Clock Start/From: **12**  
Clock To:  
1st Value:  
2nd Value:  
Value Percent:  
Continuous Index:  
Within 8" of Joint: **YES**  
Remarks:

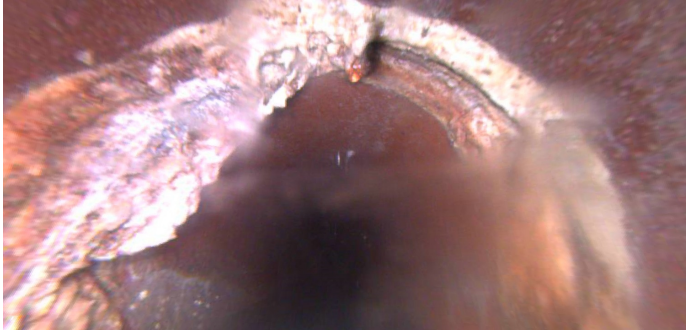
Code: **DAE**  
Description: **Deposits Attached Encrustation**

Distance (ft): **201.5**  
Structural Grade: **0**  
O&M Grade: **3**  
Clock Start/From: **8**  
Clock To: **4**  
1st Value:  
2nd Value:  
Value Percent: **15.000**  
Continuous Index:  
Within 8" of Joint: **YES**  
Remarks:

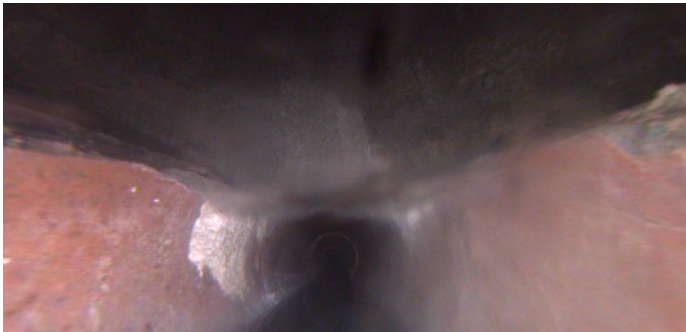
Code: **AMH**  
Description: **Manhole**

Distance (ft): **213.5**  
Structural Grade: **0**  
O&M Grade: **0**  
Clock Start/From:  
Clock To:  
1st Value:  
2nd Value:  
Value Percent:  
Continuous Index:  
Within 8" of Joint: **NO**  
Remarks: **M-606-011**
