## Profile/Photo Observation Report

Street:	<b>FOXCROFT STREET</b>	Flow Control:	<b>Not Controlled</b>
City:	<b>Hobart, IN</b>	Year Renewed:	
Location:	<b>Yard</b>	Tape/Media #:	
Purpose:	<b>Routine Assessment</b>	Dia/Height:	<b>10"</b>
Use:	<b>Sanitary</b>	Material:	<b>VCP</b>
Drain Area:	<b>NA</b>	Lining:	
Category:	<b>NA</b>		
Comment:	<b>Flow direction is marked wrong.</b>		
Location Details:		Direction of Survey:	<b>Upstream</b>
US MH:	<b>M-606-011</b>	DS MH:	<b>M-606-012</b>
		Total Length Surveyed (ft):	<b>221.0</b>

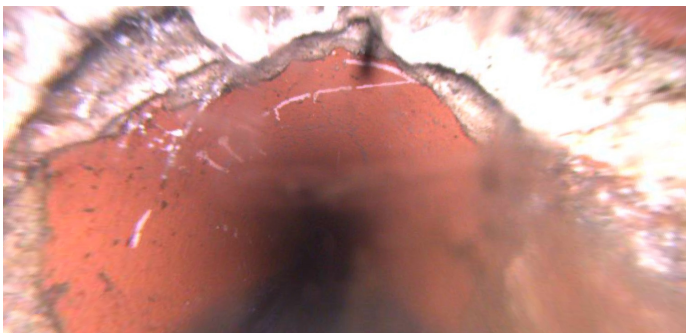
Code: **DAE**  
Description: **Deposits Attached Encrustation**

Distance (ft): **9.8**  
Structural Grade: **0**  
O&M Grade: **2**  
Clock Start/From: **8**  
Clock To: **4**  
1st Value:  
2nd Value:  
Value Percent: **10.000**  
Continuous Index:  
Within 8" of Joint: **YES**  
Remarks:

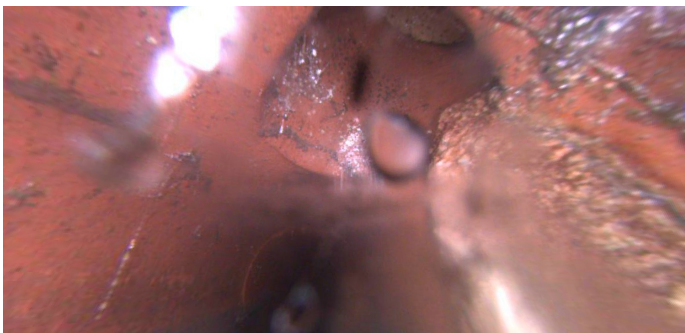
Code: **TFC**  
Description: **Tap Factory Capped**

Distance (ft): **54.3**  
Structural Grade: **0**  
O&M Grade: **0**  
Clock Start/From: **1**  
Clock To:  
1st Value: **4.000**  
2nd Value:  
Value Percent:  
Continuous Index:  
Within 8" of Joint:  
Remarks:

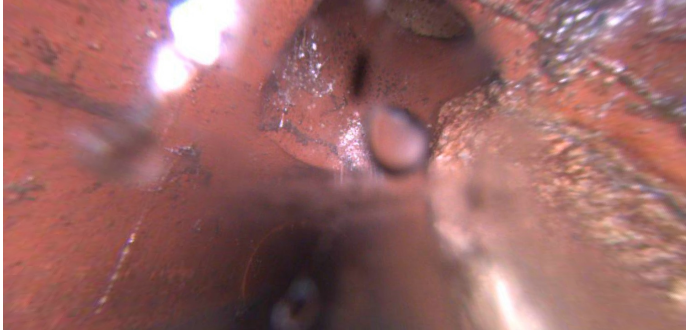
Code: **DAE**  
Description: **Deposits Attached Encrustation**

Distance (ft): **54.3**  
Structural Grade: **0**  
O&M Grade: **2**  
Clock Start/From: **1**  
Clock To: **4**  
1st Value:  
2nd Value:  
Value Percent: **10.000**  
Continuous Index:  
Within 8" of Joint: **NO**  
Remarks:

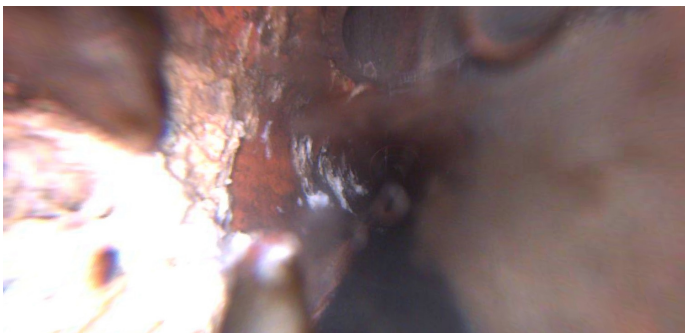
Code: **DAGS**  
Description: **Deposits Attached Grease**

Distance (ft): **77.0**  
Structural Grade: **0**  
O&M Grade: **2**  
Clock Start/From: **7**  
Clock To: **12**  
1st Value:  
2nd Value:  
Value Percent: **10.000**  
Continuous Index:  
Within 8" of Joint: **NO**  
Remarks:

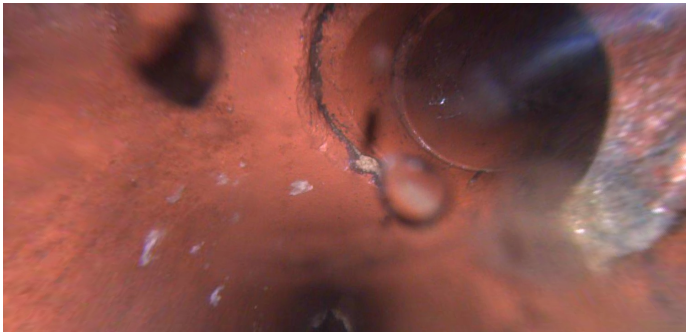
Code: **TBI**  
Description: **Tap Break-in Intruding**

Distance (ft): **127.2**  
Structural Grade: **0**  
O&M Grade: **2**  
Clock Start/From: **1**  
Clock To:  
1st Value: **4.000**  
2nd Value: **1.000**  
Value Percent:  
Continuous Index:  
Within 8" of Joint:  
Remarks:

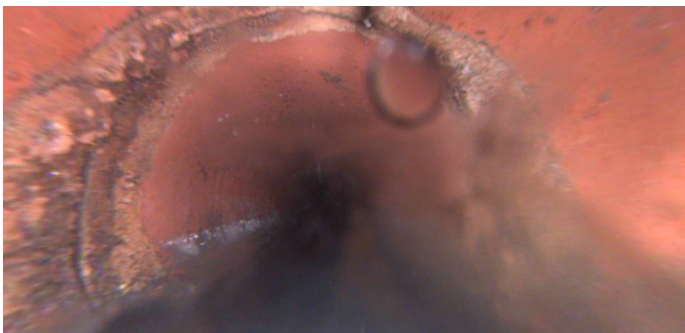
Code: **DAE**  
Description: **Deposits Attached Encrustation**

Distance (ft): **210.6**  
Structural Grade: **0**  
O&M Grade: **2**  
Clock Start/From: **8**  
Clock To: **4**  
1st Value:  
2nd Value:  
Value Percent: **5.000**  
Continuous Index:  
Within 8" of Joint: **YES**  
Remarks:

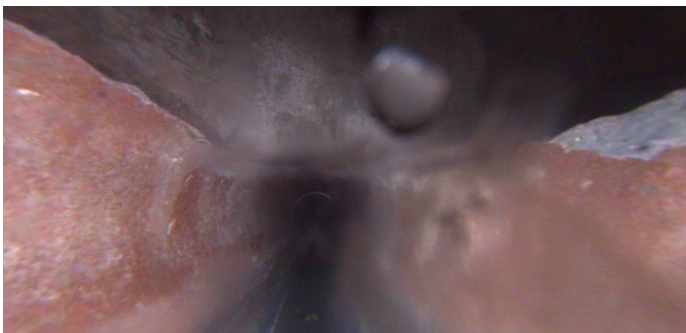
Code: **AMH**  
Description: **Manhole**

Distance (ft): **221.0**  
Structural Grade: **0**  
O&M Grade: **0**  
Clock Start/From:  
Clock To:  
1st Value:  
2nd Value:  
Value Percent:  
Continuous Index:  
Within 8" of Joint: **NO**  
Remarks: **M-606-011**
