Profile/Photo Observation Report

Date:	04/10/2018	Weather:		Coding:	PACP 6.0
Pipe Length (ft):	172.0	Owner:	NA	Pre Clean:	No Pre-Cleaning
P.O.#:		Surveyor:	Mark Ruby	PSR:	P-606-017-014
Customer:		Clean Date:	01/01/1900	Shape:	C

Street:	FOXCROFT STREET	Flow Control:	Not Controlled
City:	Hobart, IN	Year Renewed:	
Location:	Yard	Tape/Media #:	
Purpose:	Routine Assessment	Dia/Height:	10"
Use:	Sanitary	Material:	VCP
Drain Area:	NA	Lining:	
Category:	NA		
Comment:

Location Details:		Direction of Survey:	Downstream
US MH:	M-606-014	DS MH:	M-606-017
		Total Length Surveyed (ft):	152.9

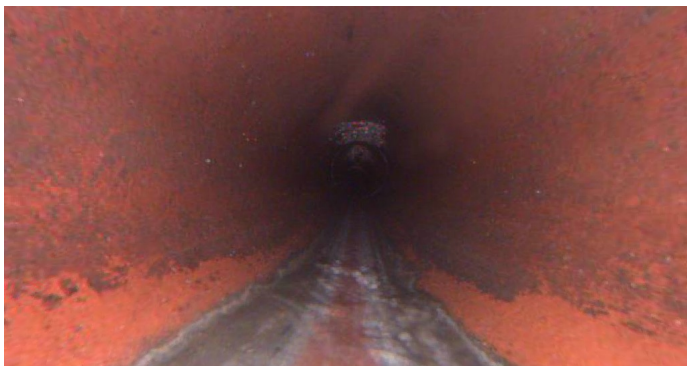
Code: **AMH**
 Description: **Manhole**

Distance (ft): **.0**
 Structural Grade: **0**
 O&M Grade: **0**
 Clock Start/From:
 Clock To:
 1st Value:
 2nd Value:
 Value Percent:
 Continuous Index:
 Within 8" of Joint: **NO**
 Remarks: **M-606-014**

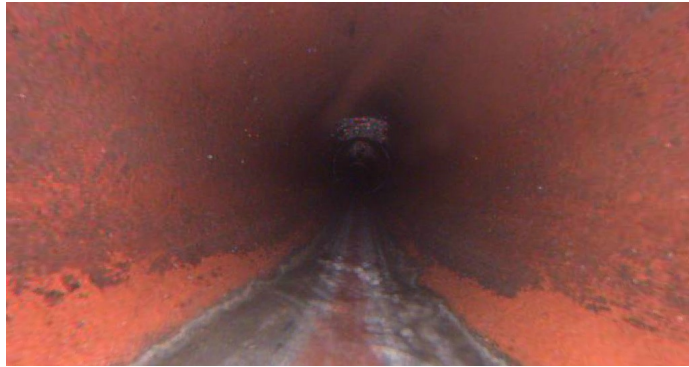
Code: **MWL**
Description: **Water Level**

Distance (ft): **.0**
Structural Grade: **0**
O&M Grade: **0**
Clock Start/From:
Clock To:
1st Value:
2nd Value:
Value Percent: **10.000**
Continuous Index:
Within 8" of Joint: **NO**
Remarks:

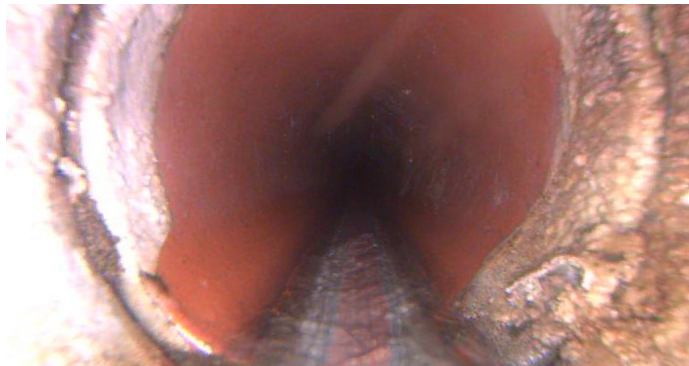
Code: **DAZ**
Description: **Deposits Attached Other**

Distance (ft): **35.1**
Structural Grade: **0**
O&M Grade: **2**
Clock Start/From: **7**
Clock To: **5**
1st Value:
2nd Value:
Value Percent: **5.000**
Continuous Index:
Within 8" of Joint: **YES**
Remarks:

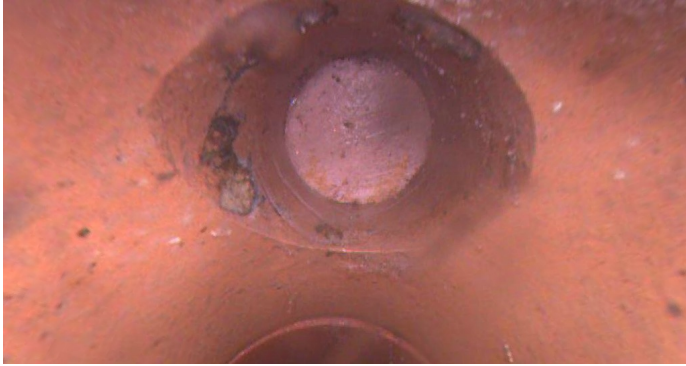
Code: **TFC**
Description: **Tap Factory Capped**

Distance (ft): **66.5**
Structural Grade: **0**
O&M Grade: **0**
Clock Start/From: **1**
Clock To:
1st Value: **4.000**
2nd Value:
Value Percent:
Continuous Index:
Within 8" of Joint:
Remarks:

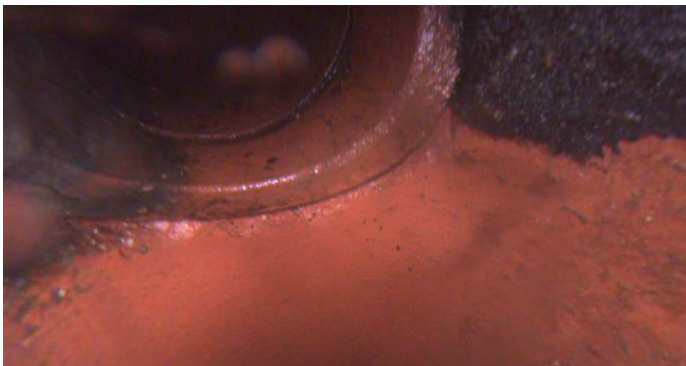
Code: **TB**
Description: **Tap Break-in**

Distance (ft): **80.9**
Structural Grade: **0**
O&M Grade: **0**
Clock Start/From: **10**
Clock To:
1st Value: **4.000**
2nd Value:
Value Percent:
Continuous Index:
Within 8" of Joint:
Remarks:

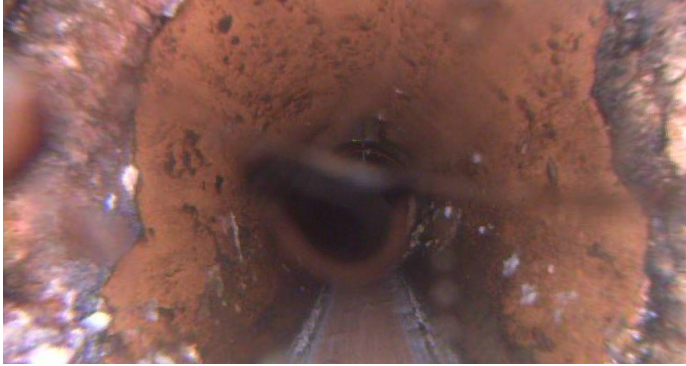
Code: **DAZ**
Description: **Deposits Attached Other**

Distance (ft): **112.3**
Structural Grade: **0**
O&M Grade: **2**
Clock Start/From: **7**
Clock To: **5**
1st Value:
2nd Value:
Value Percent: **5.000**
Continuous Index:
Within 8" of Joint: **YES**
Remarks:

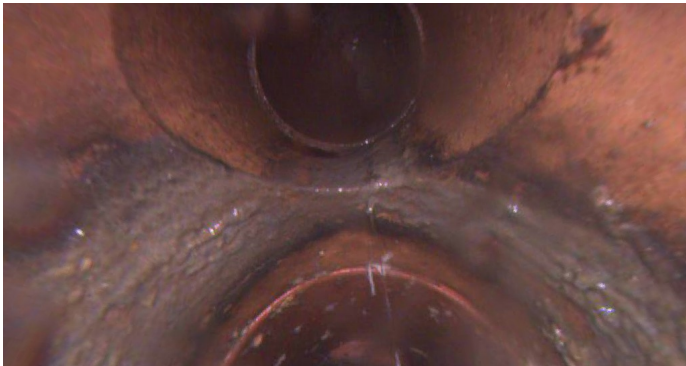
Code: **TF**
Description: **Tap Factory**

Distance (ft): **113.8**
Structural Grade: **0**
O&M Grade: **0**
Clock Start/From: **12**
Clock To:
1st Value: **4.000**
2nd Value:
Value Percent:
Continuous Index:
Within 8" of Joint:
Remarks:

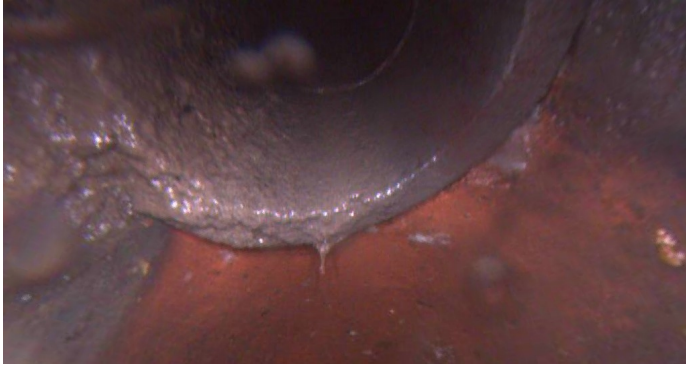
Code: **TB**
Description: **Tap Break-in**

Distance (ft): **115.7**
Structural Grade: **0**
O&M Grade: **0**
Clock Start/From: **11**
Clock To:
1st Value: **4.000**
2nd Value:
Value Percent:
Continuous Index:
Within 8" of Joint:
Remarks:

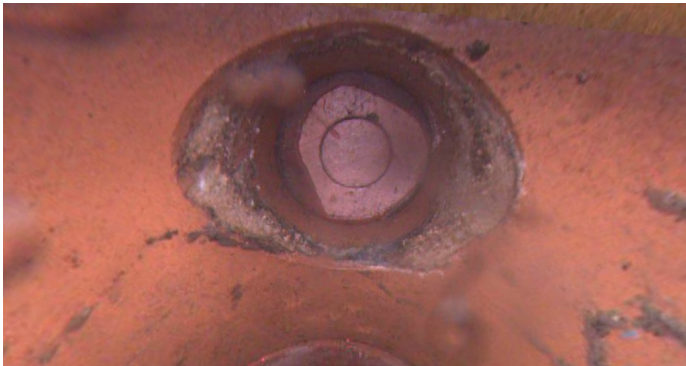
Code: **TFC**
Description: **Tap Factory Capped**

Distance (ft): **125.8**
Structural Grade: **0**
O&M Grade: **0**
Clock Start/From: **1**
Clock To:
1st Value: **4.000**
2nd Value:
Value Percent:
Continuous Index:
Within 8" of Joint:
Remarks:

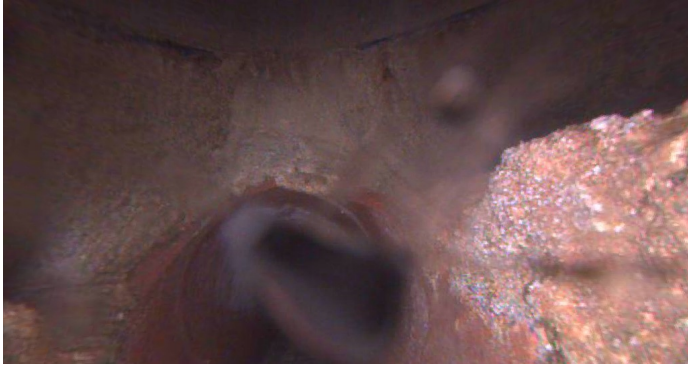
Code:	AMH
Description:	Manhole
Distance (ft):	152.9
Structural Grade:	0
O&M Grade:	0
Clock Start/From:	
Clock To:	
1st Value:	
2nd Value:	
Value Percent:	
Continuous Index:	
Within 8" of Joint:	NO
Remarks:	M-606-017
