## Profile/Photo Observation Report

| Street: | <b>W 8TH PL</b> | Flow Control: | <b>Not Controlled</b> |
| City: | <b>Hobart, IN</b> | Year Renewed: | |
| Purpose: | <b>Routine Assessment</b> | Dia/Height: | <b>10"</b> |

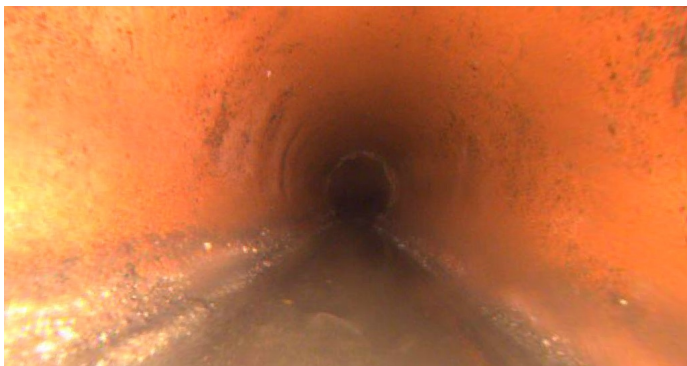
Code: **AMH**  
Description: **Manhole**

Distance (ft): **.0**  
Structural Grade: **0**  
O&M Grade: **0**  
Clock Start/From:  
Clock To:  
1st Value:  
2nd Value:  
Value Percent:  
Continuous Index:  
Within 8" of Joint: **NO**  
Remarks: **M-606-015**

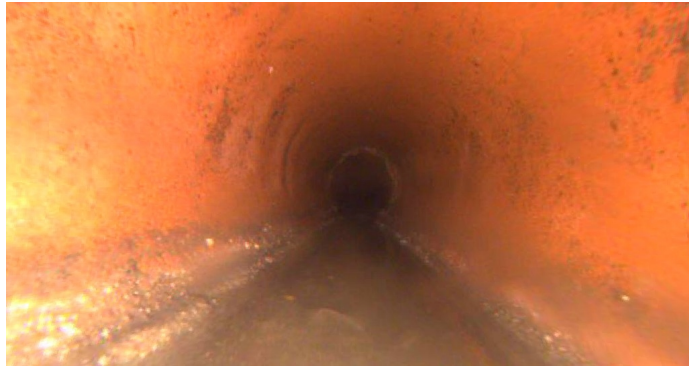
Code: **MWL**  
Description: **Water Level**

Distance (ft): **.0**  
Structural Grade: **0**  
O&M Grade: **0**  
Clock Start/From:  
Clock To:  
1st Value:  
2nd Value:  
Value Percent: **10.000**  
Continuous Index:  
Within 8" of Joint: **NO**  
Remarks:

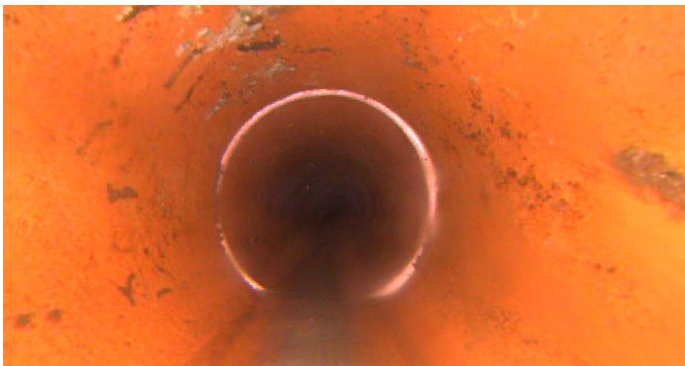
Code: **DAE**  
Description: **Deposits Attached Encrustation**

Distance (ft): **13.3**  
Structural Grade: **0**  
O&M Grade: **2**  
Clock Start/From: **7**  
Clock To: **5**  
1st Value:  
2nd Value:  
Value Percent: **5.000**  
Continuous Index: **F01**  
Within 8" of Joint: **YES**  
Remarks:

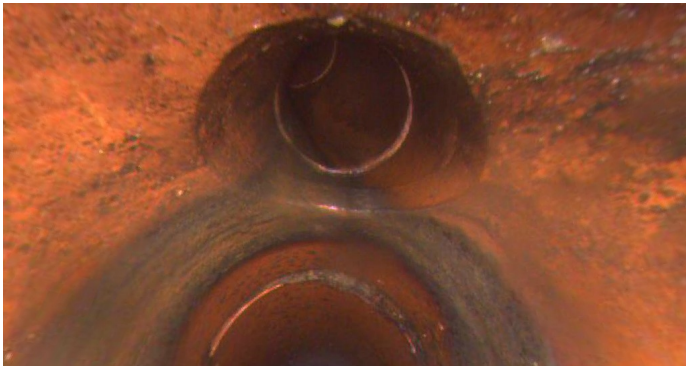
Code: **TF**  
Description: **Tap Factory**

Distance (ft): **30.1**  
Structural Grade: **0**  
O&M Grade: **0**  
Clock Start/From: **1**  
Clock To:  
1st Value: **4.000**  
2nd Value:  
Value Percent:  
Continuous Index:  
Within 8" of Joint:  
Remarks:

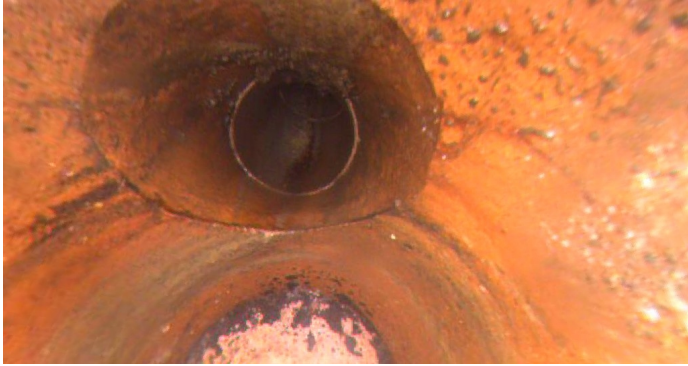
Code: **TF**  
Description: **Tap Factory**

Distance (ft): **71.7**  
Structural Grade: **0**  
O&M Grade: **0**  
Clock Start/From: **12**  
Clock To:  
1st Value: **4.000**  
2nd Value:  
Value Percent:  
Continuous Index:  
Within 8" of Joint:  
Remarks: **Lamphole**
