Profile/Photo Observation Report

Street:	FOXCROFT STREET	Flow Control:	Not Controlled
City:	Hobart, IN	Year Renewed:	
Location:	Yard	Tape/Media #:	
Purpose:	Routine Assessment	Dia/Height:	10"
Use:	Sanitary	Material:	VCP
Drain Area:	NA	Lining:	
Category:	NA		
Comment:

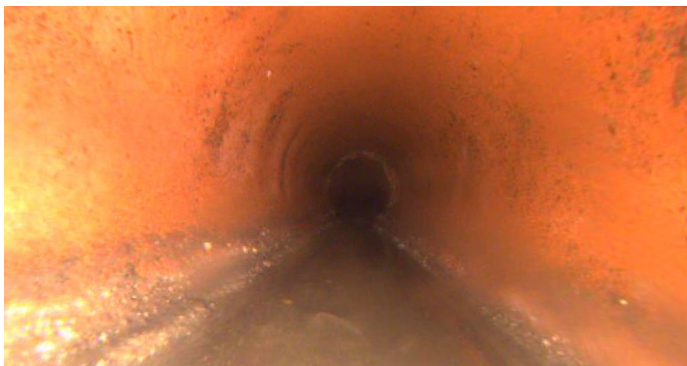
Code: **AMH**
 Description: **Manhole**

Distance (ft): **.0**
 Structural Grade: **0**
 O&M Grade: **0**
 Clock Start/From:
 Clock To:
 1st Value:
 2nd Value:
 Value Percent:
 Continuous Index:
 Within 8" of Joint: **NO**
 Remarks: **M-606-015**

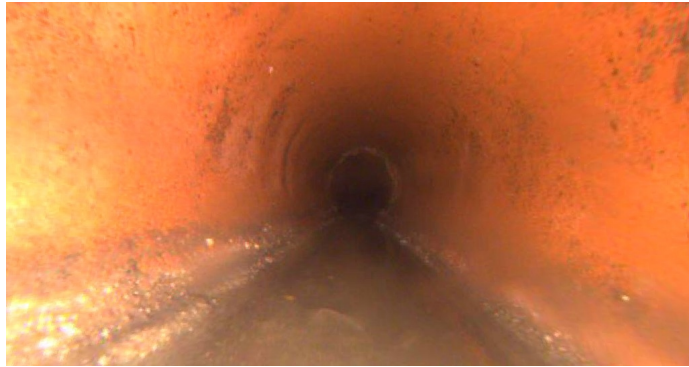
Code: **MWL**
Description: **Water Level**

Distance (ft): **.0**
Structural Grade: **0**
O&M Grade: **0**
Clock Start/From:
Clock To:
1st Value:
2nd Value:
Value Percent: **10.000**
Continuous Index:
Within 8" of Joint: **NO**
Remarks:

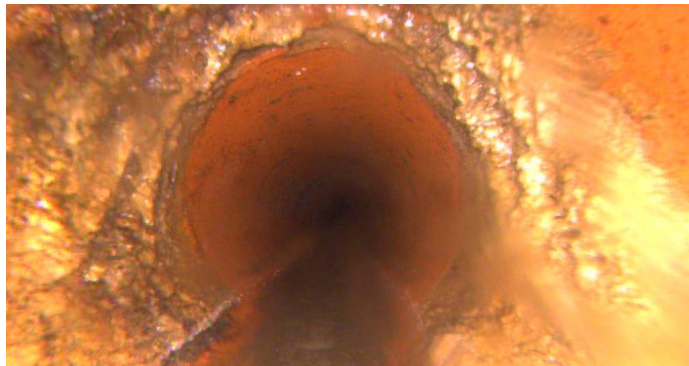
Code: **DAE**
Description: **Deposits Attached Encrustation**

Distance (ft): **4.0**
Structural Grade: **0**
O&M Grade: **2**
Clock Start/From: **7**
Clock To: **5**
1st Value:
2nd Value:
Value Percent: **5.000**
Continuous Index: **S01**
Within 8" of Joint: **YES**
Remarks:

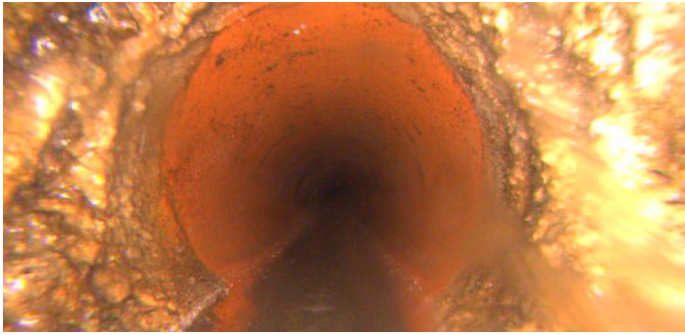
Code: **IW**
Description: **Infil Weeper**

Distance (ft): **4.1**
Structural Grade: **0**
O&M Grade: **2**
Clock Start/From: **8**
Clock To: **4**
1st Value:
2nd Value:
Value Percent:
Continuous Index: **S03**
Within 8" of Joint: **YES**
Remarks:

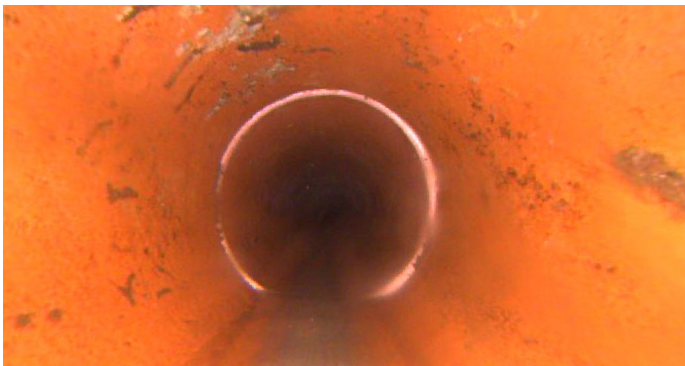
Code: **DAE**
Description: **Deposits Attached Encrustation**

Distance (ft): **13.3**
Structural Grade: **0**
O&M Grade: **2**
Clock Start/From: **7**
Clock To: **5**
1st Value:
2nd Value:
Value Percent: **5.000**
Continuous Index: **F01**
Within 8" of Joint: **YES**
Remarks:

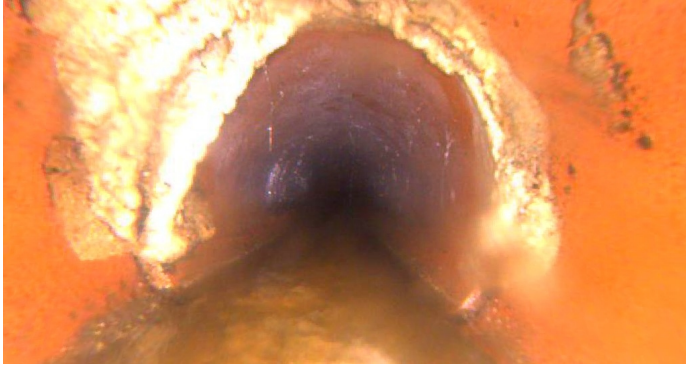
Code: **DAE**
Description: **Deposits Attached Encrustation**

Distance (ft): **23.7**
Structural Grade: **0**
O&M Grade: **2**
Clock Start/From: **7**
Clock To: **5**
1st Value:
2nd Value:
Value Percent: **5.000**
Continuous Index:
Within 8" of Joint: **YES**
Remarks:

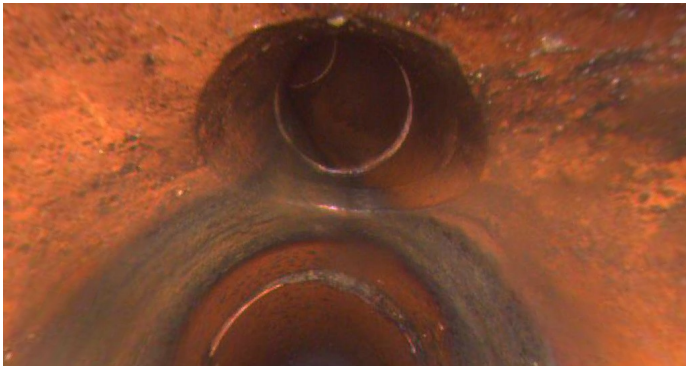
Code: **TF**
Description: **Tap Factory**

Distance (ft): **30.1**
Structural Grade: **0**
O&M Grade: **0**
Clock Start/From: **1**
Clock To:
1st Value: **4.000**
2nd Value:
Value Percent:
Continuous Index:
Within 8" of Joint:
Remarks:

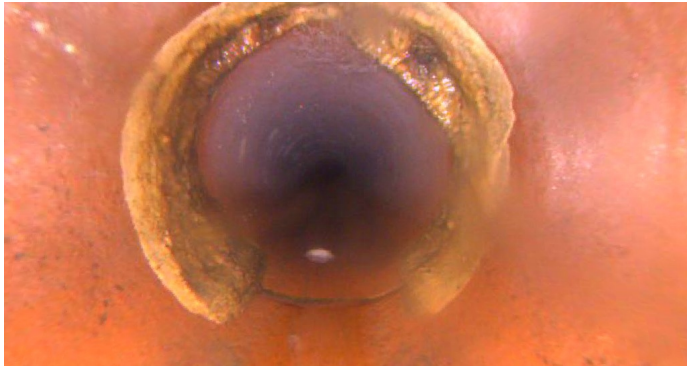
Code:	DAE
Description:	Deposits Attached Encrustation
Distance (ft):	45.3
Structural Grade:	0
O&M Grade:	2
Clock Start/From:	7
Clock To:	5
1st Value:	
2nd Value:	
Value Percent:	5.000
Continuous Index:	
Within 8" of Joint:	YES
Remarks:

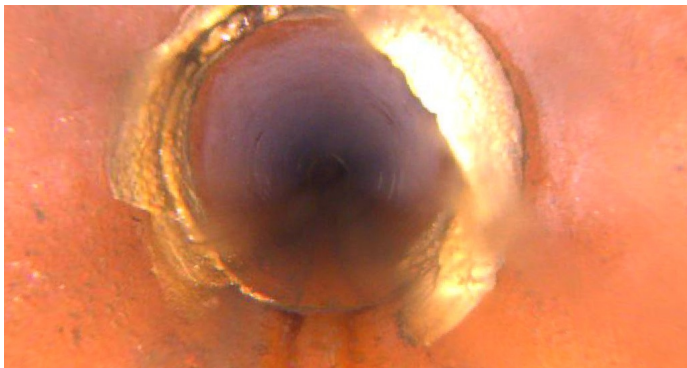
Code:	DAE
Description:	Deposits Attached Encrustation
Distance (ft):	60.2
Structural Grade:	0
O&M Grade:	2
Clock Start/From:	7
Clock To:	5
1st Value:	
2nd Value:	
Value Percent:	5.000
Continuous Index:	S02
Within 8" of Joint:	YES
Remarks:

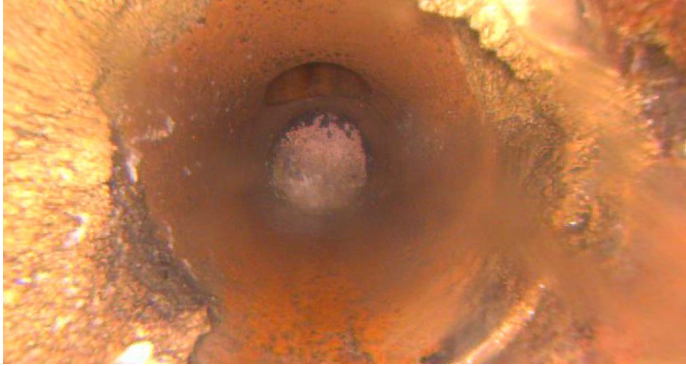
Code: **DAE**
Description: **Deposits Attached Encrustation**

Distance (ft): **70.5**
Structural Grade: **0**
O&M Grade: **2**
Clock Start/From: **7**
Clock To: **5**
1st Value:
2nd Value:
Value Percent: **5.000**
Continuous Index: **F02**
Within 8" of Joint: **YES**
Remarks:

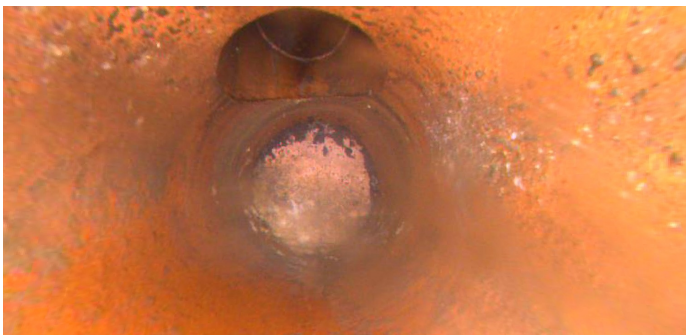
Code: **IW**
Description: **Infil Weeper**

Distance (ft): **71.2**
Structural Grade: **0**
O&M Grade: **2**
Clock Start/From: **8**
Clock To: **4**
1st Value:
2nd Value:
Value Percent:
Continuous Index: **F03**
Within 8" of Joint: **YES**
Remarks:

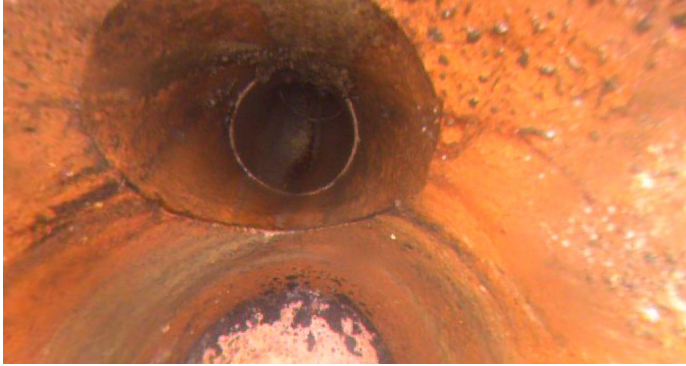
Code: **TF**
Description: **Tap Factory**

Distance (ft): **71.7**
Structural Grade: **0**
O&M Grade: **0**
Clock Start/From: **12**
Clock To:
1st Value: **4.000**
2nd Value:
Value Percent:
Continuous Index:
Within 8" of Joint:
Remarks: **Lamphole**

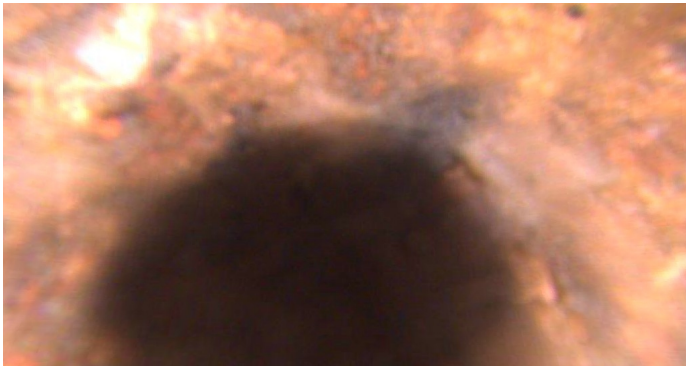
Code: **AEP**
Description: **End of Pipe**

Distance (ft): **73.1**
Structural Grade: **0**
O&M Grade: **0**
Clock Start/From:
Clock To:
1st Value:
2nd Value:
Value Percent:
Continuous Index:
Within 8" of Joint: **NO**
Remarks: **M-606-015**
