Profile/Photo Observation Report

Street:	West 8th Street	Flow Control:	Not Controlled
City:	Hobart, IN	Year Renewed:	
Location:	Light Highway	Tape/Media #:	DEP 624
Purpose:	Routine Assessment	Dia/Height:	18"
Use:	Sanitary	Material:	VCP
Drain Area:		Lining:	
Category:	NA		
Comment:	5-21-2018		
Location Details:		Direction of Survey:	Downstream
US MH:	M-606-022	DS MH:	M-606-021
		Total Length Surveyed (ft):	151.3

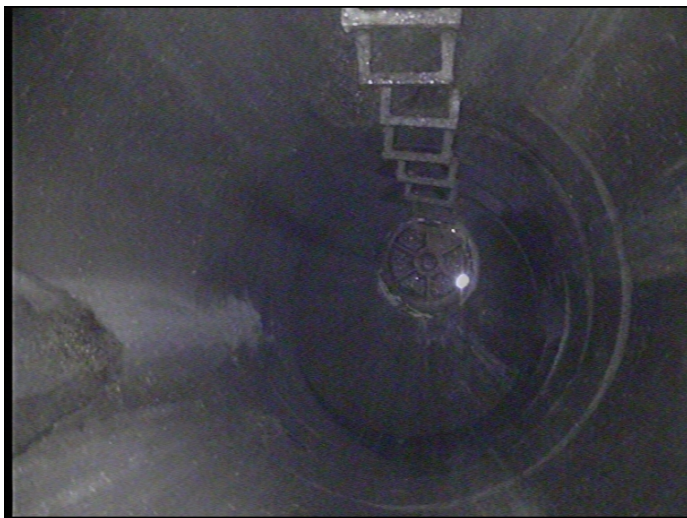
Code: **AMH**
 Description: **Manhole**

Distance (ft): **.0**
 Structural Grade: **0**
 O&M Grade: **0**
 Clock Start/From:
 Clock To:
 1st Value:
 2nd Value:
 Value Percent:
 Continuous Index:
 Within 8" of Joint: **NO**
 Remarks: **M-606-022**

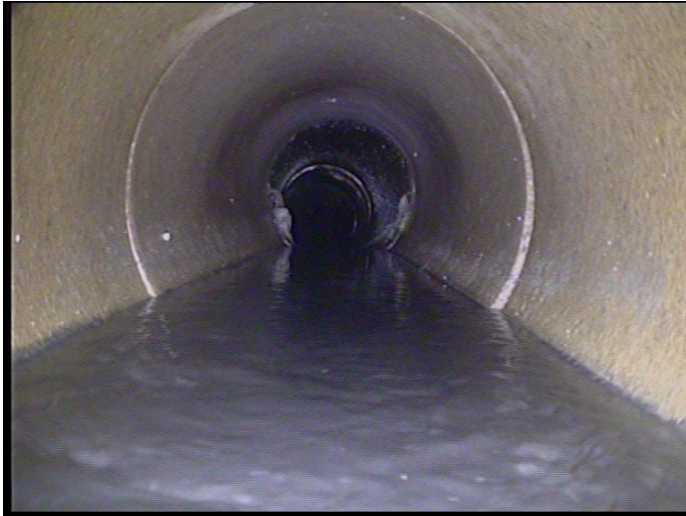
Code:	MWL
Description:	Water Level
Distance (ft):	.0
Structural Grade:	0
O&M Grade:	0
Clock Start/From:	
Clock To:	
1st Value:	
2nd Value:	
Value Percent:	10.000
Continuous Index:	
Within 8" of Joint:	NO
Remarks:

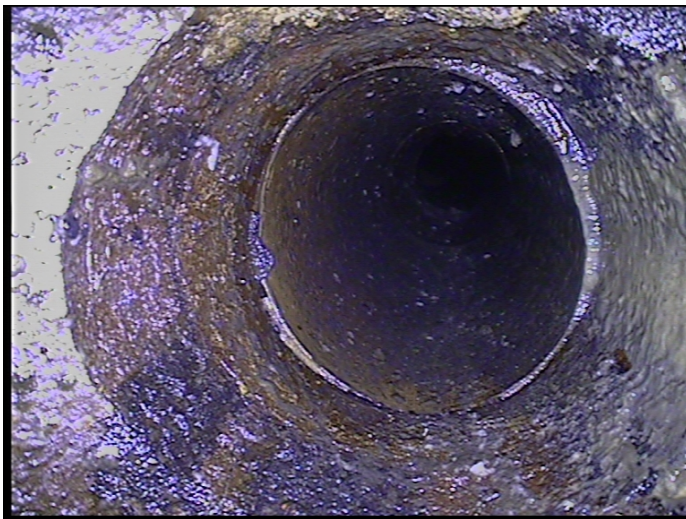
Code:	TF
Description:	Tap Factory
Distance (ft):	13.3
Structural Grade:	0
O&M Grade:	0
Clock Start/From:	2
Clock To:	
1st Value:	4.000
2nd Value:	
Value Percent:	
Continuous Index:	
Within 8" of Joint:	NO
Remarks:

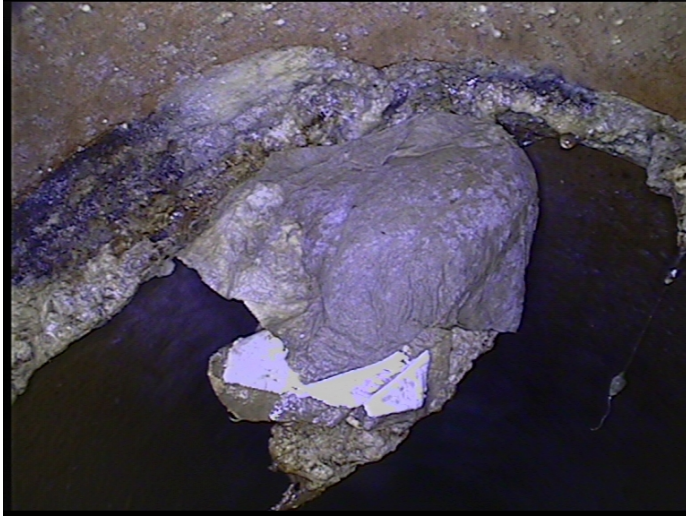
Code:	DAE
Description:	Deposits Attached Encrustation
Distance (ft):	49.7
Structural Grade:	0
O&M Grade:	2
Clock Start/From:	10
Clock To:	
1st Value:	
2nd Value:	
Value Percent:	10.000
Continuous Index:	
Within 8" of Joint:	YES
Remarks:

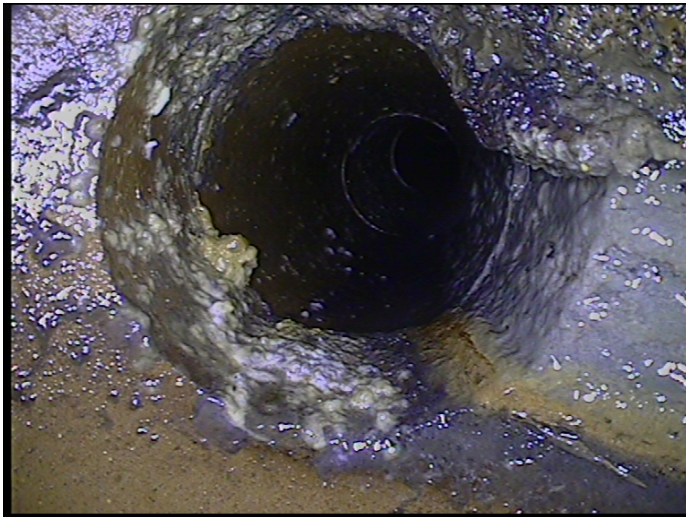
Code:	TF
Description:	Tap Factory
Distance (ft):	56.6
Structural Grade:	0
O&M Grade:	0
Clock Start/From:	2
Clock To:	
1st Value:	4.000
2nd Value:	
Value Percent:	
Continuous Index:	
Within 8" of Joint:	NO
Remarks:

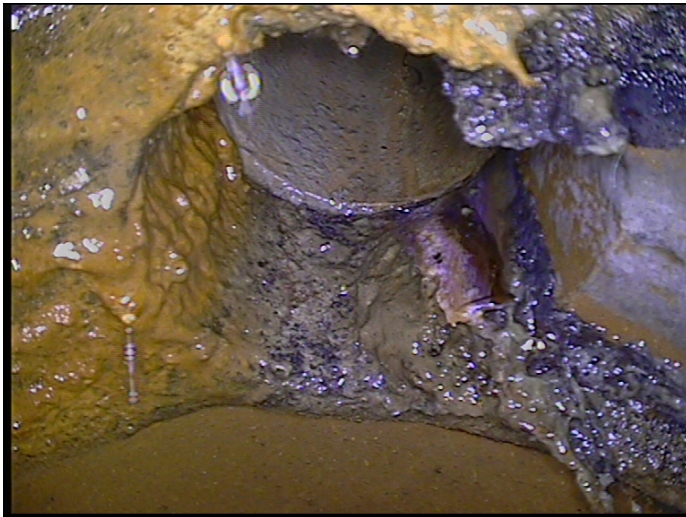
Code: **TBA**
 Description: **Tap Break-in Active**

Distance (ft): **109.4**
 Structural Grade: **0**
 O&M Grade: **0**
 Clock Start/From: **2**
 Clock To:
 1st Value: **4.000**
 2nd Value:
 Value Percent:
 Continuous Index:
 Within 8" of Joint: **NO**
 Remarks:

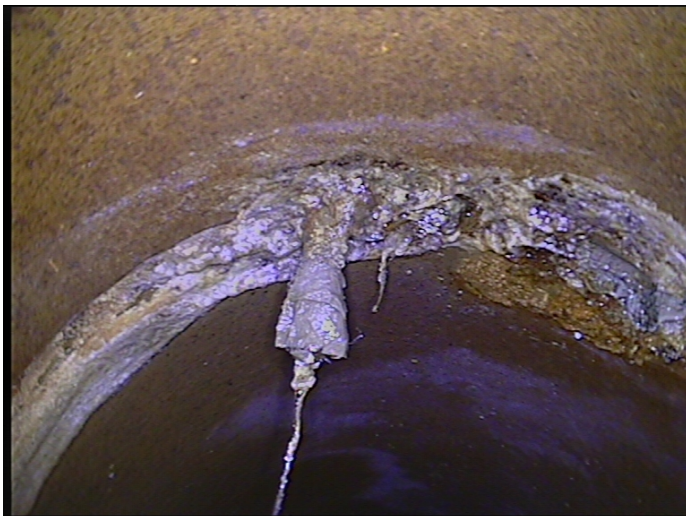
Code: **ID**
 Description: **Infil Dripper**

Distance (ft): **140.8**
 Structural Grade: **0**
 O&M Grade: **3**
 Clock Start/From: **12**
 Clock To:
 1st Value:
 2nd Value:
 Value Percent:
 Continuous Index:
 Within 8" of Joint: **YES**
 Remarks:

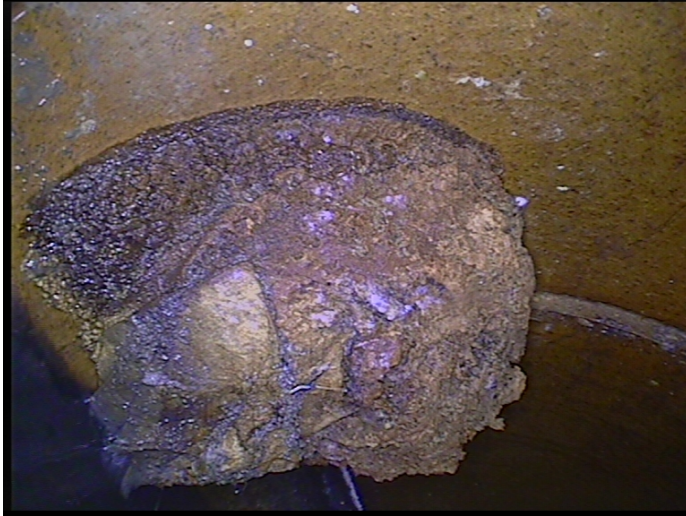
Code:	DAE
Description:	Deposits Attached Encrustation
Distance (ft):	145.8
Structural Grade:	0
O&M Grade:	2
Clock Start/From:	7
Clock To:	8
1st Value:	
2nd Value:	
Value Percent:	10.000
Continuous Index:	
Within 8" of Joint:	NO
Remarks:

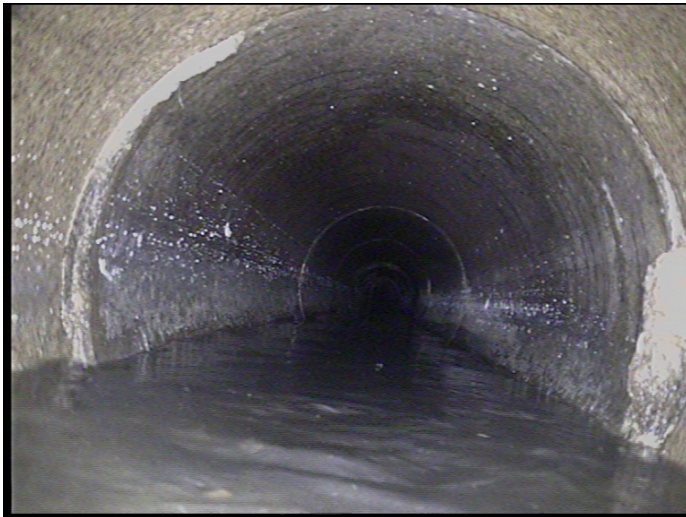
Code:	MSA
Description:	Abandoned Survey
Distance (ft):	150.3
Structural Grade:	0
O&M Grade:	0
Clock Start/From:	
Clock To:	
1st Value:	
2nd Value:	
Value Percent:	
Continuous Index:	
Within 8" of Joint:	NO
Remarks:	reverse complete
