## Profile/Photo Observation Report

Date:	<b>05/08/2018</b>	Weather:		Coding:	<b>PACP 6.0</b>
Pipe Length (ft):		Owner:	<b>City of Hobart</b>	Pre Clean:	<b>No Pre-Cleaning</b>
P.O.#:	<b>624</b>	Surveyor:	<b>M. Pielacha</b>	PSR:	<b>P-606-023-022</b>
Customer:	<b>City of Hobart</b>	Clean Date:		Shape:	<b>C</b>

Location Details:		Direction of Survey:	<b>Downstream</b>
US MH:	<b>M-606-022</b>	DS MH:	<b>M-606-023</b>
		Total Length Surveyed (ft):	<b>205.0</b>

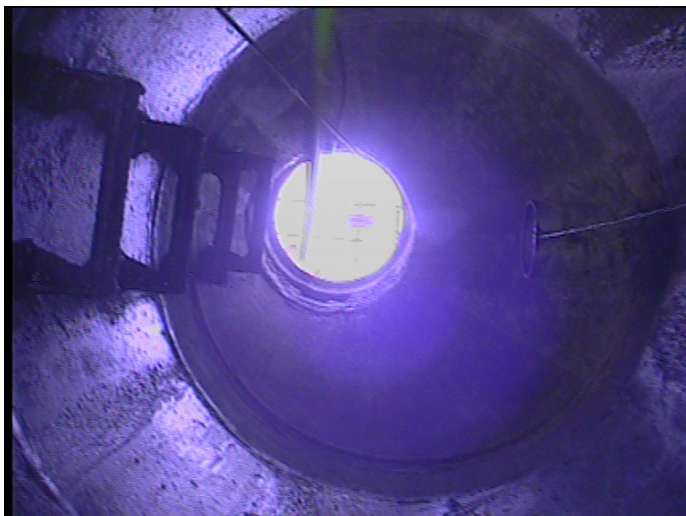
Code: **AMH**  
Description: **Manhole**

Distance (ft): **.0**  
Structural Grade: **0**  
O&M Grade: **0**  
Clock Start/From:  
Clock To:  
1st Value:  
2nd Value:  
Value Percent:  
Continuous Index:  
Within 8" of Joint: **NO**  
Remarks: **M-606-023**

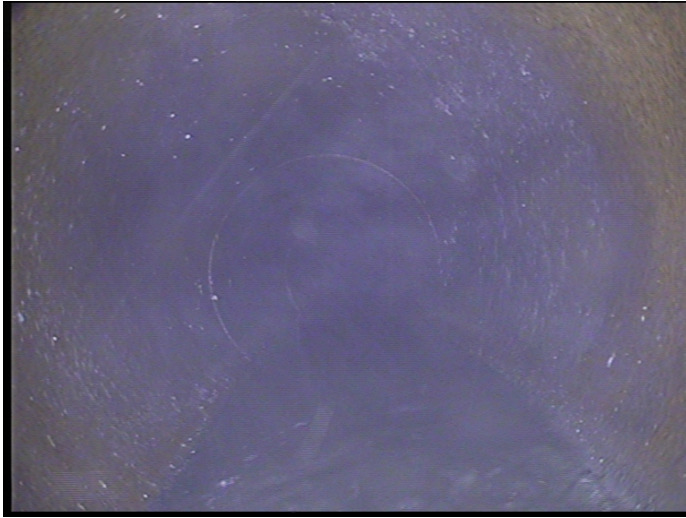
Code:	<b>MWL</b>
Description:	<b>Water Level</b>
Distance (ft):	<b>.0</b>
Structural Grade:	<b>0</b>
O&M Grade:	<b>0</b>
Clock Start/From:	
Clock To:	
1st Value:	
2nd Value:	
Value Percent:	<b>10.000</b>
Continuous Index:	
Within 8" of Joint:	<b>NO</b>
Remarks:

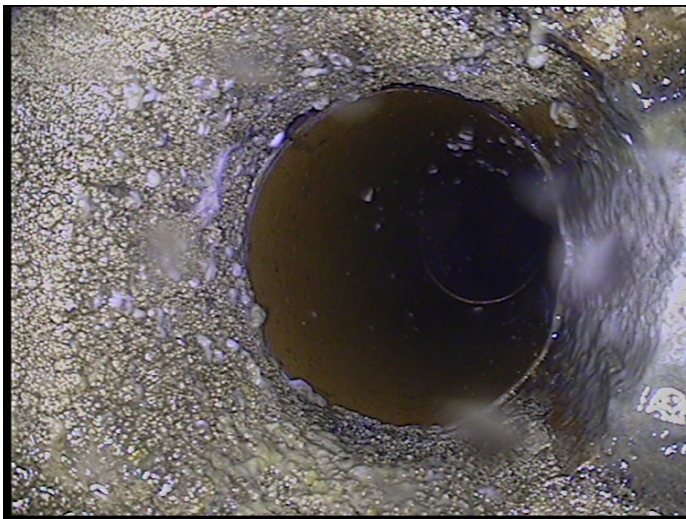
Code:	<b>TF</b>
Description:	<b>Tap Factory</b>
Distance (ft):	<b>33.9</b>
Structural Grade:	<b>0</b>
O&M Grade:	<b>0</b>
Clock Start/From:	<b>1</b>
Clock To:	
1st Value:	<b>4.000</b>
2nd Value:	
Value Percent:	
Continuous Index:	
Within 8" of Joint:	<b>NO</b>
Remarks:

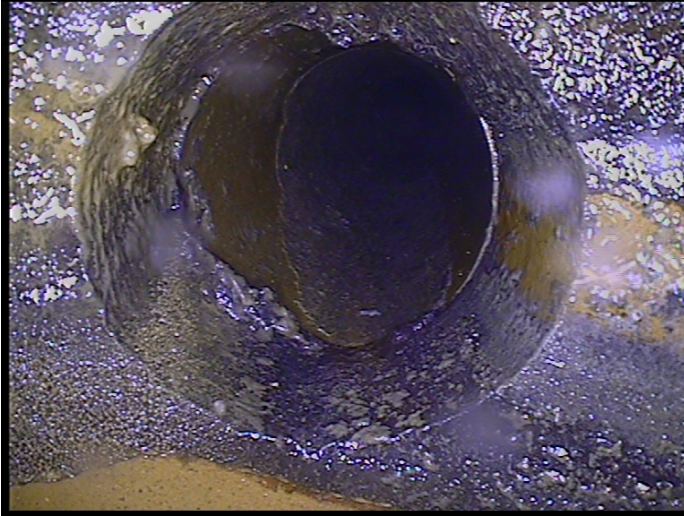
Code:	<b>TFA</b>
Description:	<b>Tap Factory Active</b>
Distance (ft):	<b>96.7</b>
Structural Grade:	<b>0</b>
O&M Grade:	<b>0</b>
Clock Start/From:	<b>2</b>
Clock To:	
1st Value:	<b>4.000</b>
2nd Value:	
Value Percent:	
Continuous Index:	
Within 8" of Joint:	<b>NO</b>
Remarks:

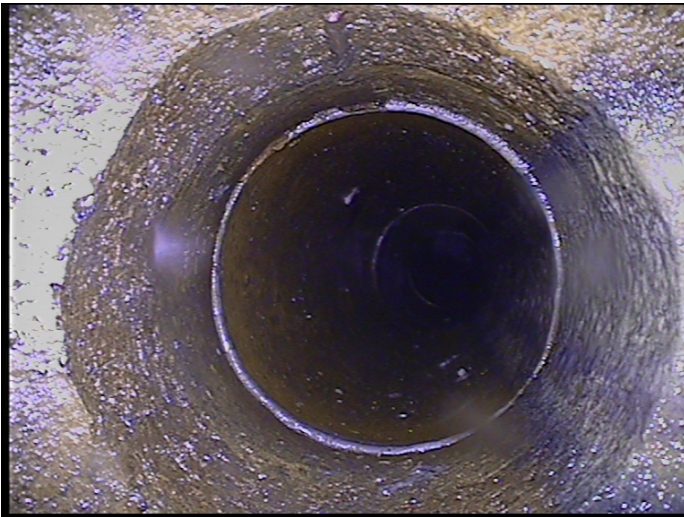
Code:	<b>TF</b>
Description:	<b>Tap Factory</b>
Distance (ft):	<b>150.1</b>
Structural Grade:	<b>0</b>
O&M Grade:	<b>0</b>
Clock Start/From:	<b>1</b>
Clock To:	
1st Value:	<b>4.000</b>
2nd Value:	
Value Percent:	
Continuous Index:	
Within 8" of Joint:	<b>NO</b>
Remarks:

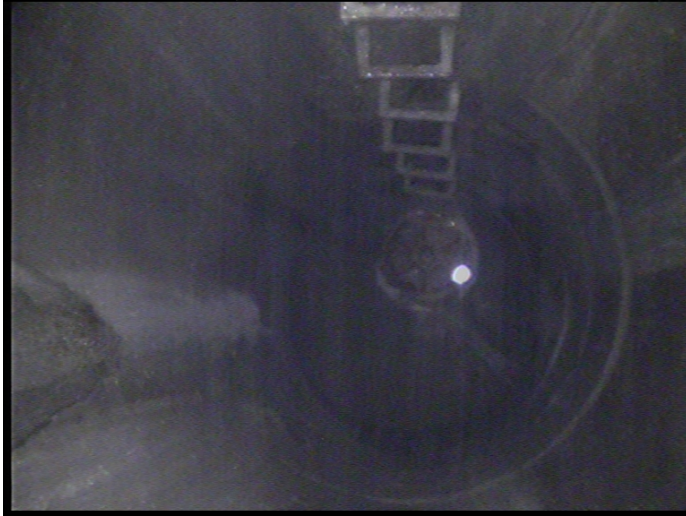
Code:	<b>AMH</b>
Description:	<b>Manhole</b>
Distance (ft):	<b>205.0</b>
Structural Grade:	<b>0</b>
O&M Grade:	<b>0</b>
Clock Start/From:	
Clock To:	
1st Value:	
2nd Value:	
Value Percent:	
Continuous Index:	
Within 8" of Joint:	<b>NO</b>
Remarks:	<b>M-606-022</b>
