Profile/Photo Observation Report

Date:	04/11/2018	Weather:		Coding:	PACP 6.0
Pipe Length (ft):	17.2	Owner:	NA	Pre Clean:	No Pre-Cleaning
P.O.#:		Surveyor:	Jen Costello	PSR:	P-706-063-028
Customer:		Clean Date:	01/01/1900	Shape:	C

Street:	FOXCROFT STREET	Flow Control:	Not Controlled
City:	Hobart, IN	Year Renewed:	
Location:	Yard	Tape/Media #:	
Purpose:	Routine Assessment	Dia/Height:	8"
Use:	Sanitary	Material:	PVC
Drain Area:	NA	Lining:	
Category:	NA		
Comment:	Flow direction is marked wrong.

Location Details:		Direction of Survey:	Upstream
US MH:	M-606-028	DS MH:	M-706-063
		Total Length Surveyed (ft):	13.0

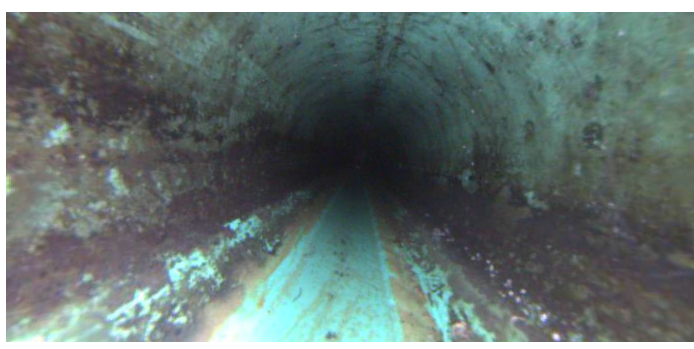
Code: **AMH**
Description: **Manhole**

Distance (ft): **.0**
Structural Grade: **0**
O&M Grade: **0**
Clock Start/From:
Clock To:
1st Value:
2nd Value:
Value Percent:
Continuous Index:
Within 8" of Joint: **NO**
Remarks: **M-706-063**

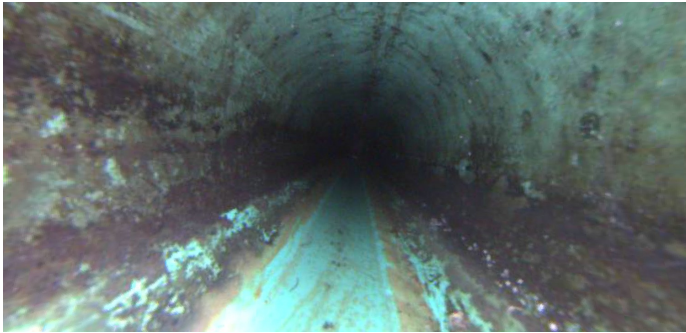
Code:	MWL
Description:	Water Level

Distance (ft):	.0
Structural Grade:	0
O&M Grade:	0
Clock Start/From:	
Clock To:	
1st Value:	
2nd Value:	
Value Percent:	5.000
Continuous Index:	
Within 8" of Joint:	NO
Remarks:

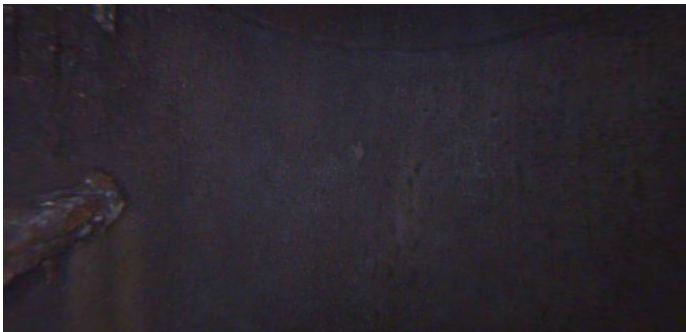
Code:	AMH
Description:	Manhole

Distance (ft):	13.0
Structural Grade:	0
O&M Grade:	0
Clock Start/From:	
Clock To:	
1st Value:	
2nd Value:	
Value Percent:	
Continuous Index:	
Within 8" of Joint:	NO
Remarks:	M-606-028
