Profile/Photo Observation Report

Street:	West 8th Street	Flow Control:	Not Controlled
City:	Hobart, IN	Year Renewed:	
Location:	Light Highway	Tape/Media #:	DEP 623
Purpose:	Routine Assessment	Dia/Height:	18"
Use:	Sanitary	Material:	VCP
Drain Area:		Lining:	
Category:	NA		
Comment:	5-21-2018		
Location Details:		Direction of Survey:	Upstream
US MH:	M-606-051	DS MH:	M-606-023
		Total Length Surveyed (ft):	57.6

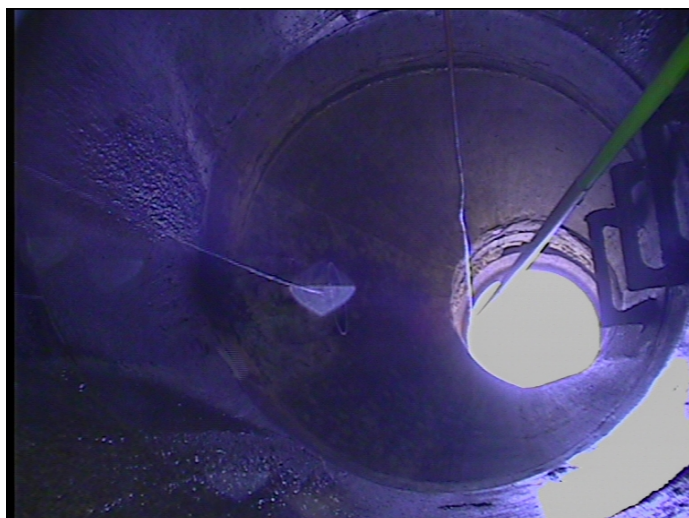
Code: **AMH**
Description: **Manhole**

Distance (ft): **.0**
Structural Grade: **0**
O&M Grade: **0**
Clock Start/From:
Clock To:
1st Value:
2nd Value:
Value Percent:
Continuous Index:
Within 8" of Joint: **NO**
Remarks: **M-606-023**

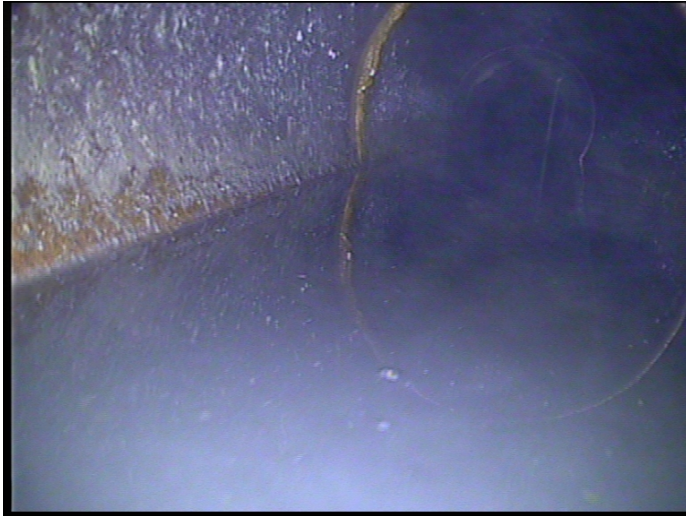
Code: **MWL**
Description: **Water Level**

Distance (ft): **.0**
Structural Grade: **0**
O&M Grade: **0**
Clock Start/From:
Clock To:
1st Value:
2nd Value:
Value Percent: **15.000**
Continuous Index:
Within 8" of Joint: **NO**
Remarks:

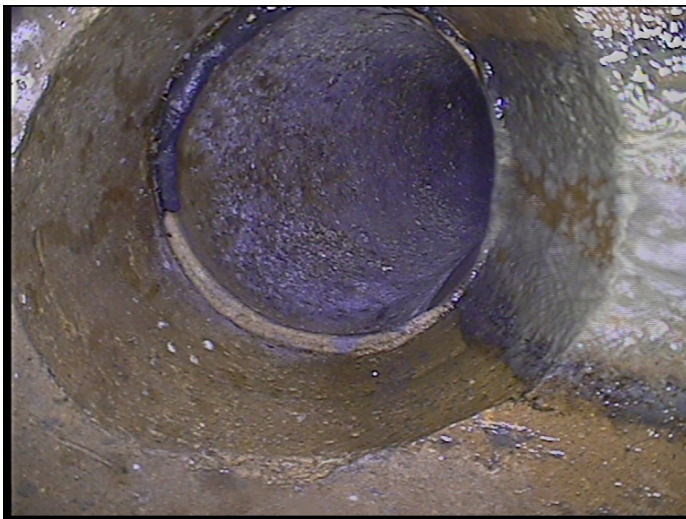
Code: **TFA**
Description: **Tap Factory Active**

Distance (ft): **4.7**
Structural Grade: **0**
O&M Grade: **0**
Clock Start/From: **3**
Clock To:
1st Value: **4.000**
2nd Value:
Value Percent:
Continuous Index:
Within 8" of Joint: **NO**
Remarks:

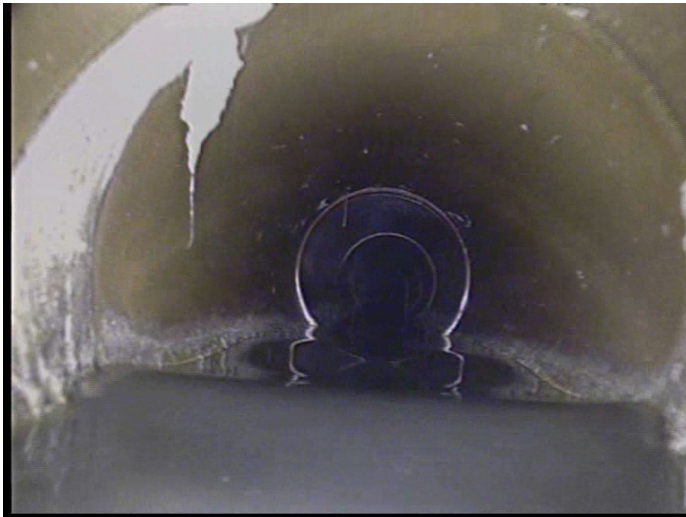
Code:	DAE
Description:	Deposits Attached Encrustation
Distance (ft):	22.0
Structural Grade:	0
O&M Grade:	2
Clock Start/From:	3
Clock To:	11
1st Value:	
2nd Value:	
Value Percent:	5.000
Continuous Index:	
Within 8" of Joint:	YES
Remarks:

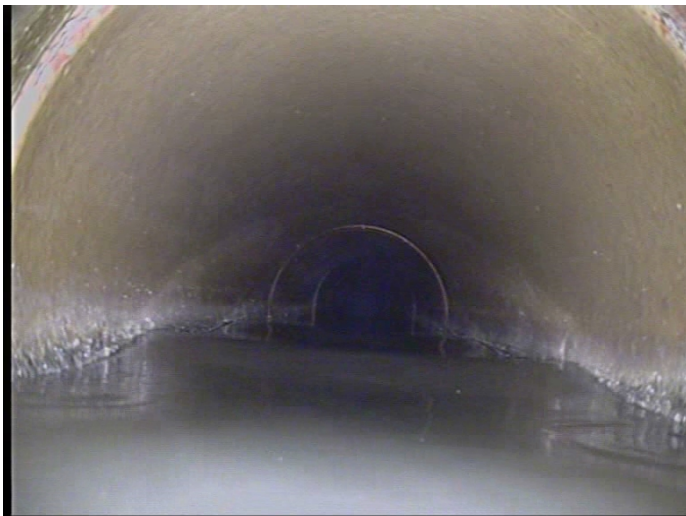
Code:	MWL
Description:	Water Level
Distance (ft):	47.6
Structural Grade:	0
O&M Grade:	0
Clock Start/From:	
Clock To:	
1st Value:	
2nd Value:	
Value Percent:	40.000
Continuous Index:	
Within 8" of Joint:	NO
Remarks:

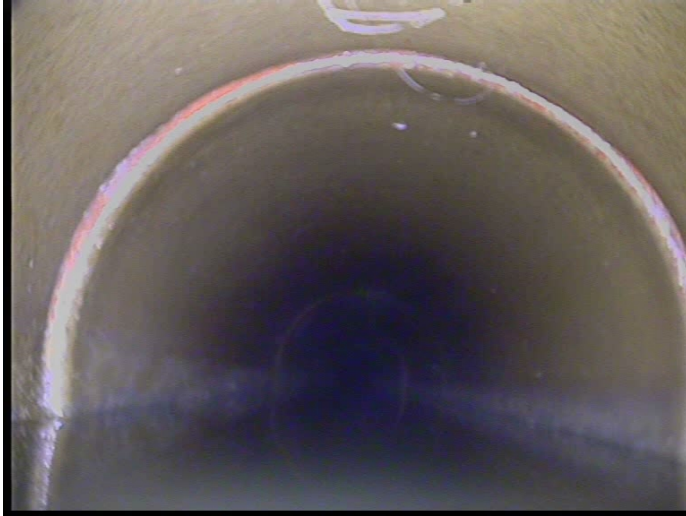
Code:	MSA
Description:	Abandoned Survey
Distance (ft):	57.6
Structural Grade:	0
O&M Grade:	0
Clock Start/From:	
Clock To:	
1st Value:	
2nd Value:	
Value Percent:	
Continuous Index:	
Within 8" of Joint:	NO
Remarks:	Asset stops
