Profile/Photo Observation Report

Date:	04/10/2018	Weather:		Coding:	PACP 6.0
Pipe Length (ft):	156.7	Owner:	NA	Pre Clean:	No Pre-Cleaning
P.O.#:		Surveyor:	Jen Costello	PSR:	P-606-052-051
Customer:		Clean Date:	01/01/1900	Shape:	C

Street:	W 8TH ST & S ASH ST	Flow Control:	Not Controlled
City:	Hobart, IN	Year Renewed:	
Location:	Yard	Tape/Media #:	
Purpose:	Routine Assessment	Dia/Height:	12"
Use:	Sanitary	Material:	VCP
Drain Area:	NA	Lining:	
Category:	NA		
Comment:	P_C DAE, flow direction is marked wrong.

Location Details:		Direction of Survey:	Downstream
US MH:	M-606-051	DS MH:	M-606-052
		Total Length Surveyed (ft):	11.6

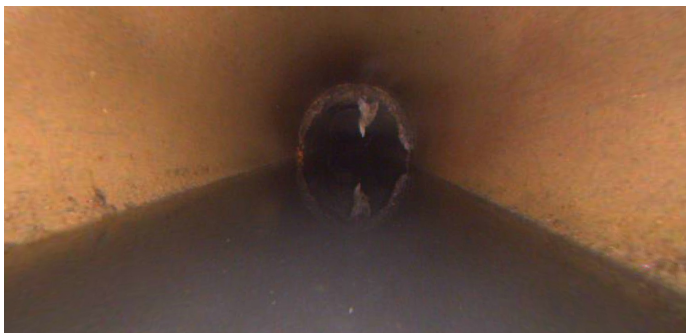
Code: **AMH**
Description: **Manhole**

Distance (ft): **.0**
Structural Grade: **0**
O&M Grade: **0**
Clock Start/From:
Clock To:
1st Value:
2nd Value:
Value Percent:
Continuous Index:
Within 8" of Joint: **NO**
Remarks: **M-606-051**

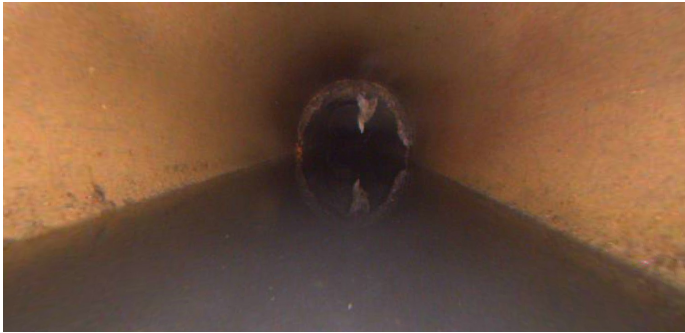
Code:	MWL
Description:	Water Level

Distance (ft):	.0
Structural Grade:	0
O&M Grade:	0
Clock Start/From:	
Clock To:	
1st Value:	
2nd Value:	
Value Percent:	30.000
Continuous Index:	
Within 8" of Joint:	NO
Remarks:

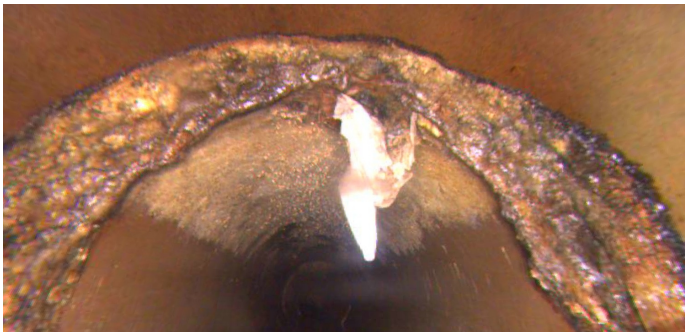
Code:	DAE
Description:	Deposits Attached Encrustation

Distance (ft):	2.9
Structural Grade:	0
O&M Grade:	2
Clock Start/From:	8
Clock To:	4
1st Value:	
2nd Value:	
Value Percent:	10.000
Continuous Index:	
Within 8" of Joint:	YES
Remarks:

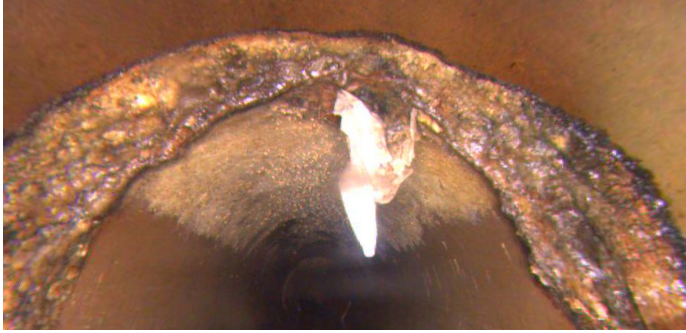
Code: **DAR**
Description: **Deposits Attached Ragging**

Distance (ft): **2.9**
Structural Grade: **0**
O&M Grade: **2**
Clock Start/From: **12**
Clock To:
1st Value:
2nd Value:
Value Percent: **5.000**
Continuous Index:
Within 8" of Joint: **YES**
Remarks:

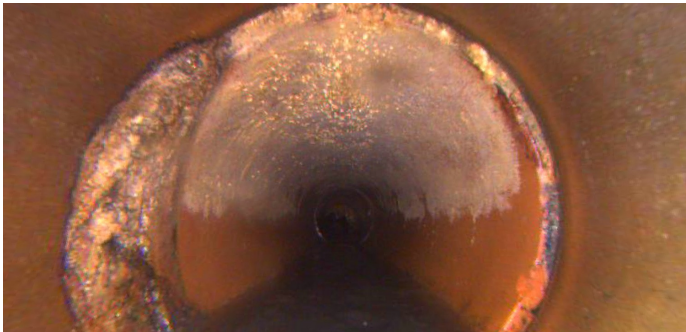
Code: **DAE**
Description: **Deposits Attached Encrustation**

Distance (ft): **6.6**
Structural Grade: **0**
O&M Grade: **2**
Clock Start/From: **7**
Clock To: **11**
1st Value:
2nd Value:
Value Percent: **5.000**
Continuous Index:
Within 8" of Joint: **YES**
Remarks:

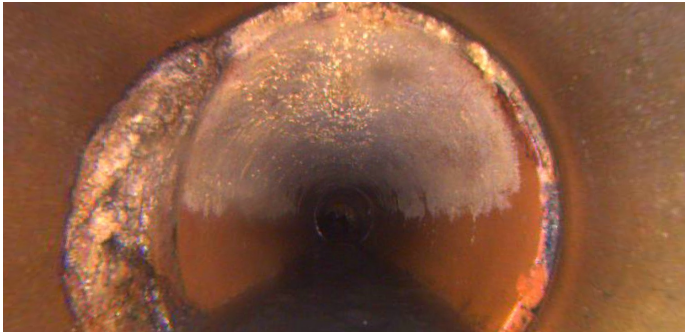
Code: **IW**
Description: **Infil Weeper**

Distance (ft): **6.6**
Structural Grade: **0**
O&M Grade: **2**
Clock Start/From: **7**
Clock To: **11**
1st Value:
2nd Value:
Value Percent:
Continuous Index:
Within 8" of Joint: **YES**
Remarks:

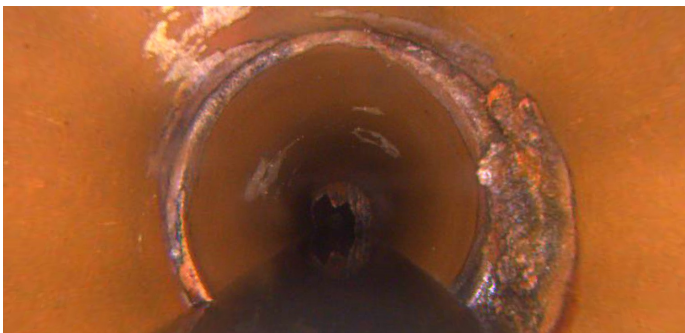
Code: **DAE**
Description: **Deposits Attached Encrustation**

Distance (ft): **10.4**
Structural Grade: **0**
O&M Grade: **2**
Clock Start/From: **8**
Clock To: **4**
1st Value:
2nd Value:
Value Percent: **5.000**
Continuous Index:
Within 8" of Joint: **YES**
Remarks:

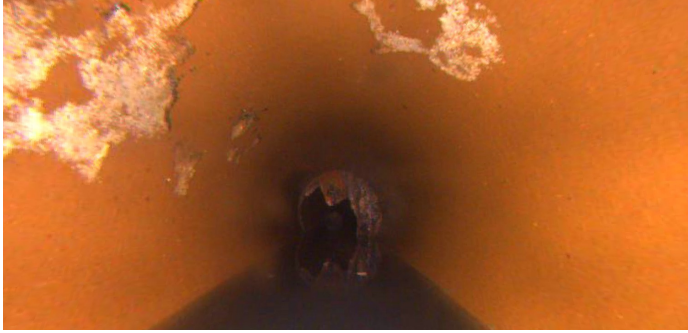
Code:	MSA
Description:	Abandoned Survey
Distance (ft):	11.6
Structural Grade:	0
O&M Grade:	0
Clock Start/From:	
Clock To:	
1st Value:	
2nd Value:	
Value Percent:	
Continuous Index:	
Within 8" of Joint:	NO
Remarks:	dae
