## Profile/Photo Observation Report

Street:	<b>FOXCROFT STREET</b>	Flow Control:	<b>Not Controlled</b>
City:	<b>Hobart, IN</b>	Year Renewed:	
Location:	<b>Yard</b>	Tape/Media #:	
Purpose:	<b>Routine Assessment</b>	Dia/Height:	<b>12"</b>
Use:	<b>Sanitary</b>	Material:	<b>VCP</b>
Drain Area:	<b>NA</b>	Lining:	
Category:	<b>NA</b>		
Comment:	<b>P_C DAE, flow direction is marked wrong.</b>

Location Details:		Direction of Survey:	<b>Downstream</b>
US MH:	<b>M-606-051</b>	DS MH:	<b>M-606-052</b>
		Total Length Surveyed (ft):	<b>11.6</b>

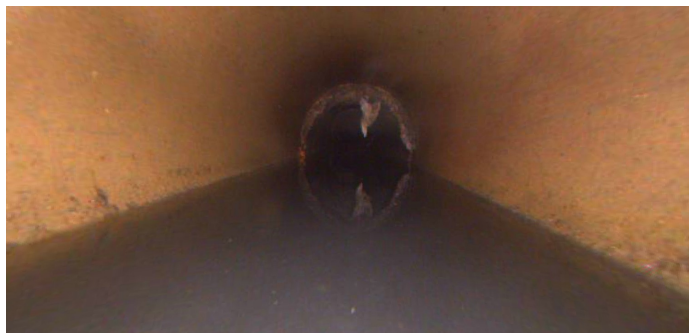
Code: **AMH**  
 Description: **Manhole**

Distance (ft): **.0**  
 Structural Grade: **0**  
 O&M Grade: **0**  
 Clock Start/From:  
 Clock To:  
 1st Value:  
 2nd Value:  
 Value Percent:  
 Continuous Index:  
 Within 8" of Joint: **NO**  
 Remarks: **M-606-051**

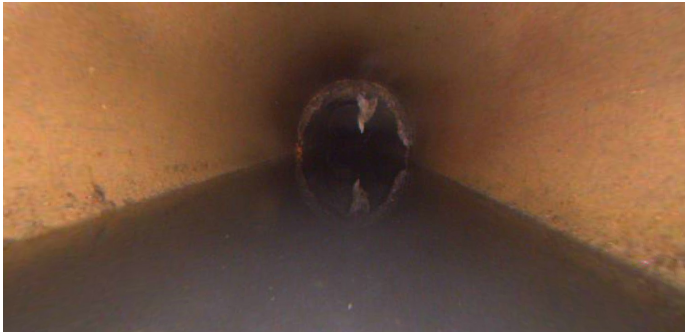
Code:	<b>MWL</b>
Description:	<b>Water Level</b>

Distance (ft):	<b>.0</b>
Structural Grade:	<b>0</b>
O&M Grade:	<b>0</b>
Clock Start/From:	
Clock To:	
1st Value:	
2nd Value:	
Value Percent:	<b>30.000</b>
Continuous Index:	
Within 8" of Joint:	<b>NO</b>
Remarks:

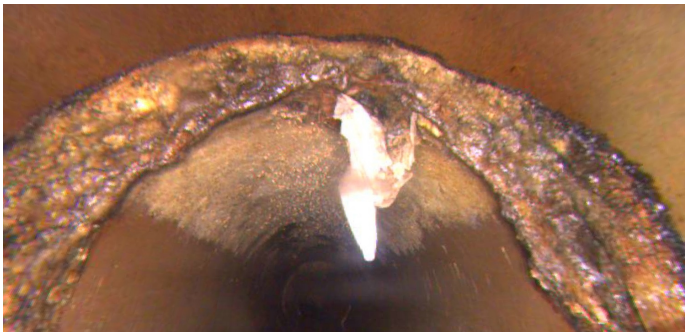
Code:	<b>DAE</b>
Description:	<b>Deposits Attached Encrustation</b>

Distance (ft):	<b>2.9</b>
Structural Grade:	<b>0</b>
O&M Grade:	<b>2</b>
Clock Start/From:	<b>8</b>
Clock To:	<b>4</b>
1st Value:	
2nd Value:	
Value Percent:	<b>10.000</b>
Continuous Index:	
Within 8" of Joint:	<b>YES</b>
Remarks:

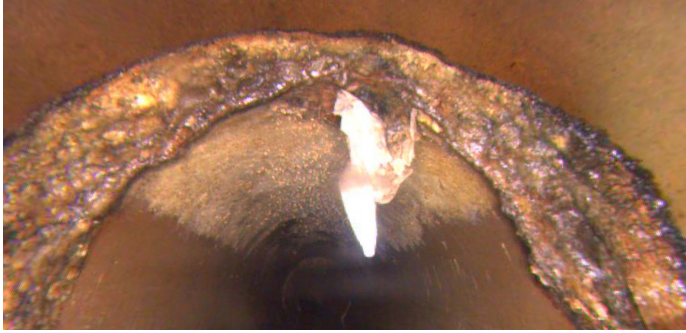
Code: **DAR**  
Description: **Deposits Attached Ragging**

Distance (ft): **2.9**  
Structural Grade: **0**  
O&M Grade: **2**  
Clock Start/From: **12**  
Clock To:  
1st Value:  
2nd Value:  
Value Percent: **5.000**  
Continuous Index:  
Within 8" of Joint: **YES**  
Remarks:

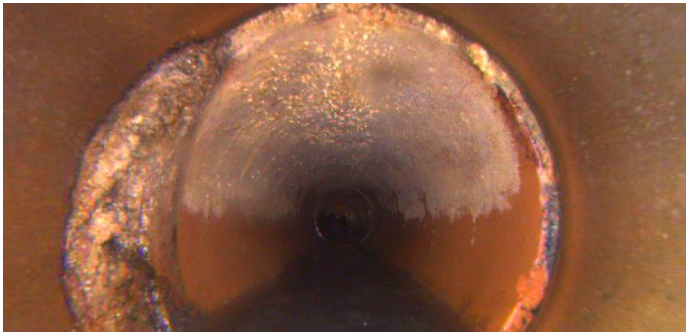
Code: **DAE**  
Description: **Deposits Attached Encrustation**

Distance (ft): **6.6**  
Structural Grade: **0**  
O&M Grade: **2**  
Clock Start/From: **7**  
Clock To: **11**  
1st Value:  
2nd Value:  
Value Percent: **5.000**  
Continuous Index:  
Within 8" of Joint: **YES**  
Remarks:

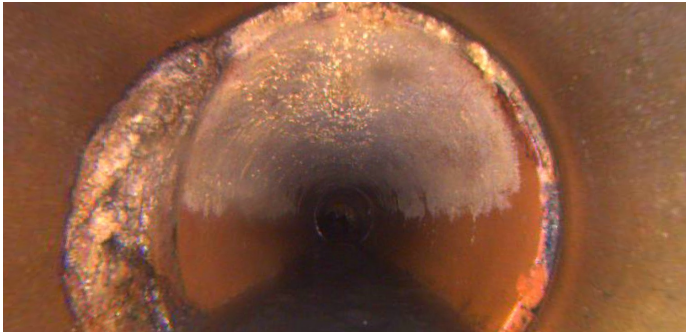
Code: **IW**  
Description: **Infil Weeper**

Distance (ft): **6.6**  
Structural Grade: **0**  
O&M Grade: **2**  
Clock Start/From: **7**  
Clock To: **11**  
1st Value:  
2nd Value:  
Value Percent:  
Continuous Index:  
Within 8" of Joint: **YES**  
Remarks:

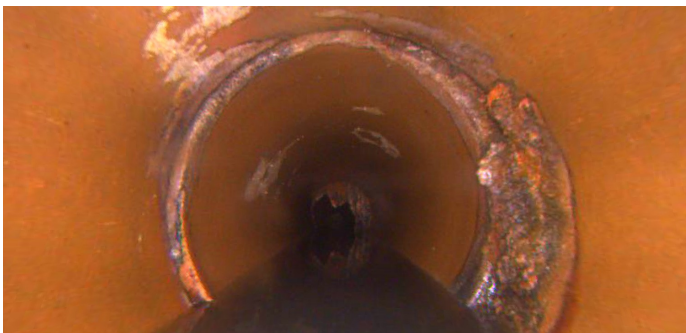
Code: **DAE**  
Description: **Deposits Attached Encrustation**

Distance (ft): **10.4**  
Structural Grade: **0**  
O&M Grade: **2**  
Clock Start/From: **8**  
Clock To: **4**  
1st Value:  
2nd Value:  
Value Percent: **5.000**  
Continuous Index:  
Within 8" of Joint: **YES**  
Remarks:

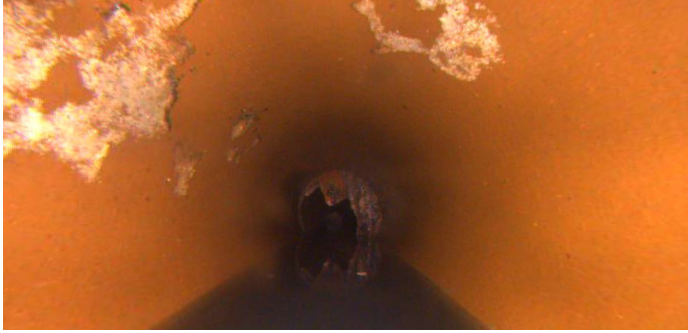
Code:	<b>MSA</b>
Description:	<b>Abandoned Survey</b>
Distance (ft):	<b>11.6</b>
Structural Grade:	<b>0</b>
O&M Grade:	<b>0</b>
Clock Start/From:	
Clock To:	
1st Value:	
2nd Value:	
Value Percent:	
Continuous Index:	
Within 8" of Joint:	<b>NO</b>
Remarks:	<b>dae</b>
