Profile/Photo Observation Report

Street:	S ASH ST	Flow Control:	Not Controlled
City:	Hobart, IN	Year Renewed:	
Location:	Yard	Tape/Media #:	
Purpose:	Routine Assessment	Dia/Height:	10"
Use:	Sanitary	Material:	VCP
Drain Area:	NA	Lining:	
Category:	NA		
Comment:	P_C DAE, flow direction is marked wrong.		
Location Details:		Direction of Survey:	Upstream
US MH:	M-606-053	DS MH:	M-606-054
		Total Length Surveyed (ft):	99.9

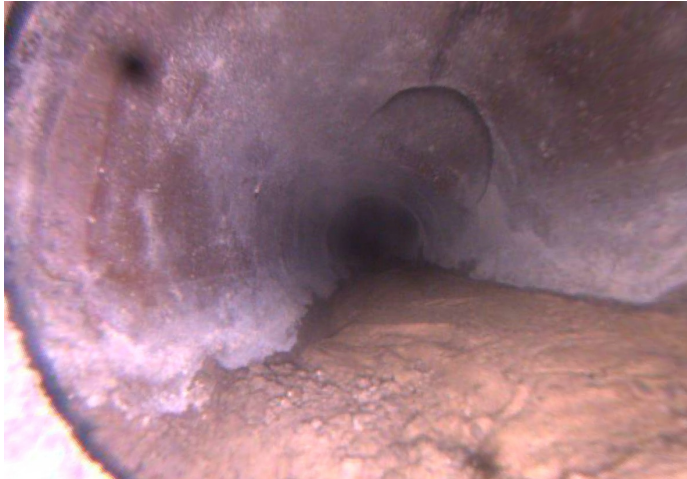
Code: **MWL**
Description: **Water Level**

Distance (ft): **.0**
Structural Grade: **0**
O&M Grade: **0**
Clock Start/From:
Clock To:
1st Value:
2nd Value:
Value Percent: **10.000**
Continuous Index:
Within 8" of Joint: **NO**
Remarks:

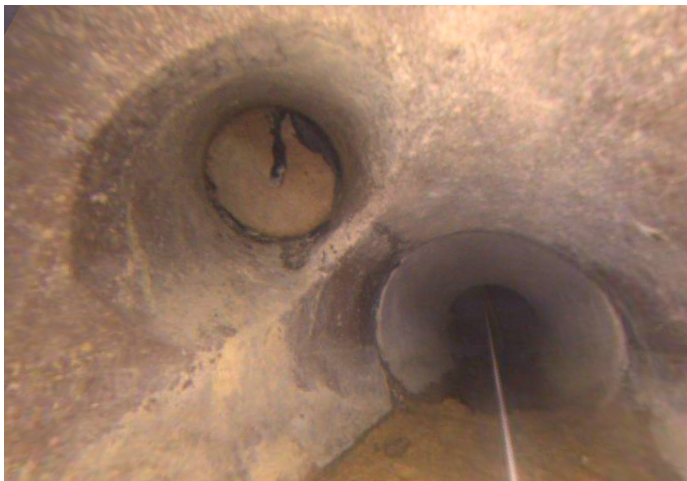
Code: **TFC**
Description: **Tap Factory Capped**

Distance (ft): **2.7**
Structural Grade: **0**
O&M Grade: **0**
Clock Start/From: **10**
Clock To:
1st Value: **6.000**
2nd Value:
Value Percent:
Continuous Index:
Within 8" of Joint:
Remarks:

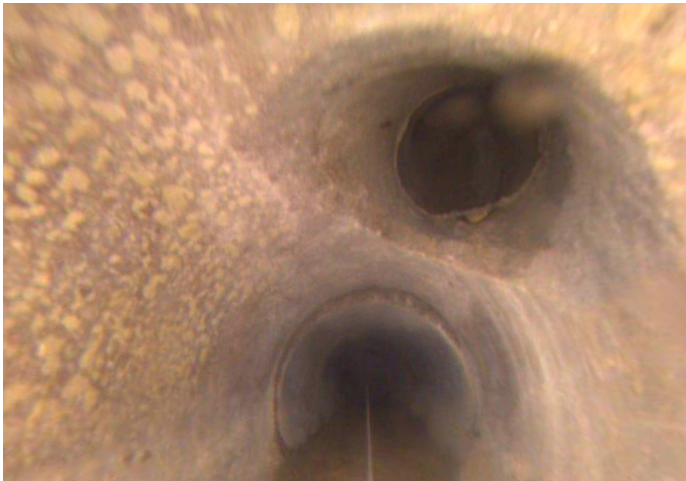
Code: **TF**
Description: **Tap Factory**

Distance (ft): **4.8**
Structural Grade: **0**
O&M Grade: **0**
Clock Start/From: **1**
Clock To:
1st Value: **6.000**
2nd Value:
Value Percent:
Continuous Index:
Within 8" of Joint:
Remarks:

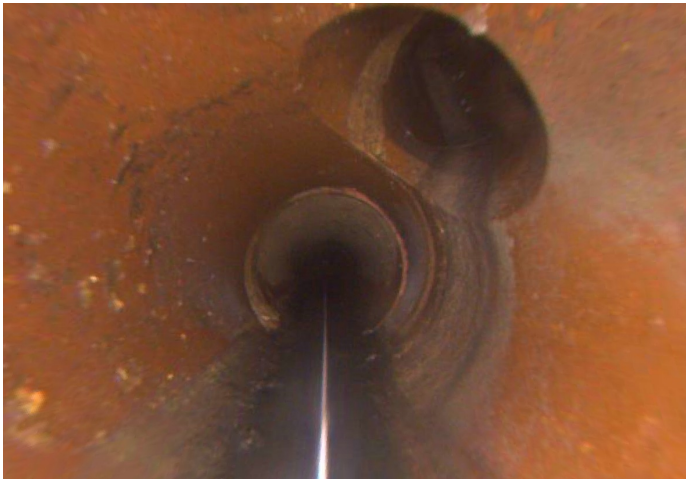
Code: **TF**
Description: **Tap Factory**

Distance (ft): **35.0**
Structural Grade: **0**
O&M Grade: **0**
Clock Start/From: **2**
Clock To:
1st Value: **6.000**
2nd Value:
Value Percent:
Continuous Index:
Within 8" of Joint:
Remarks:

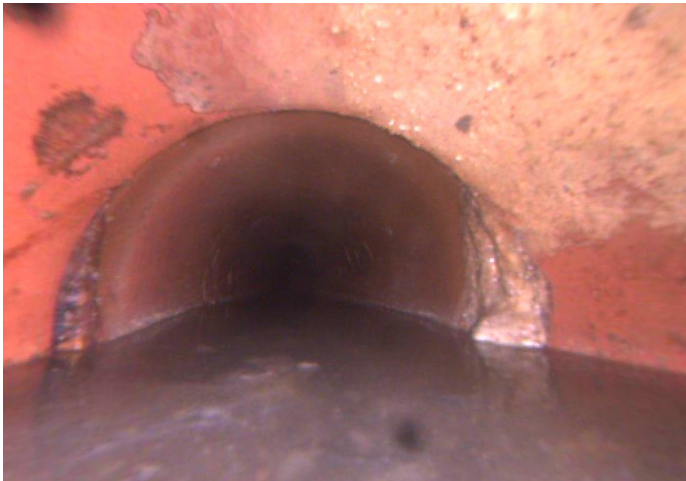
Code:	MWL
Description:	Water Level
Distance (ft):	63.2
Structural Grade:	0
O&M Grade:	0
Clock Start/From:	
Clock To:	
1st Value:	
2nd Value:	
Value Percent:	40.000
Continuous Index:	
Within 8" of Joint:	NO
Remarks:

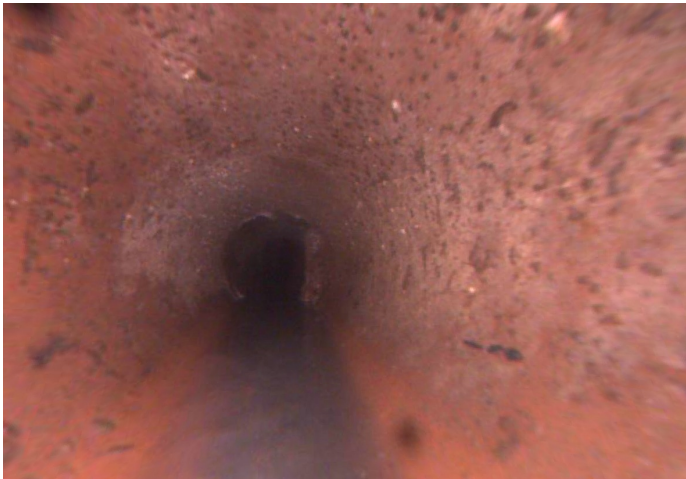
Code:	MWL
Description:	Water Level
Distance (ft):	73.3
Structural Grade:	0
O&M Grade:	0
Clock Start/From:	
Clock To:	
1st Value:	
2nd Value:	
Value Percent:	10.000
Continuous Index:	
Within 8" of Joint:	NO
Remarks:

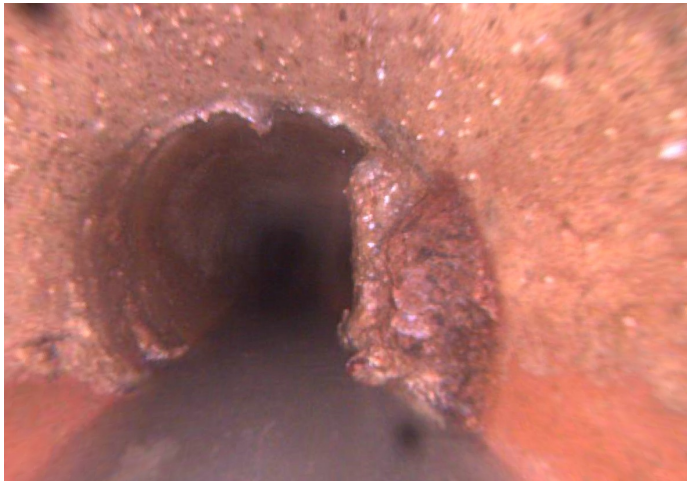
Code:	DAE
Description:	Deposits Attached Encrustation
Distance (ft):	74.8
Structural Grade:	0
O&M Grade:	3
Clock Start/From:	1
Clock To:	4
1st Value:	
2nd Value:	
Value Percent:	20.000
Continuous Index:	
Within 8" of Joint:	YES
Remarks:

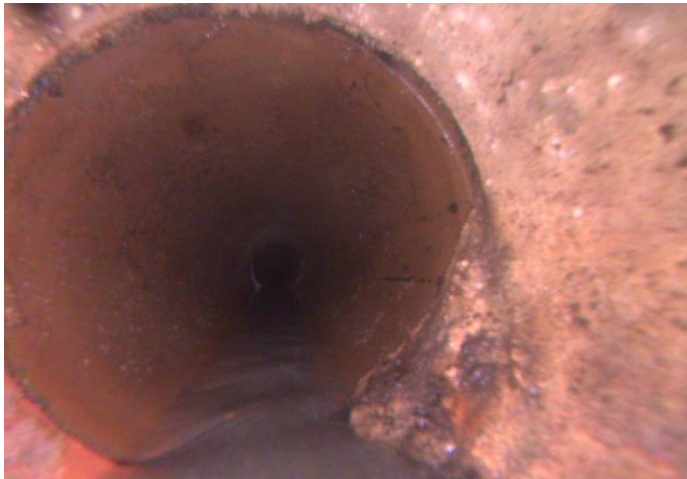
Code:	DAE
Description:	Deposits Attached Encrustation
Distance (ft):	79.1
Structural Grade:	0
O&M Grade:	2
Clock Start/From:	3
Clock To:	5
1st Value:	
2nd Value:	
Value Percent:	5.000
Continuous Index:	
Within 8" of Joint:	YES
Remarks:

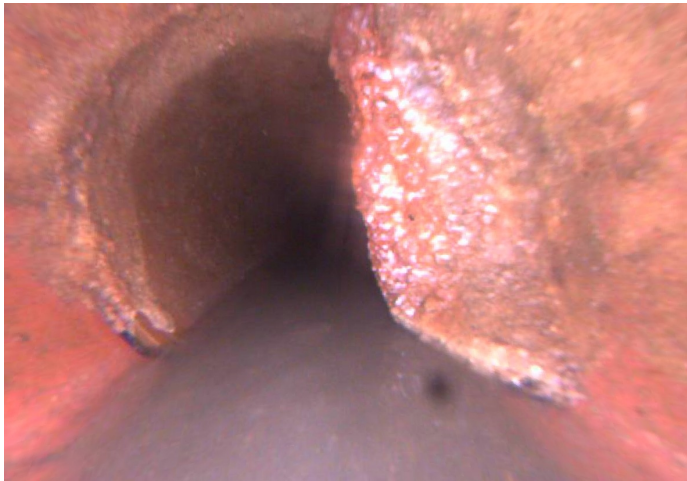
Code:	DAE
Description:	Deposits Attached Encrustation
Distance (ft):	99.1
Structural Grade:	0
O&M Grade:	4
Clock Start/From:	12
Clock To:	5
1st Value:	
2nd Value:	
Value Percent:	30.000
Continuous Index:	
Within 8" of Joint:	YES
Remarks:

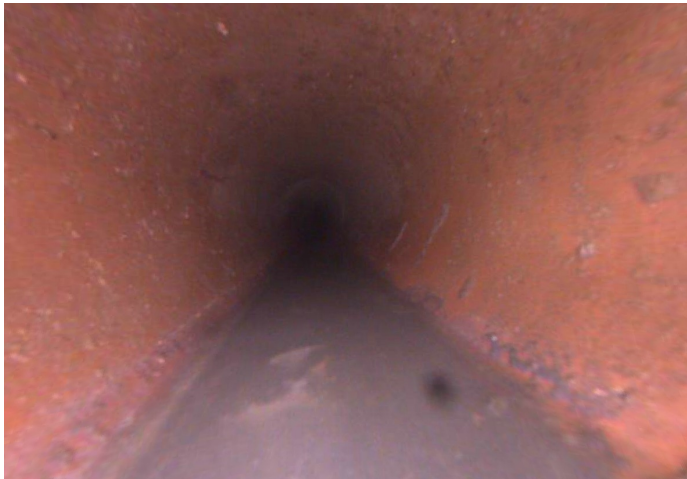
Code:	MSA
Description:	Abandoned Survey
Distance (ft):	99.9
Structural Grade:	0
O&M Grade:	0
Clock Start/From:	
Clock To:	
1st Value:	
2nd Value:	
Value Percent:	
Continuous Index:	
Within 8" of Joint:	NO
Remarks:	Unable to pass DAE
