Profile/Photo Observation Report

Street:	FOXCROFT STREET	Flow Control:	Not Controlled
City:	Hobart, IN	Year Renewed:	
Location:	Yard	Tape/Media #:	
Purpose:	Routine Assessment	Dia/Height:	10"
Use:	Sanitary	Material:	VCP
Drain Area:	NA	Lining:	
Category:	NA		
Comment:	P_C DAE, flow direction is marked wrong.		
Location Details:		Direction of Survey:	Upstream
US MH:	M-606-053	DS MH:	M-606-054
		Total Length Surveyed (ft):	99.9

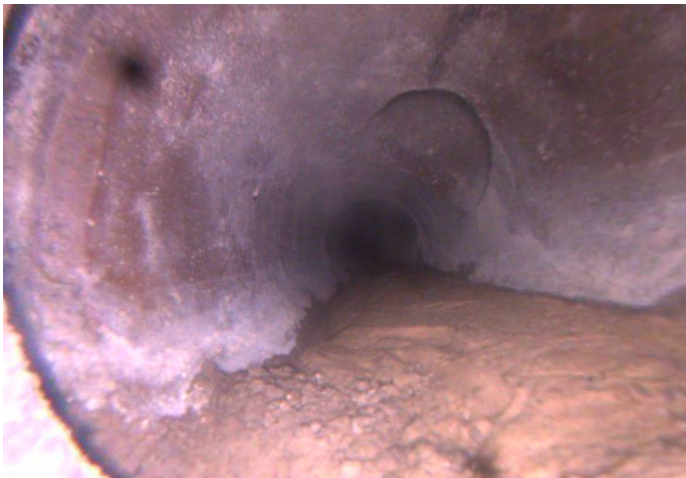
O&M Index:	2.60	O&M Quick:	4131	O&M Rating:	13.00
Structural Index:	0.00	Structural Quick:	0000	Structural Rating:	0.00
Overall Index:	2.60	Overall Quick:	4131	Overall Rating:	13.00

Position	Code	Observation	Video (sec)	Grade
M-606-054				
.0	AMH	Manhole	10	NA
.0	MWL	Water Level	20	NA
2.7	TFC	Tap Factory Capped	38	NA
4.8	TF	Tap Factory	53	NA
35.0	TF	Tap Factory	124	NA
63.2	MWL	Water Level	193	NA
73.3	MWL	Water Level	228	NA
74.8	DAE	Deposits Attached Encrustation	246	M 3
79.1	DAE	Deposits Attached Encrustation	269	M 2
83.3	DAE	Deposits Attached Encrustation	292	M 2
91.0	DAE	Deposits Attached Encrustation	322	M 2
99.1	DAE	Deposits Attached Encrustation	353	M 4
99.9	MSA	Abandoned Survey	370	NA
M-606-053

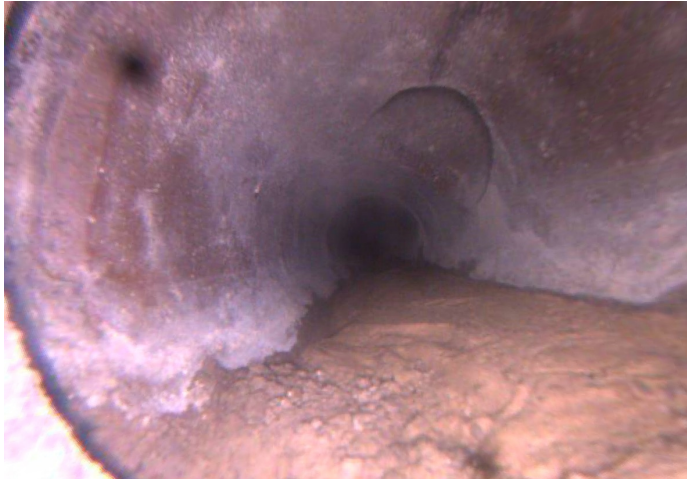
Code: **MWL**
Description: **Water Level**

Distance (ft): **.0**
Structural Grade: **0**
O&M Grade: **0**
Clock Start/From:
Clock To:
1st Value:
2nd Value:
Value Percent: **10.000**
Continuous Index:
Within 8" of Joint: **NO**
Remarks:

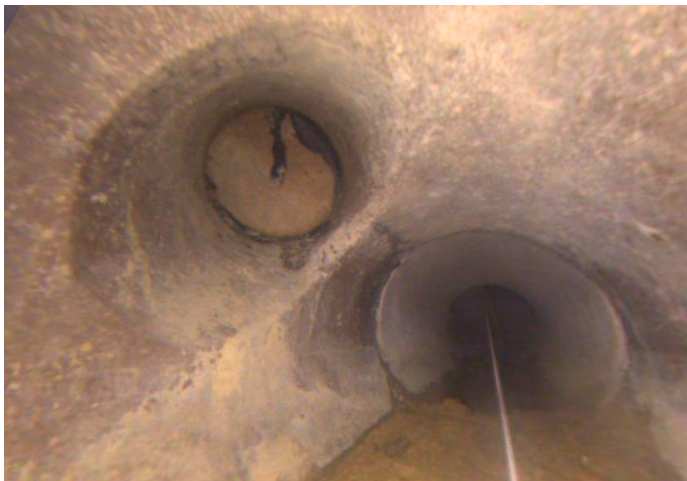
Code: **TFC**
Description: **Tap Factory Capped**

Distance (ft): **2.7**
Structural Grade: **0**
O&M Grade: **0**
Clock Start/From: **10**
Clock To:
1st Value: **6.000**
2nd Value:
Value Percent:
Continuous Index:
Within 8" of Joint:
Remarks:

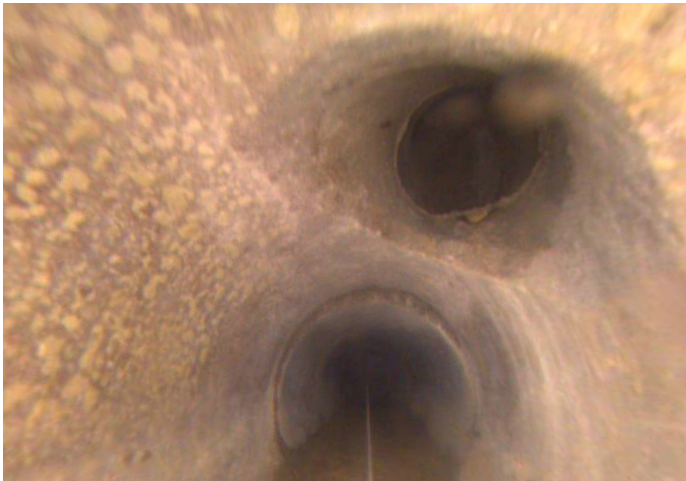
Code: **TF**
Description: **Tap Factory**

Distance (ft): **4.8**
Structural Grade: **0**
O&M Grade: **0**
Clock Start/From: **1**
Clock To:
1st Value: **6.000**
2nd Value:
Value Percent:
Continuous Index:
Within 8" of Joint:
Remarks:

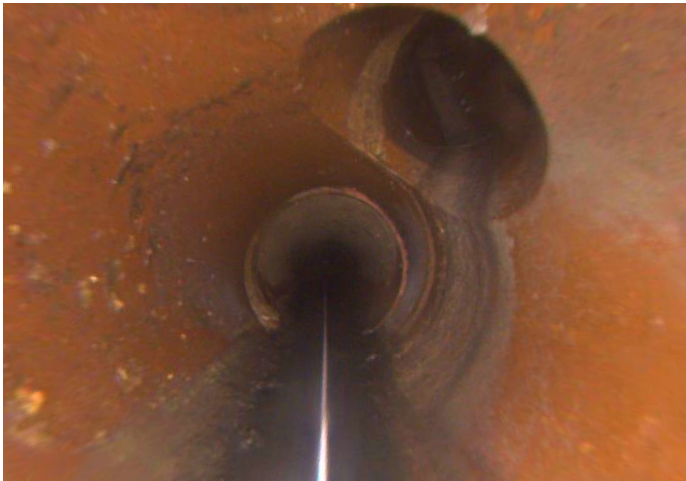
Code: **TF**
Description: **Tap Factory**

Distance (ft): **35.0**
Structural Grade: **0**
O&M Grade: **0**
Clock Start/From: **2**
Clock To:
1st Value: **6.000**
2nd Value:
Value Percent:
Continuous Index:
Within 8" of Joint:
Remarks:

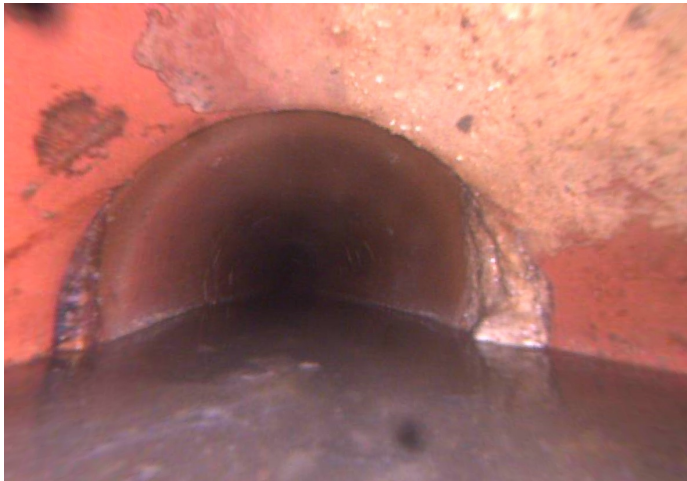
Code: **MWL**
Description: **Water Level**

Distance (ft): **63.2**
Structural Grade: **0**
O&M Grade: **0**
Clock Start/From:
Clock To:
1st Value:
2nd Value:
Value Percent: **40.000**
Continuous Index:
Within 8" of Joint: **NO**
Remarks:

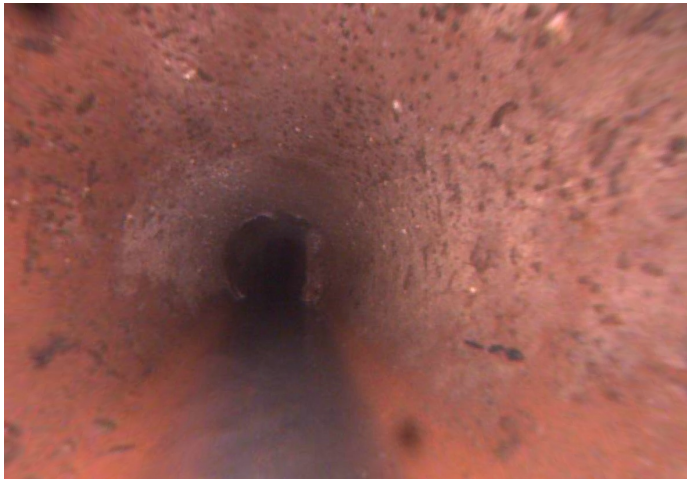
Code: **MWL**
Description: **Water Level**

Distance (ft): **73.3**
Structural Grade: **0**
O&M Grade: **0**
Clock Start/From:
Clock To:
1st Value:
2nd Value:
Value Percent: **10.000**
Continuous Index:
Within 8" of Joint: **NO**
Remarks:

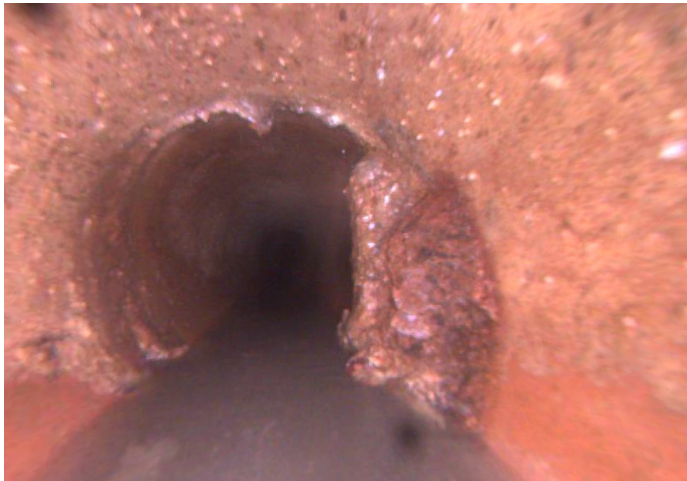
Code:	DAE
Description:	Deposits Attached Encrustation
Distance (ft):	74.8
Structural Grade:	0
O&M Grade:	3
Clock Start/From:	1
Clock To:	4
1st Value:	
2nd Value:	
Value Percent:	20.000
Continuous Index:	
Within 8" of Joint:	YES
Remarks:

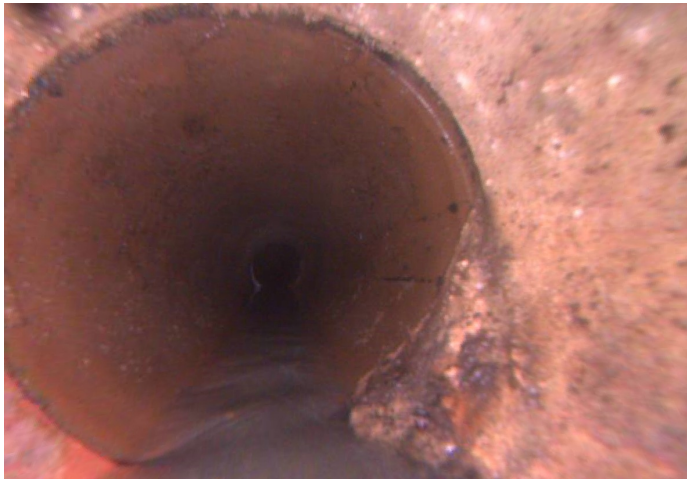
Code:	DAE
Description:	Deposits Attached Encrustation
Distance (ft):	79.1
Structural Grade:	0
O&M Grade:	2
Clock Start/From:	3
Clock To:	5
1st Value:	
2nd Value:	
Value Percent:	5.000
Continuous Index:	
Within 8" of Joint:	YES
Remarks:

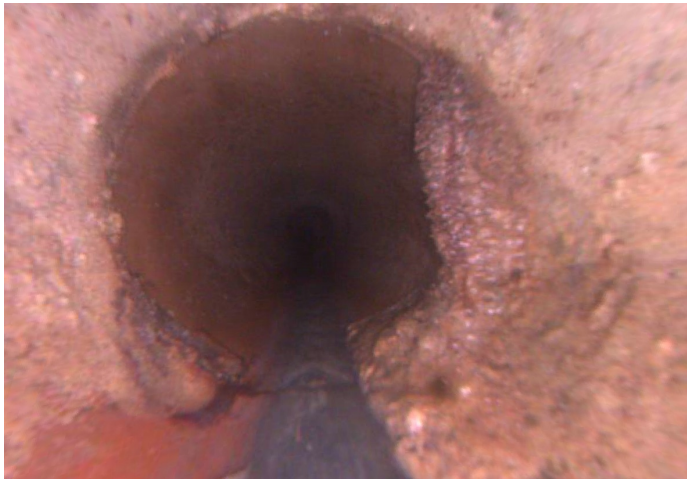
Code:	DAE
Description:	Deposits Attached Encrustation
Distance (ft):	91.0
Structural Grade:	0
O&M Grade:	2
Clock Start/From:	2
Clock To:	5
1st Value:	
2nd Value:	
Value Percent:	5.000
Continuous Index:	
Within 8" of Joint:	YES
Remarks:

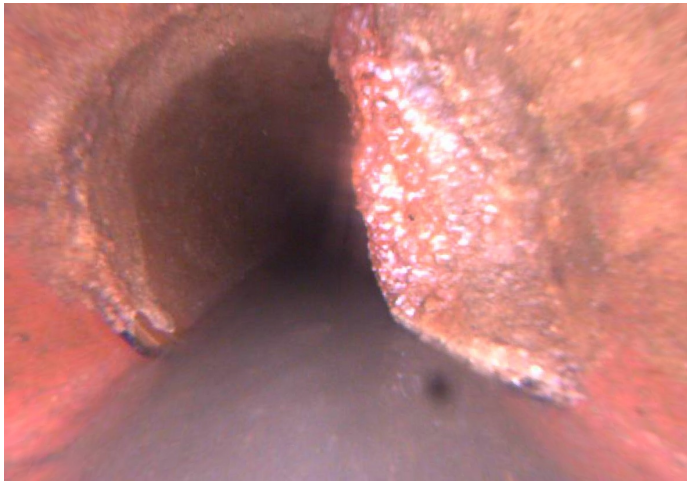
Code:	DAE
Description:	Deposits Attached Encrustation
Distance (ft):	99.1
Structural Grade:	0
O&M Grade:	4
Clock Start/From:	12
Clock To:	5
1st Value:	
2nd Value:	
Value Percent:	30.000
Continuous Index:	
Within 8" of Joint:	YES
Remarks:

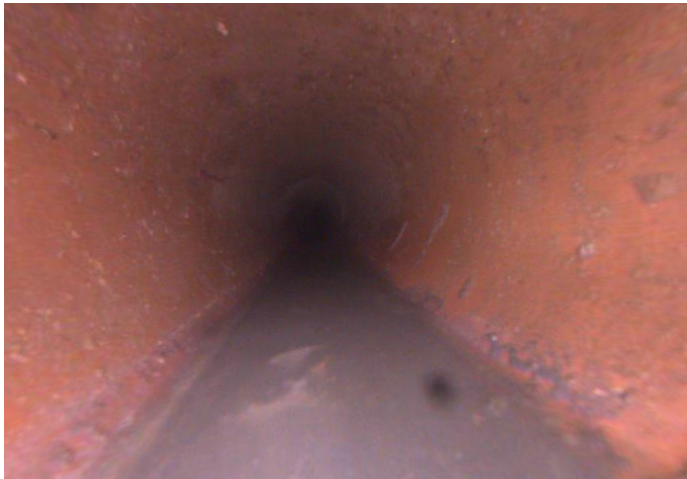
Code:	MSA
Description:	Abandoned Survey
Distance (ft):	99.9
Structural Grade:	0
O&M Grade:	0
Clock Start/From:	
Clock To:	
1st Value:	
2nd Value:	
Value Percent:	
Continuous Index:	
Within 8" of Joint:	NO
Remarks:	Unable to pass DAE
