## Profile/Photo Observation Report

Date:	<b>05/07/2018</b>	Weather:		Coding:	<b>PACP 6.0</b>
Pipe Length (ft):		Owner:	<b>City of Hobart</b>	Pre Clean:	<b>No Pre-Cleaning</b>
P.O.#:	<b>619</b>	Surveyor:	<b>M. Pielacha</b>	PSR:	<b>P-606-056-055</b>
Customer:	<b>City of Hobart</b>	Clean Date:		Shape:	<b>C</b>

Street:	<b>Off of 8th Street</b>	Flow Control:	<b>Not Controlled</b>
City:	<b>Hobart, IN</b>	Year Renewed:	
Location:	<b>Sidewalk</b>	Tape/Media #:	<b>DEP 619</b>
Purpose:	<b>Routine Assessment</b>	Dia/Height:	<b>18"</b>
Use:	<b>Sanitary</b>	Material:	<b>VCP</b>
Drain Area:		Lining:	
Category:	<b>NA</b>		
Comment:	<b>5-21-2018</b>		
Location Details:		Direction of Survey:	<b>Downstream</b>
US MH:	<b>M-606-056</b>	DS MH:	<b>M-606-055</b>
		Total Length Surveyed (ft):	<b>148.2</b>

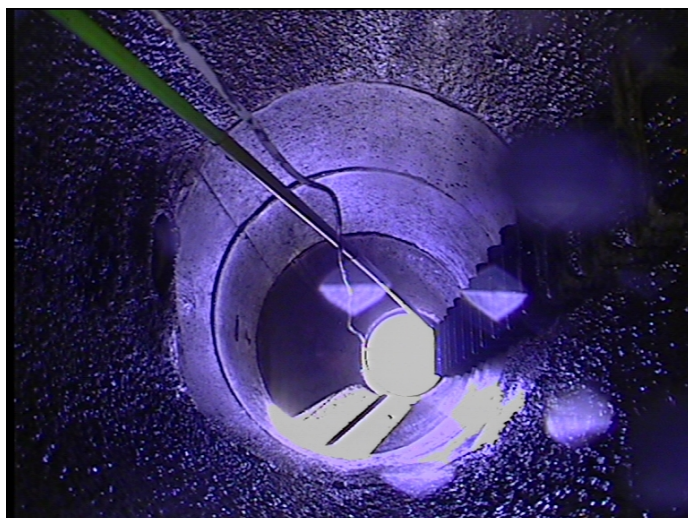
Code: **AMH**  
Description: **Manhole**

Distance (ft): **.0**  
Structural Grade: **0**  
O&M Grade: **0**  
Clock Start/From:  
Clock To:  
1st Value:  
2nd Value:  
Value Percent:  
Continuous Index:  
Within 8" of Joint: **NO**  
Remarks: **M-606-056**

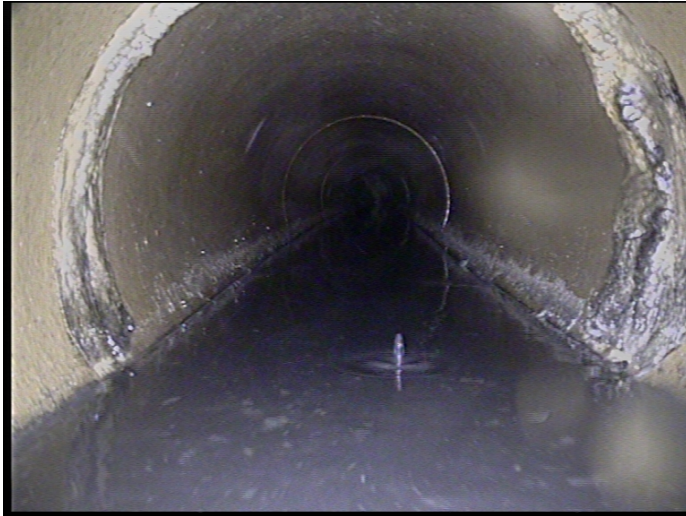
Code: **MWL**  
Description: **Water Level**

Distance (ft): **.0**  
Structural Grade: **0**  
O&M Grade: **0**  
Clock Start/From:  
Clock To:  
1st Value:  
2nd Value:  
Value Percent: **10.000**  
Continuous Index:  
Within 8" of Joint: **NO**  
Remarks:

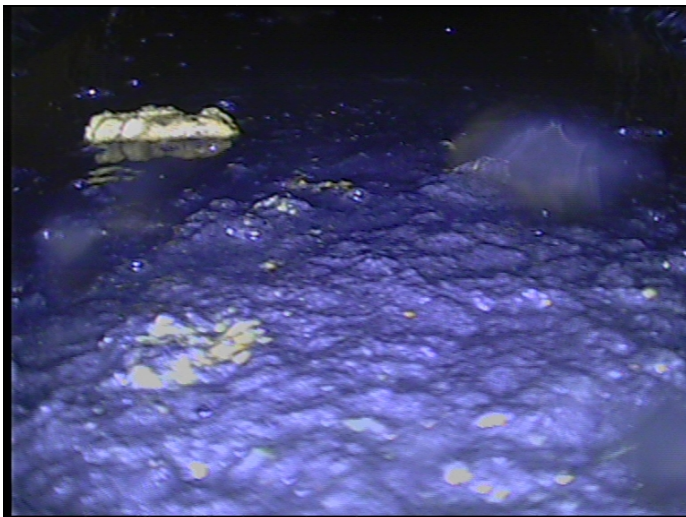
Code: **DSF**  
Description: **Deposits Settled Fine**

Distance (ft): **14.0**  
Structural Grade: **0**  
O&M Grade: **3**  
Clock Start/From: **4**  
Clock To: **8**  
1st Value:  
2nd Value:  
Value Percent: **15.000**  
Continuous Index: **S01**  
Within 8" of Joint: **YES**  
Remarks:

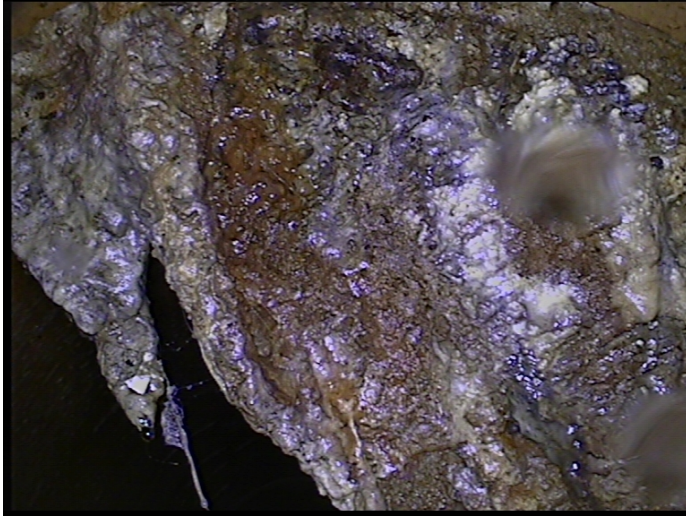
Code: **DAE**  
Description: **Deposits Attached Encrustation**

Distance (ft): **30.5**  
Structural Grade: **0**  
O&M Grade: **4**  
Clock Start/From: **12**  
Clock To: **5**  
1st Value:  
2nd Value:  
Value Percent: **25.000**  
Continuous Index:  
Within 8" of Joint: **YES**  
Remarks:

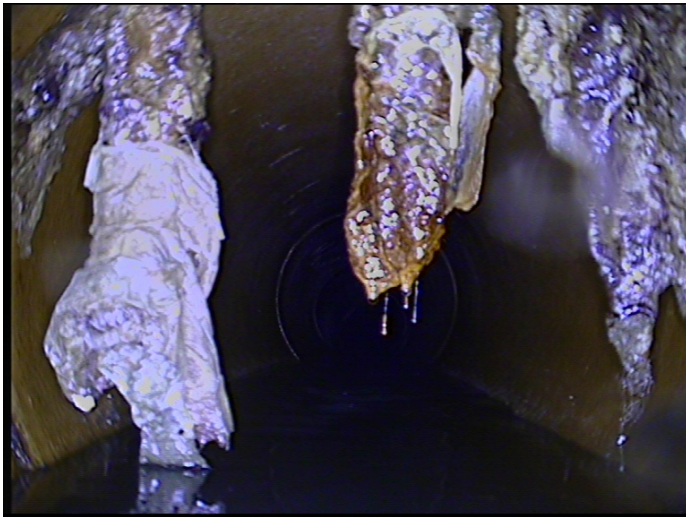
Code: **DAE**  
Description: **Deposits Attached Encrustation**

Distance (ft): **59.6**  
Structural Grade: **0**  
O&M Grade: **2**  
Clock Start/From: **9**  
Clock To: **3**  
1st Value:  
2nd Value:  
Value Percent: **10.000**  
Continuous Index:  
Within 8" of Joint: **YES**  
Remarks:

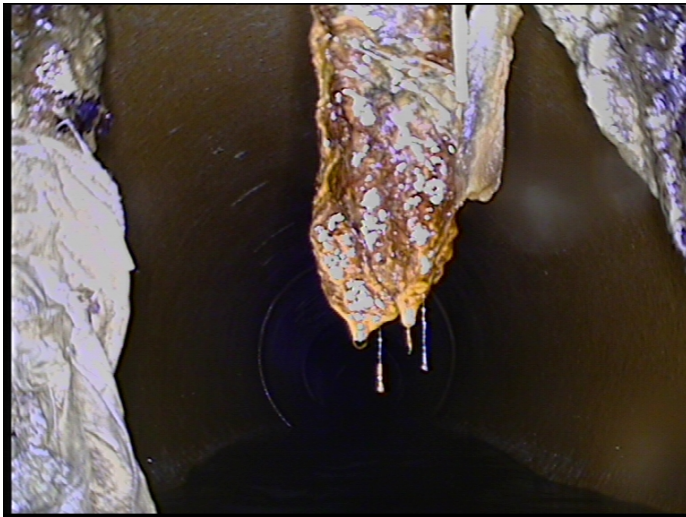
Code: **ID**  
Description: **Infil Dripper**

Distance (ft): **60.2**  
Structural Grade: **0**  
O&M Grade: **3**  
Clock Start/From: **12**  
Clock To:  
1st Value:  
2nd Value:  
Value Percent:  
Continuous Index:  
Within 8" of Joint: **YES**  
Remarks:

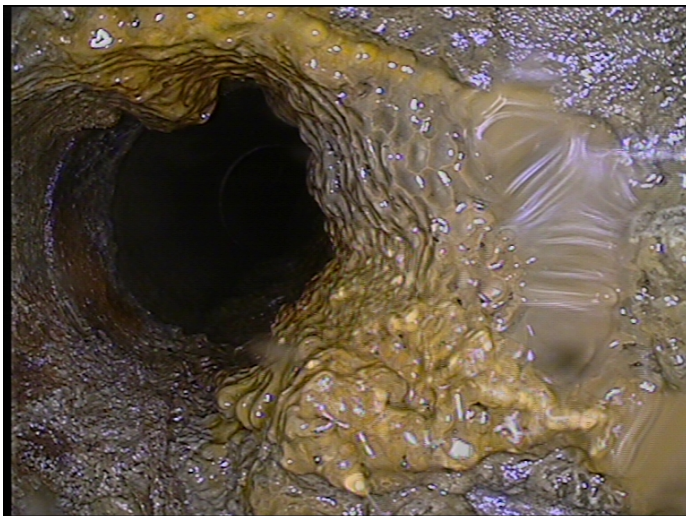
Code: **TBA**  
Description: **Tap Break-in Active**

Distance (ft): **96.5**  
Structural Grade: **0**  
O&M Grade: **0**  
Clock Start/From: **2**  
Clock To:  
1st Value: **4.000**  
2nd Value:  
Value Percent:  
Continuous Index:  
Within 8" of Joint: **NO**  
Remarks:

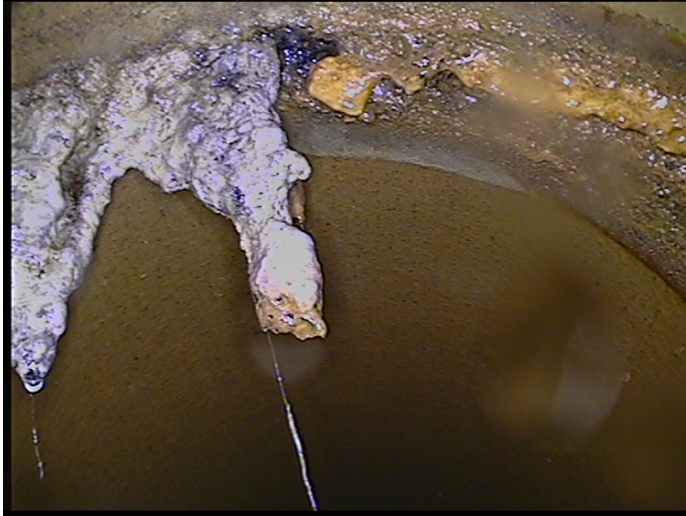
Code: **ID**  
Description: **Infil Dripper**

Distance (ft): **123.2**  
Structural Grade: **0**  
O&M Grade: **3**  
Clock Start/From: **1**  
Clock To:  
1st Value:  
2nd Value:  
Value Percent:  
Continuous Index:  
Within 8" of Joint: **YES**  
Remarks:

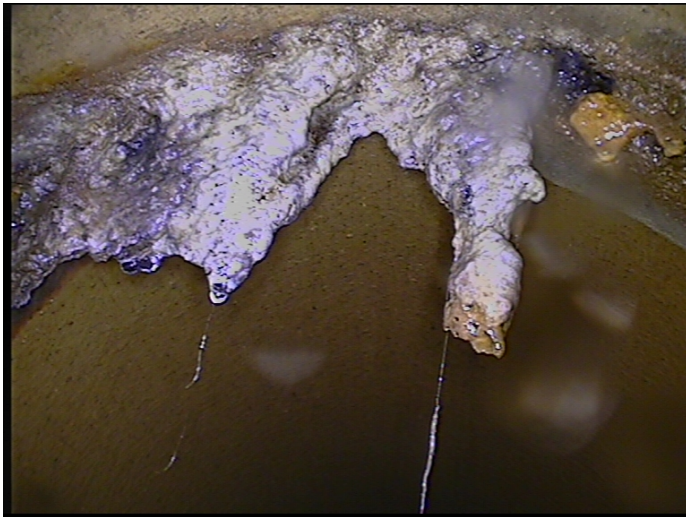
Code: **DAE**  
Description: **Deposits Attached Encrustation**

Distance (ft): **123.2**  
Structural Grade: **0**  
O&M Grade: **2**  
Clock Start/From: **9**  
Clock To: **3**  
1st Value:  
2nd Value:  
Value Percent: **5.000**  
Continuous Index:  
Within 8" of Joint: **YES**  
Remarks:

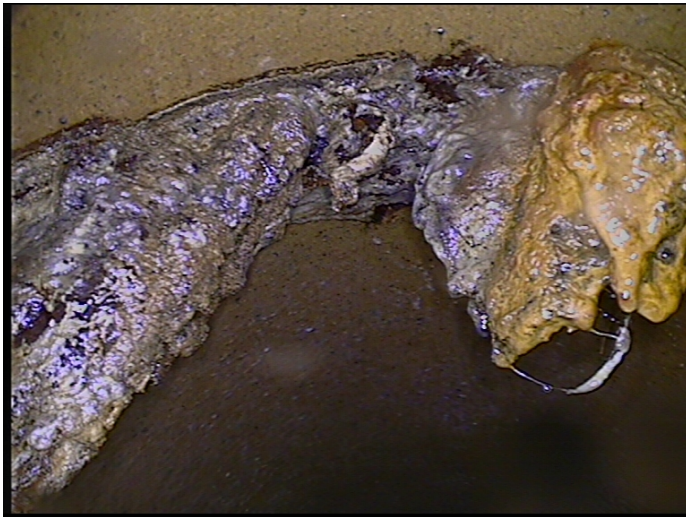
Code: **ID**  
Description: **Infil Dripper**

Distance (ft): **138.2**  
Structural Grade: **0**  
O&M Grade: **3**  
Clock Start/From: **12**  
Clock To:  
1st Value:  
2nd Value:  
Value Percent:  
Continuous Index:  
Within 8" of Joint: **YES**  
Remarks:

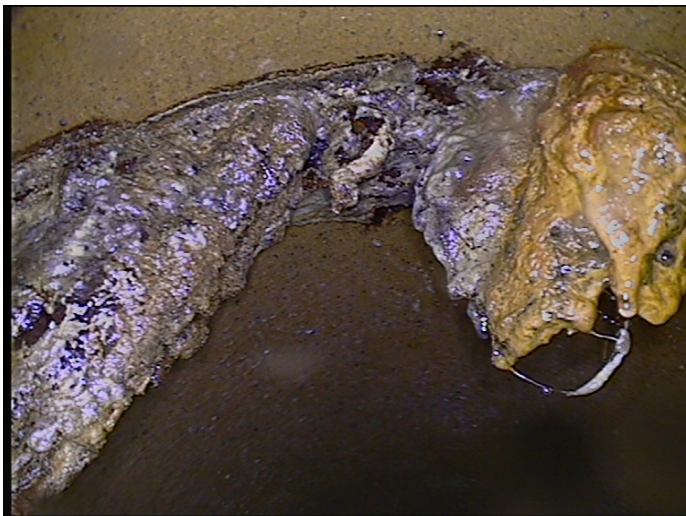
Code: **DAE**  
Description: **Deposits Attached Encrustation**

Distance (ft): **138.2**  
Structural Grade: **0**  
O&M Grade: **2**  
Clock Start/From: **10**  
Clock To: **12**  
1st Value:  
2nd Value:  
Value Percent: **5.000**  
Continuous Index:  
Within 8" of Joint: **YES**  
Remarks:

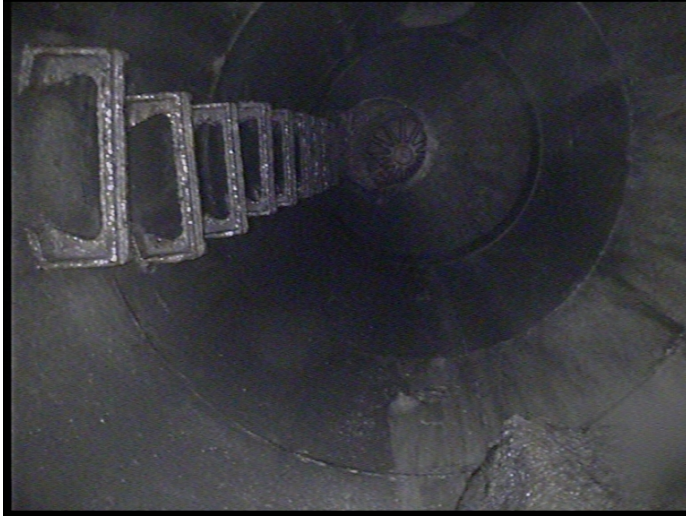
Code: **DSF**  
Description: **Deposits Settled Fine**

Distance (ft): **148.2**  
Structural Grade: **0**  
O&M Grade: **3**  
Clock Start/From: **4**  
Clock To: **8**  
1st Value:  
2nd Value:  
Value Percent: **15.000**  
Continuous Index: **F01**  
Within 8" of Joint: **NO**  
Remarks:

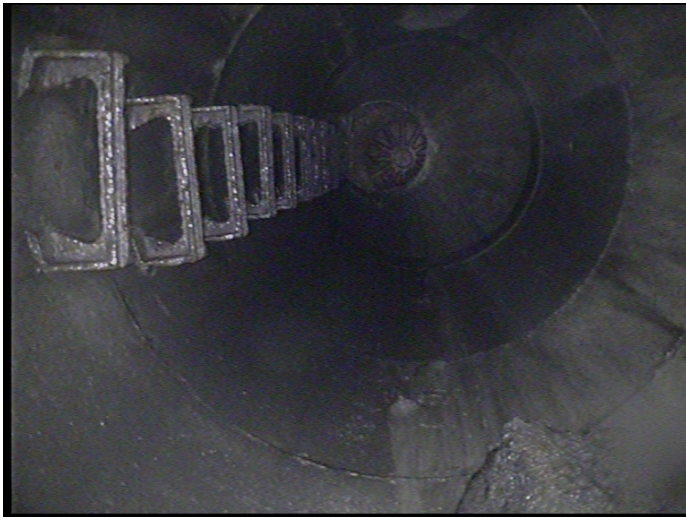
Code: **AMH**  
Description: **Manhole**

Distance (ft): **148.2**  
Structural Grade: **0**  
O&M Grade: **0**  
Clock Start/From:  
Clock To:  
1st Value:  
2nd Value:  
Value Percent:  
Continuous Index:  
Within 8" of Joint: **NO**  
Remarks: **M-606-055**
