Profile/Photo Observation Report

Street:	West 8th Street	Flow Control:	Not Controlled
City:	Hobart, IN	Year Renewed:	
Location:	Light Highway	Tape/Media #:	DEP 620
Purpose:	Routine Assessment	Dia/Height:	18"
Use:	Sanitary	Material:	VCP
Drain Area:		Lining:	
Category:	NA		
Comment:	5-21-2018

Location Details:		Direction of Survey:	Upstream
US MH:	M-606-057	DS MH:	M-606-056
		Total Length Surveyed (ft):	158.7

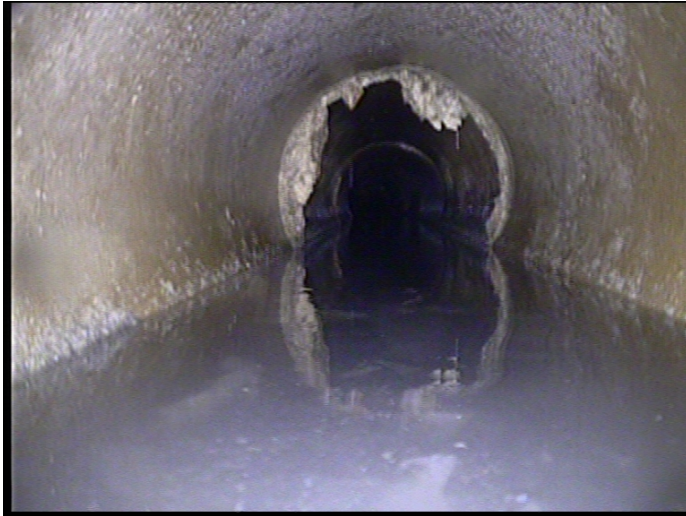
Code:	MWL
Description:	Water Level
Distance (ft):	.0
Structural Grade:	0
O&M Grade:	0
Clock Start/From:	
Clock To:	
1st Value:	
2nd Value:	
Value Percent:	15.000
Continuous Index:	
Within 8" of Joint:	NO
Remarks:

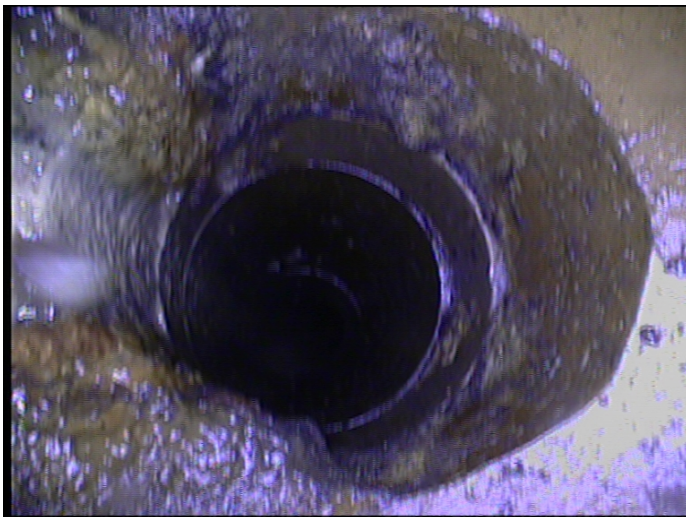
Code:	TF
Description:	Tap Factory
Distance (ft):	31.6
Structural Grade:	0
O&M Grade:	0
Clock Start/From:	10
Clock To:	
1st Value:	4.000
2nd Value:	
Value Percent:	
Continuous Index:	
Within 8" of Joint:	NO
Remarks:

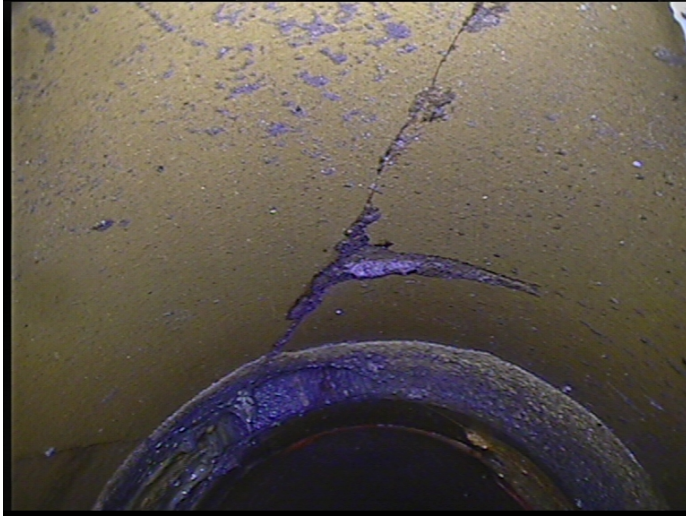
Code:	FL
Description:	Fracture Longitudinal
Distance (ft):	111.3
Structural Grade:	3
O&M Grade:	0
Clock Start/From:	1
Clock To:	
1st Value:	
2nd Value:	
Value Percent:	
Continuous Index:	
Within 8" of Joint:	YES
Remarks:
