Profile/Photo Observation Report

Date:	04/08/2018	Weather:		Coding:	PACP 6.0
Pipe Length (ft):	229.6	Owner:	NA	Pre Clean:	No Pre-Cleaning
P.O.#:		Surveyor:	Mark Ruby	PSR:	P-606-060-061
Customer:		Clean Date:	01/01/1900	Shape:	C

Street:	ALLEY BETWEEN W 8TH ST & W 7TH	Flow Control:	Not Controlled
City:	Hobart, IN	Year Renewed:	
Location:	Yard	Tape/Media #:	
Purpose:	Routine Assessment	Dia/Height:	10"
Use:	Sanitary	Material:	VCP
Drain Area:	NA	Lining:	
Category:	NA		
Comment:	Flow direction is marked wrong.		
Location Details:		Direction of Survey:	Downstream
US MH:	M-606-061	DS MH:	M-606-060
		Total Length Surveyed (ft):	218.1

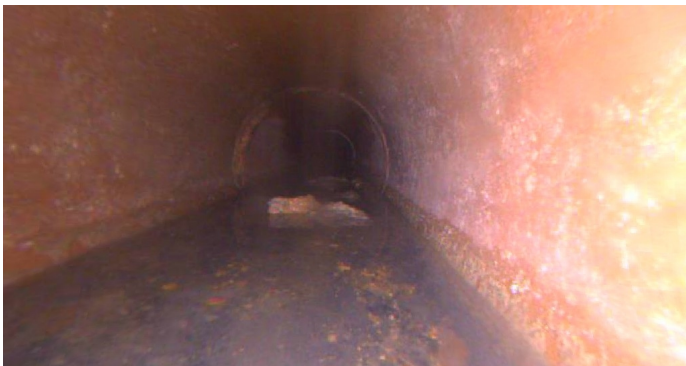
Code: **AMH**
Description: **Manhole**

Distance (ft): **.0**
Structural Grade: **0**
O&M Grade: **0**
Clock Start/From:
Clock To:
1st Value:
2nd Value:
Value Percent:
Continuous Index:
Within 8" of Joint: **NO**
Remarks: **M-606-061**

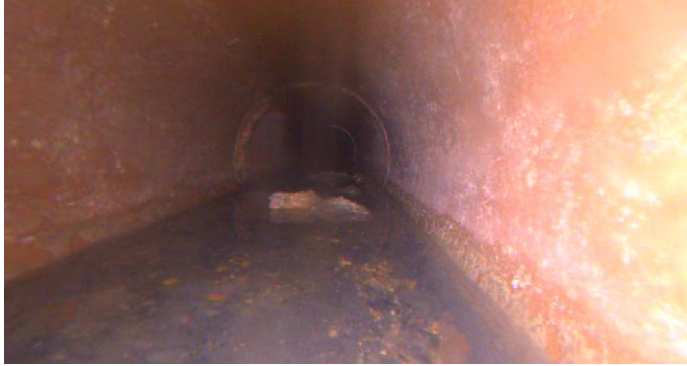
Code: **MWL**
Description: **Water Level**

Distance (ft): **.0**
Structural Grade: **0**
O&M Grade: **0**
Clock Start/From:
Clock To:
1st Value:
2nd Value:
Value Percent: **10.000**
Continuous Index:
Within 8" of Joint: **NO**
Remarks:

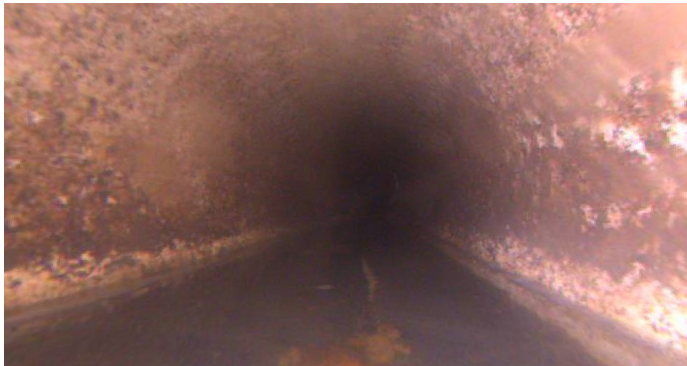
Code: **MMC**
Description: **Material Change**

Distance (ft): **6.3**
Structural Grade: **0**
O&M Grade: **0**
Clock Start/From:
Clock To:
1st Value:
2nd Value:
Value Percent:
Continuous Index:
Within 8" of Joint: **NO**
Remarks: **PVC**

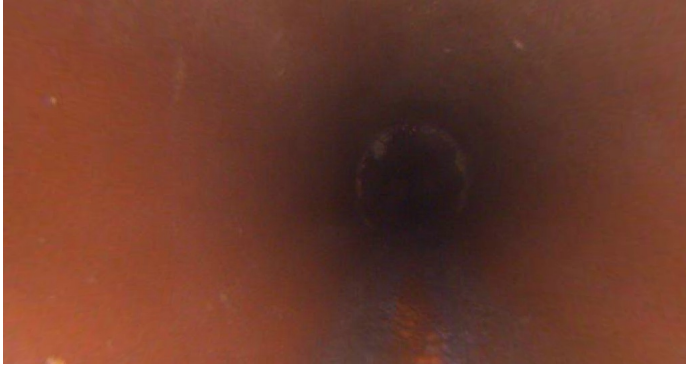
Code: **MMC**
Description: **Material Change**

Distance (ft): **12.3**
Structural Grade: **0**
O&M Grade: **0**
Clock Start/From:
Clock To:
1st Value:
2nd Value:
Value Percent:
Continuous Index:
Within 8" of Joint: **NO**
Remarks: **VCP**

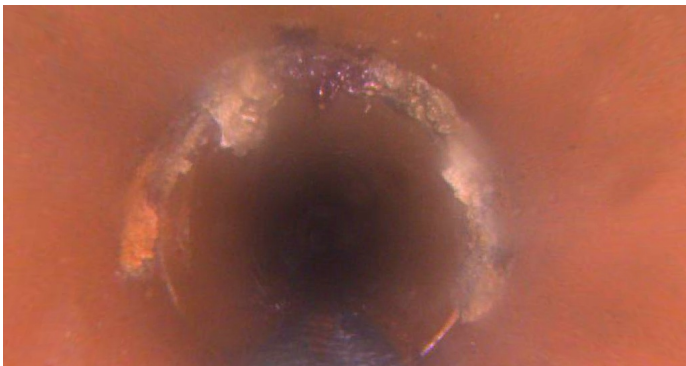
Code: **DAE**
Description: **Deposits Attached Encrustation**

Distance (ft): **13.8**
Structural Grade: **0**
O&M Grade: **2**
Clock Start/From: **7**
Clock To: **5**
1st Value:
2nd Value:
Value Percent: **5.000**
Continuous Index:
Within 8" of Joint: **YES**
Remarks:

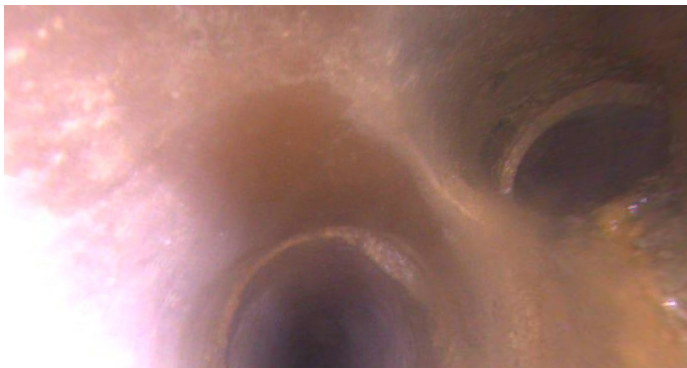
Code:	TF
Description:	Tap Factory
Distance (ft):	23.3
Structural Grade:	0
O&M Grade:	0
Clock Start/From:	2
Clock To:	
1st Value:	4.000
2nd Value:	
Value Percent:	
Continuous Index:	
Within 8" of Joint:	
Remarks:

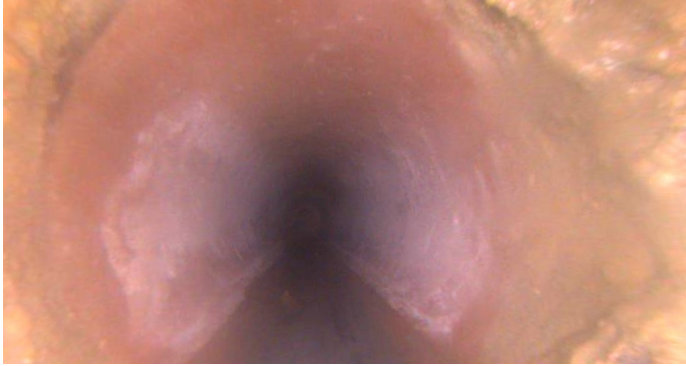
Code: **DAE**
Description: **Deposits Attached Encrustation**

Distance (ft): **24.1**
Structural Grade: **0**
O&M Grade: **2**
Clock Start/From: **7**
Clock To: **5**
1st Value:
2nd Value:
Value Percent: **5.000**
Continuous Index: **S01**
Within 8" of Joint: **YES**
Remarks:

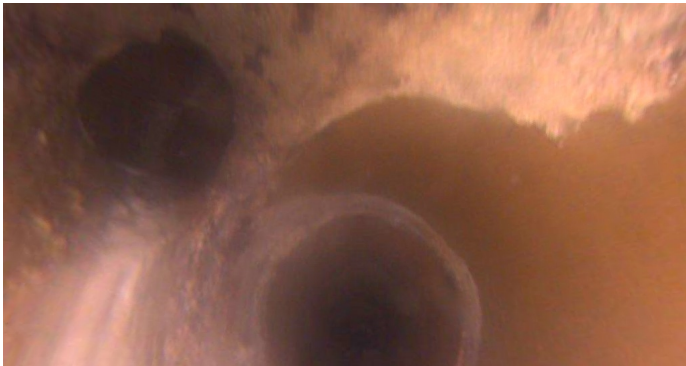
Code: **TF**
Description: **Tap Factory**

Distance (ft): **41.1**
Structural Grade: **0**
O&M Grade: **0**
Clock Start/From: **10**
Clock To:
1st Value: **4.000**
2nd Value:
Value Percent:
Continuous Index:
Within 8" of Joint:
Remarks:

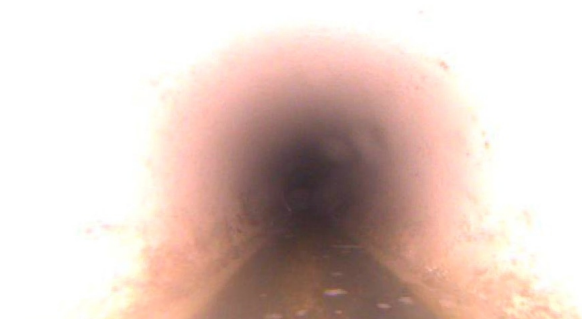
Code:	MMC
Description:	Material Change
Distance (ft):	66.0
Structural Grade:	0
O&M Grade:	0
Clock Start/From:	
Clock To:	
1st Value:	
2nd Value:	
Value Percent:	
Continuous Index:	
Within 8" of Joint:	NO
Remarks:	PVC

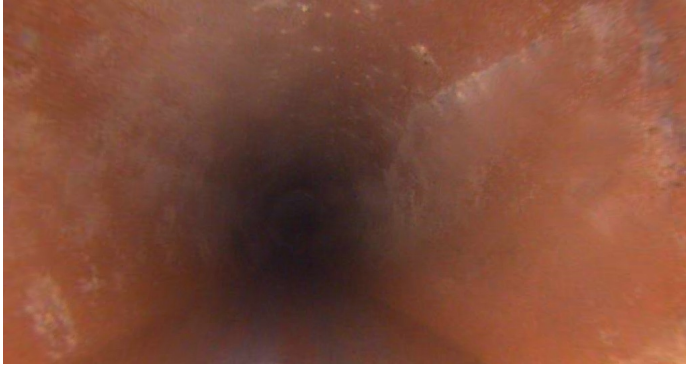
Code: **MMC**
Description: **Material Change**

Distance (ft): **70.3**
Structural Grade: **0**
O&M Grade: **0**
Clock Start/From:
Clock To:
1st Value:
2nd Value:
Value Percent:
Continuous Index:
Within 8" of Joint: **NO**
Remarks: **VCP**

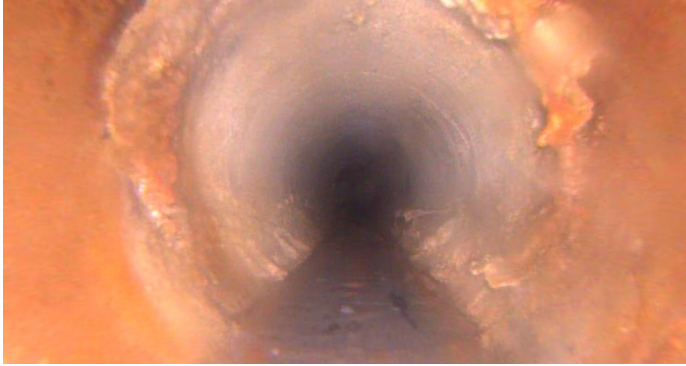
Code: **DAE**
Description: **Deposits Attached Encrustation**

Distance (ft): **73.8**
Structural Grade: **0**
O&M Grade: **2**
Clock Start/From: **7**
Clock To: **5**
1st Value:
2nd Value:
Value Percent: **10.000**
Continuous Index: **S02**
Within 8" of Joint: **YES**
Remarks:

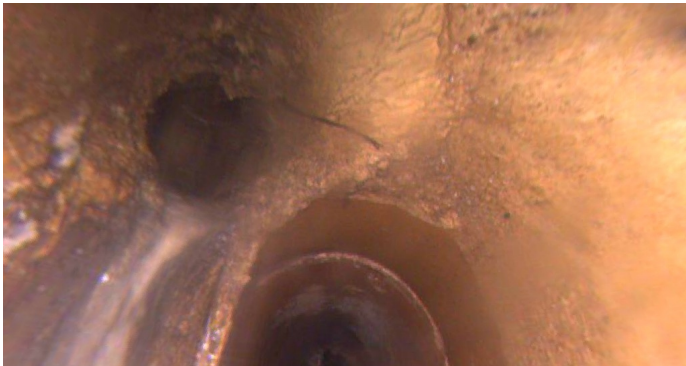
Code: **TFD**
Description: **Tap Factory Defective**

Distance (ft): **95.0**
Structural Grade: **0**
O&M Grade: **2**
Clock Start/From: **10**
Clock To:
1st Value: **4.000**
2nd Value:
Value Percent:
Continuous Index:
Within 8" of Joint:
Remarks: **RFL**

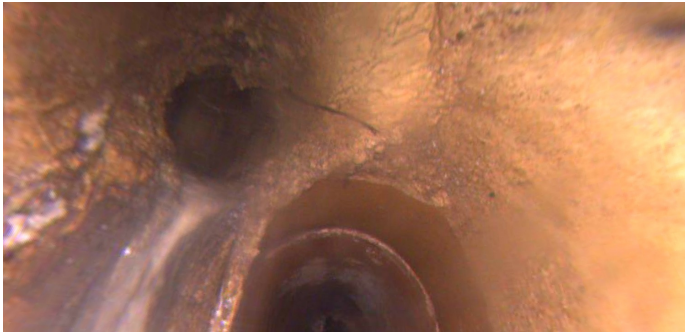
Code: **RFL**
Description: **Roots Fine Lateral**

Distance (ft): **95.0**
Structural Grade: **0**
O&M Grade: **1**
Clock Start/From: **11**
Clock To:
1st Value:
2nd Value:
Value Percent:
Continuous Index:
Within 8" of Joint: **NO**
Remarks:

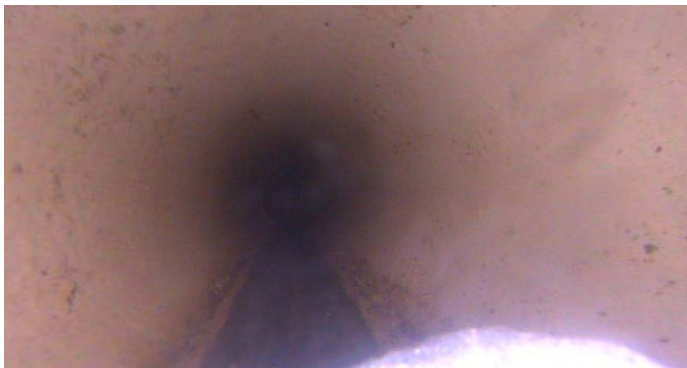
Code:	MMC
Description:	Material Change
Distance (ft):	114.2
Structural Grade:	0
O&M Grade:	0
Clock Start/From:	
Clock To:	
1st Value:	
2nd Value:	
Value Percent:	
Continuous Index:	
Within 8" of Joint:	NO
Remarks:	PVC

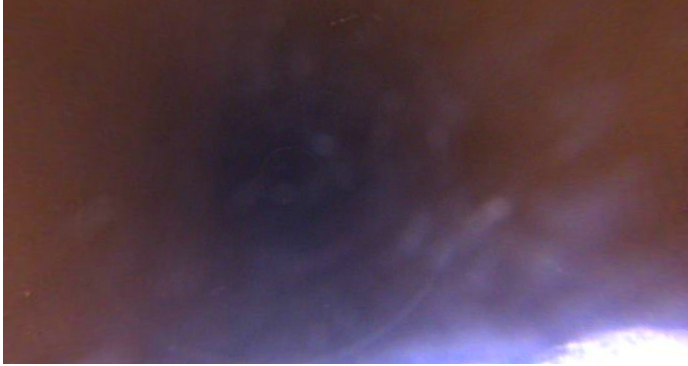
Code:	MMC
Description:	Material Change
Distance (ft):	118.1
Structural Grade:	0
O&M Grade:	0
Clock Start/From:	
Clock To:	
1st Value:	
2nd Value:	
Value Percent:	
Continuous Index:	
Within 8" of Joint:	NO
Remarks:	VCP

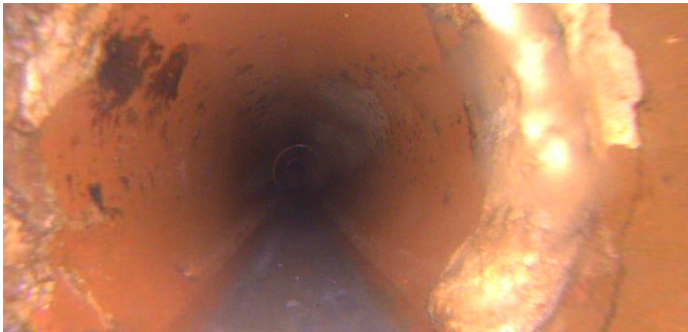
Code:	IW
Description:	Infil Weeper
Distance (ft):	129.6
Structural Grade:	0
O&M Grade:	2
Clock Start/From:	8
Clock To:	4
1st Value:	
2nd Value:	
Value Percent:	
Continuous Index:	S04
Within 8" of Joint:	YES
Remarks:

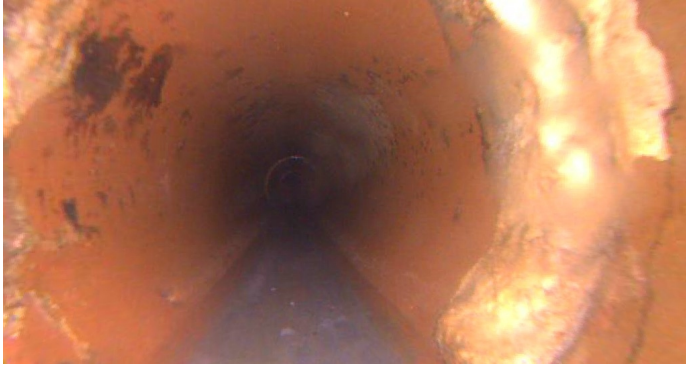
Code: **DAE**
Description: **Deposits Attached Encrustation**

Distance (ft): **129.6**
Structural Grade: **0**
O&M Grade: **2**
Clock Start/From: **7**
Clock To: **5**
1st Value:
2nd Value:
Value Percent: **5.000**
Continuous Index: **S03**
Within 8" of Joint: **YES**
Remarks:

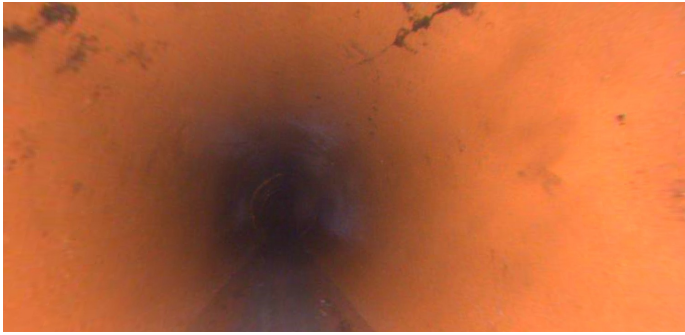
Code: **FL**
Description: **Fracture Longitudinal**

Distance (ft): **154.1**
Structural Grade: **3**
O&M Grade: **0**
Clock Start/From: **1**
Clock To:
1st Value:
2nd Value:
Value Percent:
Continuous Index:
Within 8" of Joint: **YES**
Remarks:

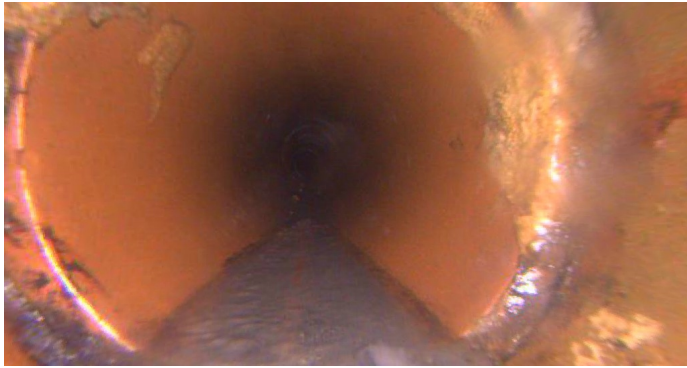
Code:	DAE
Description:	Deposits Attached Encrustation
Distance (ft):	171.3
Structural Grade:	0
O&M Grade:	2
Clock Start/From:	7
Clock To:	5
1st Value:	
2nd Value:	
Value Percent:	5.000
Continuous Index:	
Within 8" of Joint:	YES
Remarks:

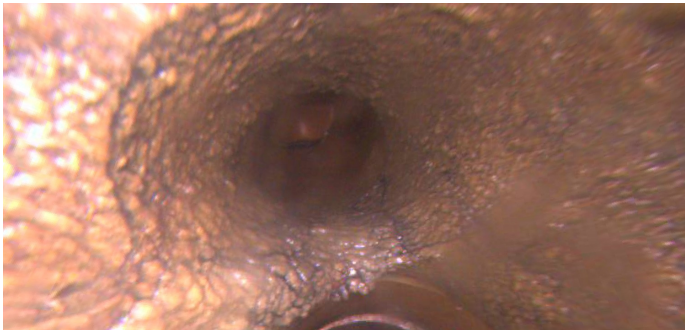
Code: **TF**
Description: **Tap Factory**

Distance (ft): **214.3**
Structural Grade: **0**
O&M Grade: **0**
Clock Start/From: **12**
Clock To:
1st Value: **4.000**
2nd Value:
Value Percent:
Continuous Index:
Within 8" of Joint:
Remarks:

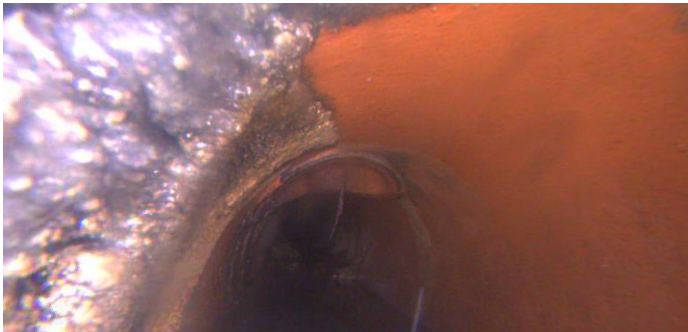
Code: **IW**
Description: **Infil Weeper**

Distance (ft): **218.1**
Structural Grade: **0**
O&M Grade: **2**
Clock Start/From: **8**
Clock To: **4**
1st Value:
2nd Value:
Value Percent:
Continuous Index: **F04**
Within 8" of Joint: **YES**
Remarks:

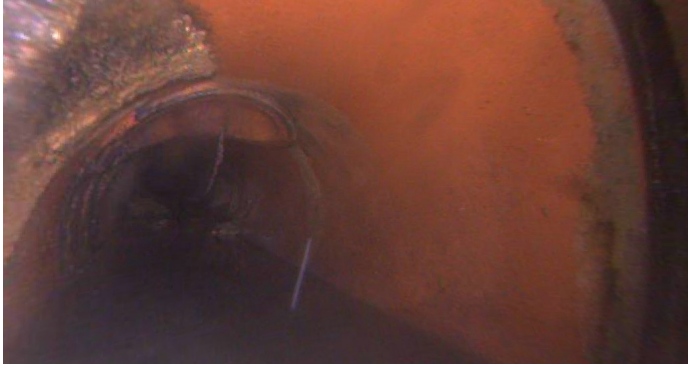
Code:	DAE
Description:	Deposits Attached Encrustation
Distance (ft):	218.1
Structural Grade:	0
O&M Grade:	2
Clock Start/From:	7
Clock To:	5
1st Value:	
2nd Value:	
Value Percent:	5.000
Continuous Index:	F03
Within 8" of Joint:	YES
Remarks:

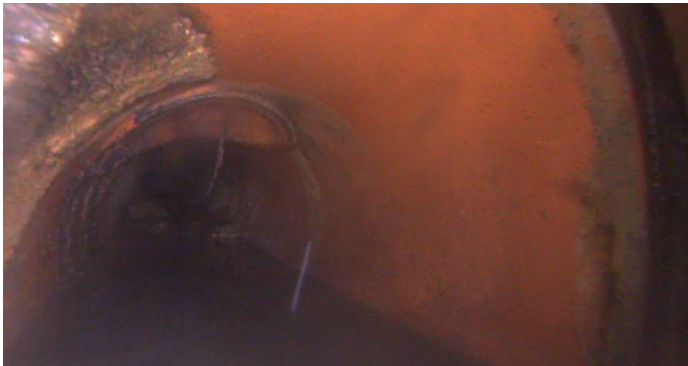
Code:	MSA
Description:	Abandoned Survey
Distance (ft):	218.1
Structural Grade:	0
O&M Grade:	0
Clock Start/From:	
Clock To:	
1st Value:	
2nd Value:	
Value Percent:	
Continuous Index:	
Within 8" of Joint:	NO
Remarks:	Debris
