Profile/Photo Observation Report

Date:	04/08/2018	Weather:		Coding:	PACP 6.0
Pipe Length (ft):	229.6	Owner:	NA	Pre Clean:	No Pre-Cleaning
P.O.#:		Surveyor:	Mark Ruby	PSR:	P-606-060-061
Customer:		Clean Date:	01/01/1900	Shape:	C

Street:	FOXCROFT STREET	Flow Control:	Not Controlled
City:	Hobart, IN	Year Renewed:	
Location:	Yard	Tape/Media #:	
Purpose:	Routine Assessment	Dia/Height:	10"
Use:	Sanitary	Material:	VCP
Drain Area:	NA	Lining:	
Category:	NA		
Comment:	Flow direction is marked wrong.		
Location Details:		Direction of Survey:	Downstream
US MH:	M-606-061	DS MH:	M-606-060
		Total Length Surveyed (ft):	218.1

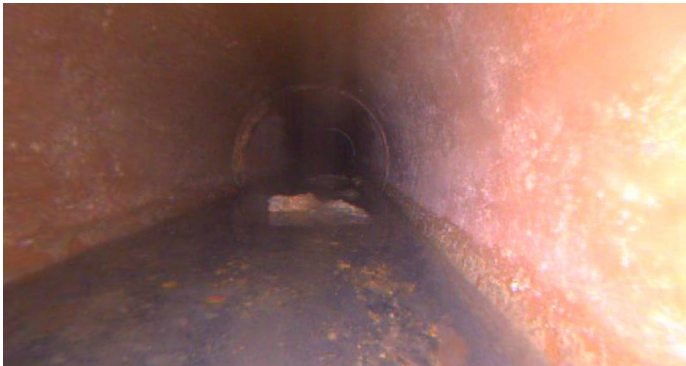
Code: **AMH**
Description: **Manhole**

Distance (ft): **.0**
Structural Grade: **0**
O&M Grade: **0**
Clock Start/From:
Clock To:
1st Value:
2nd Value:
Value Percent:
Continuous Index:
Within 8" of Joint: **NO**
Remarks: **M-606-061**

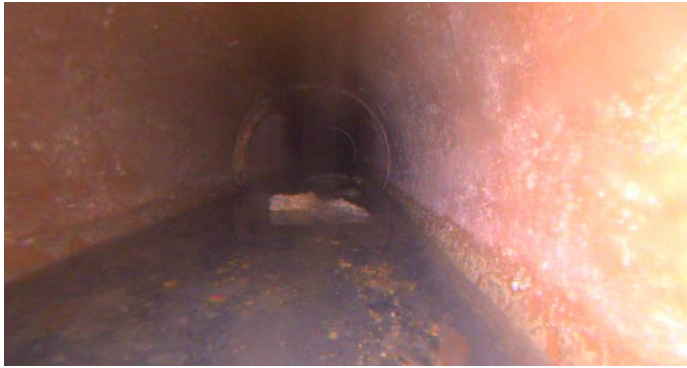
Code: **MWL**
Description: **Water Level**

Distance (ft): **.0**
Structural Grade: **0**
O&M Grade: **0**
Clock Start/From:
Clock To:
1st Value:
2nd Value:
Value Percent: **10.000**
Continuous Index:
Within 8" of Joint: **NO**
Remarks:

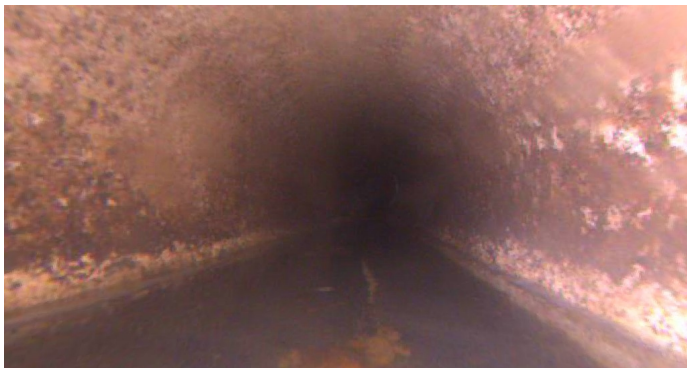
Code: **MMC**
Description: **Material Change**

Distance (ft): **6.3**
Structural Grade: **0**
O&M Grade: **0**
Clock Start/From:
Clock To:
1st Value:
2nd Value:
Value Percent:
Continuous Index:
Within 8" of Joint: **NO**
Remarks: **PVC**

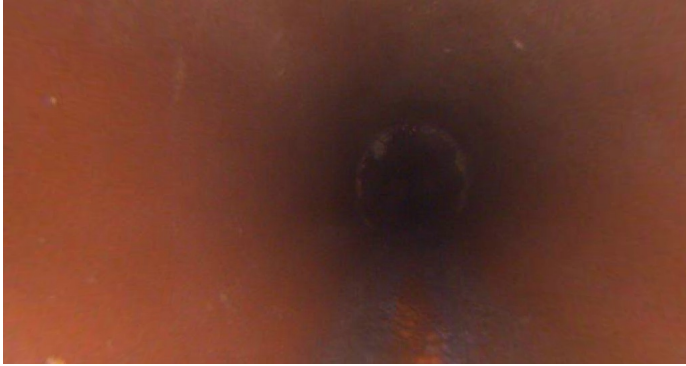
Code: **MMC**
Description: **Material Change**

Distance (ft): **12.3**
Structural Grade: **0**
O&M Grade: **0**
Clock Start/From:
Clock To:
1st Value:
2nd Value:
Value Percent:
Continuous Index:
Within 8" of Joint: **NO**
Remarks: **VCP**

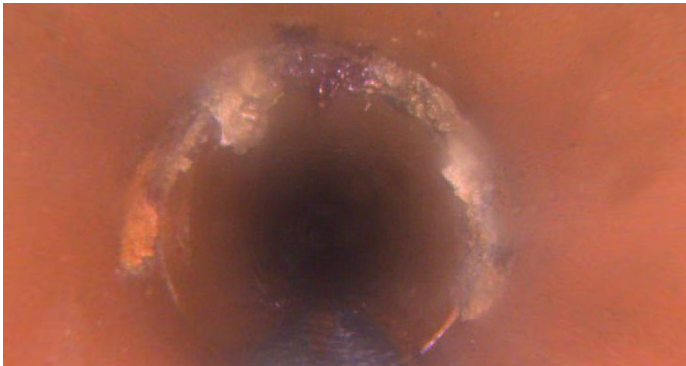
Code: **DAE**
Description: **Deposits Attached Encrustation**

Distance (ft): **13.8**
Structural Grade: **0**
O&M Grade: **2**
Clock Start/From: **7**
Clock To: **5**
1st Value:
2nd Value:
Value Percent: **5.000**
Continuous Index:
Within 8" of Joint: **YES**
Remarks:

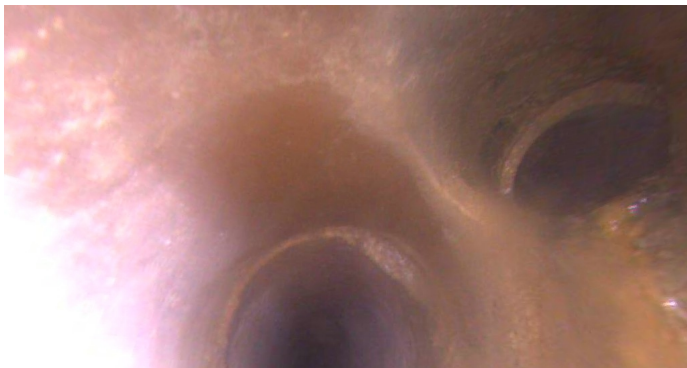
Code:	TF
Description:	Tap Factory
Distance (ft):	23.3
Structural Grade:	0
O&M Grade:	0
Clock Start/From:	2
Clock To:	
1st Value:	4.000
2nd Value:	
Value Percent:	
Continuous Index:	
Within 8" of Joint:	
Remarks:

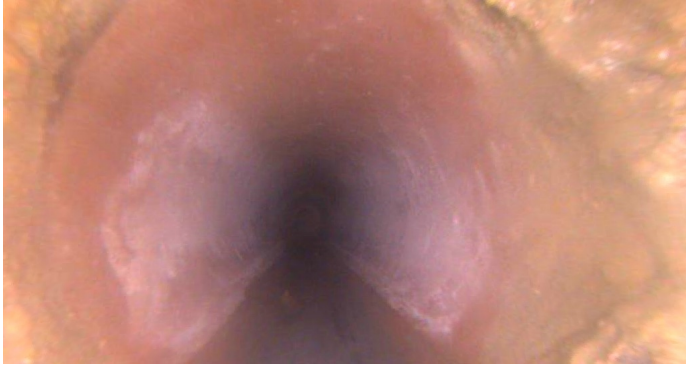
Code: **DAE**
Description: **Deposits Attached Encrustation**

Distance (ft): **24.1**
Structural Grade: **0**
O&M Grade: **2**
Clock Start/From: **7**
Clock To: **5**
1st Value:
2nd Value:
Value Percent: **5.000**
Continuous Index: **S01**
Within 8" of Joint: **YES**
Remarks:

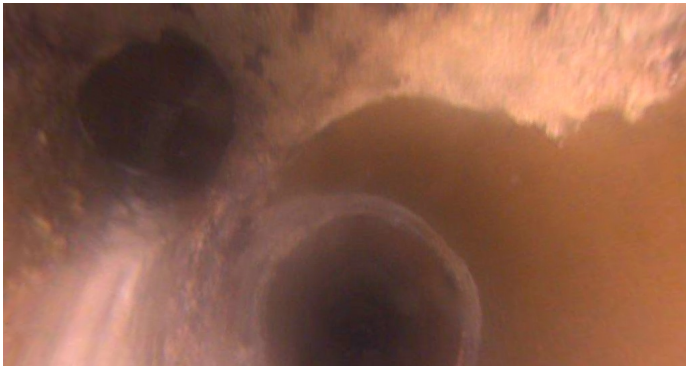
Code: **TF**
Description: **Tap Factory**

Distance (ft): **41.1**
Structural Grade: **0**
O&M Grade: **0**
Clock Start/From: **10**
Clock To:
1st Value: **4.000**
2nd Value:
Value Percent:
Continuous Index:
Within 8" of Joint:
Remarks:

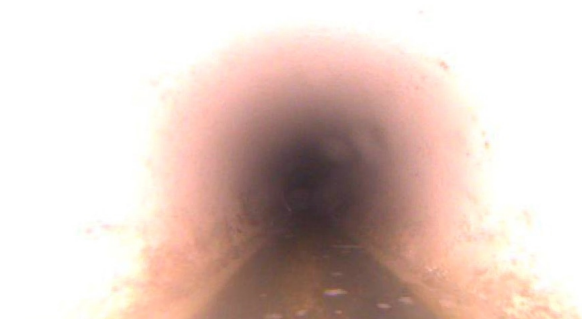
Code:	MMC
Description:	Material Change
Distance (ft):	66.0
Structural Grade:	0
O&M Grade:	0
Clock Start/From:	
Clock To:	
1st Value:	
2nd Value:	
Value Percent:	
Continuous Index:	
Within 8" of Joint:	NO
Remarks:	PVC

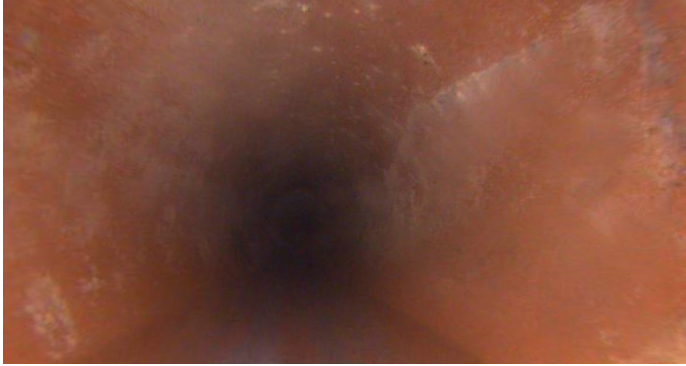
Code: **MMC**
Description: **Material Change**

Distance (ft): **70.3**
Structural Grade: **0**
O&M Grade: **0**
Clock Start/From:
Clock To:
1st Value:
2nd Value:
Value Percent:
Continuous Index:
Within 8" of Joint: **NO**
Remarks: **VCP**

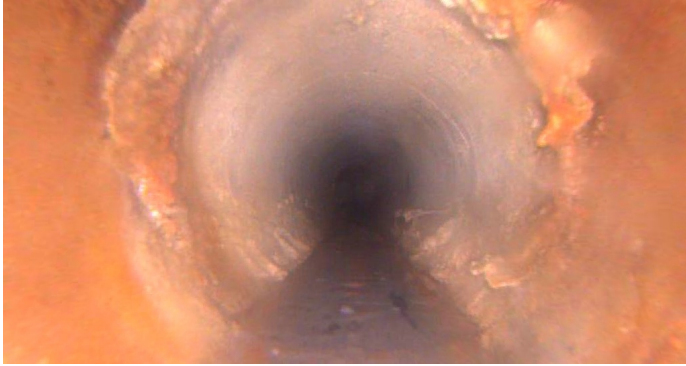
Code: **DAE**
Description: **Deposits Attached Encrustation**

Distance (ft): **73.8**
Structural Grade: **0**
O&M Grade: **2**
Clock Start/From: **7**
Clock To: **5**
1st Value:
2nd Value:
Value Percent: **10.000**
Continuous Index: **S02**
Within 8" of Joint: **YES**
Remarks:

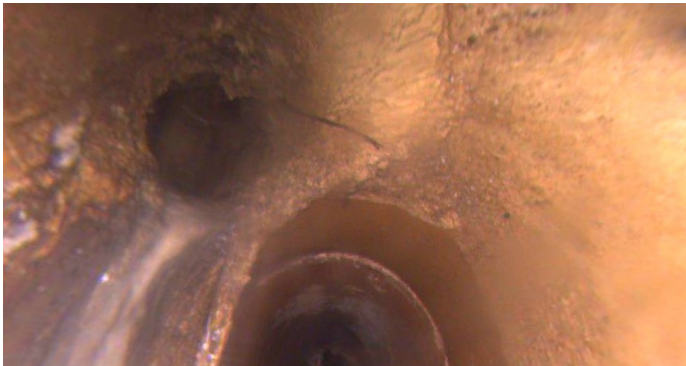
Code: **TFD**
Description: **Tap Factory Defective**

Distance (ft): **95.0**
Structural Grade: **0**
O&M Grade: **2**
Clock Start/From: **10**
Clock To:
1st Value: **4.000**
2nd Value:
Value Percent:
Continuous Index:
Within 8" of Joint:
Remarks: **RFL**

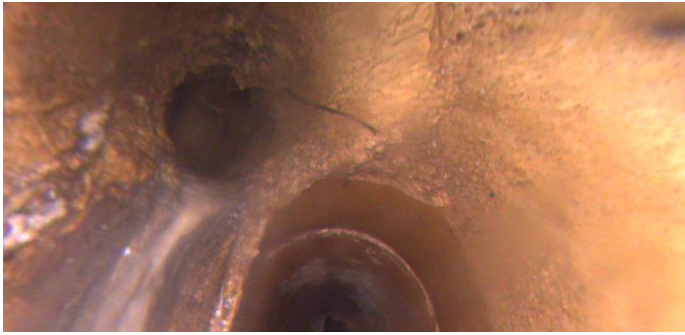
Code: **RFL**
Description: **Roots Fine Lateral**

Distance (ft): **95.0**
Structural Grade: **0**
O&M Grade: **1**
Clock Start/From: **11**
Clock To:
1st Value:
2nd Value:
Value Percent:
Continuous Index:
Within 8" of Joint: **NO**
Remarks:

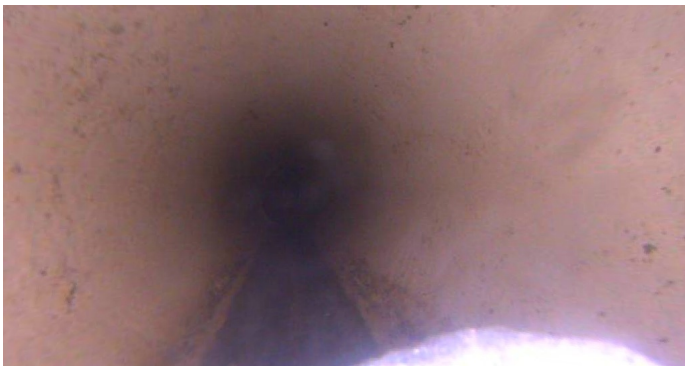
Code: **MMC**
Description: **Material Change**

Distance (ft): **114.2**
Structural Grade: **0**
O&M Grade: **0**
Clock Start/From:
Clock To:
1st Value:
2nd Value:
Value Percent:
Continuous Index:
Within 8" of Joint: **NO**
Remarks: **PVC**

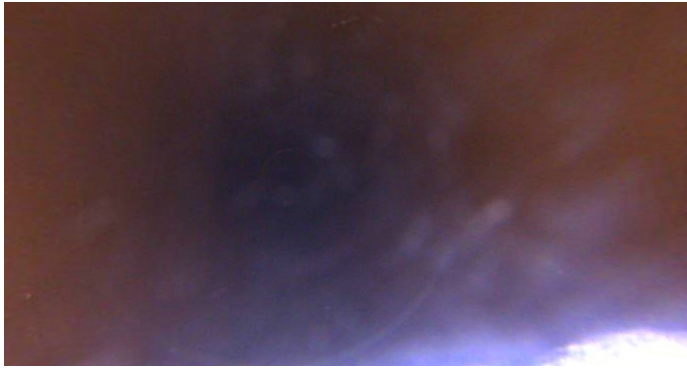
Code:	MMC
Description:	Material Change
Distance (ft):	118.1
Structural Grade:	0
O&M Grade:	0
Clock Start/From:	
Clock To:	
1st Value:	
2nd Value:	
Value Percent:	
Continuous Index:	
Within 8" of Joint:	NO
Remarks:	VCP

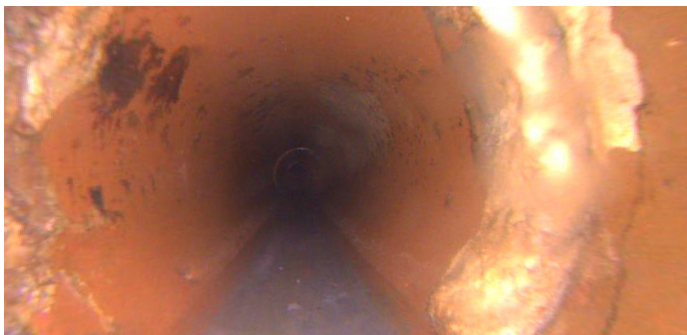
Code:	IW
Description:	Infil Weeper
Distance (ft):	129.6
Structural Grade:	0
O&M Grade:	2
Clock Start/From:	8
Clock To:	4
1st Value:	
2nd Value:	
Value Percent:	
Continuous Index:	S04
Within 8" of Joint:	YES
Remarks:

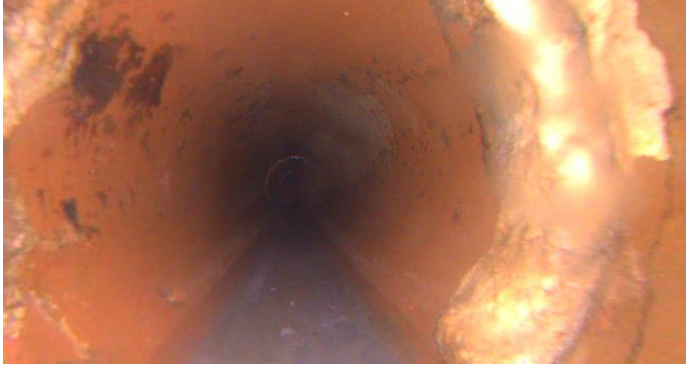
Code: **DAE**
Description: **Deposits Attached Encrustation**

Distance (ft): **129.6**
Structural Grade: **0**
O&M Grade: **2**
Clock Start/From: **7**
Clock To: **5**
1st Value:
2nd Value:
Value Percent: **5.000**
Continuous Index: **S03**
Within 8" of Joint: **YES**
Remarks:

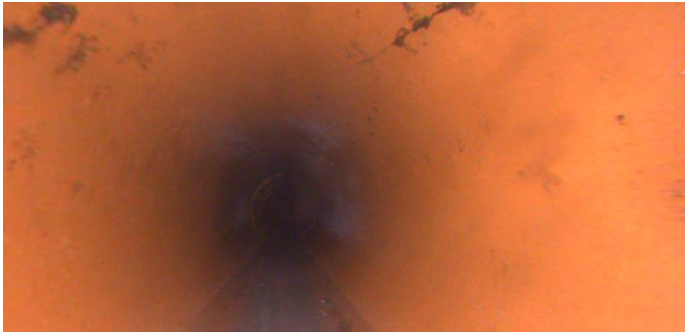
Code: **FL**
Description: **Fracture Longitudinal**

Distance (ft): **154.1**
Structural Grade: **3**
O&M Grade: **0**
Clock Start/From: **1**
Clock To:
1st Value:
2nd Value:
Value Percent:
Continuous Index:
Within 8" of Joint: **YES**
Remarks:

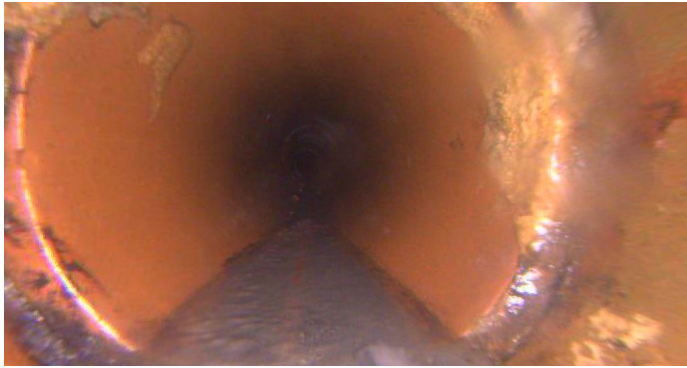
Code:	DAE
Description:	Deposits Attached Encrustation
Distance (ft):	171.3
Structural Grade:	0
O&M Grade:	2
Clock Start/From:	7
Clock To:	5
1st Value:	
2nd Value:	
Value Percent:	5.000
Continuous Index:	
Within 8" of Joint:	YES
Remarks:

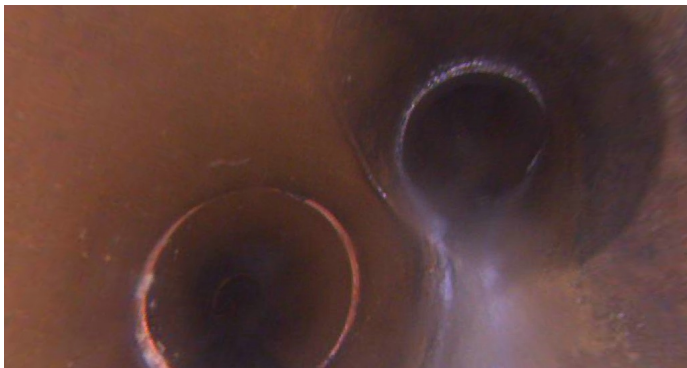
Code:	TF
Description:	Tap Factory
Distance (ft):	180.4
Structural Grade:	0
O&M Grade:	0
Clock Start/From:	2
Clock To:	
1st Value:	4.000
2nd Value:	
Value Percent:	
Continuous Index:	
Within 8" of Joint:	
Remarks:

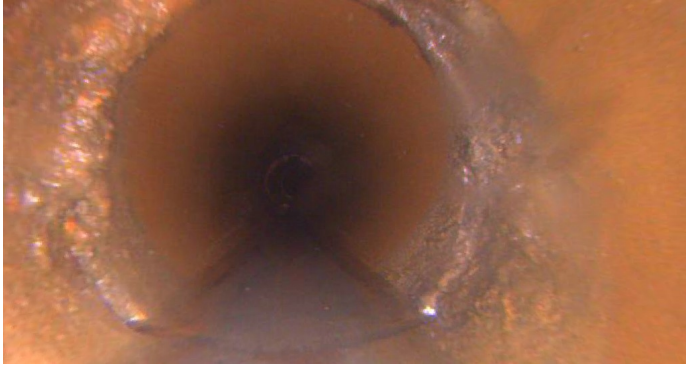
Code: **DAE**
Description: **Deposits Attached Encrustation**

Distance (ft): **185.0**
Structural Grade: **0**
O&M Grade: **2**
Clock Start/From: **7**
Clock To: **5**
1st Value:
2nd Value:
Value Percent: **5.000**
Continuous Index:
Within 8" of Joint: **YES**
Remarks:

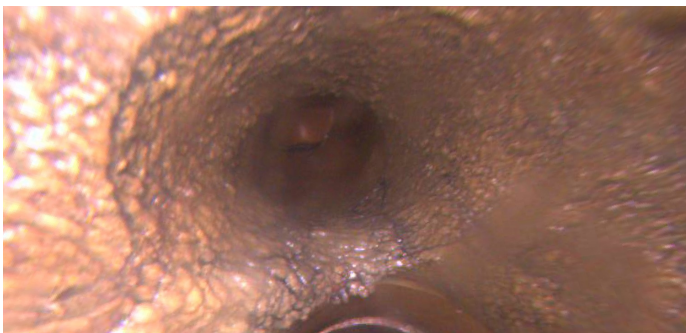
Code: **TF**
Description: **Tap Factory**

Distance (ft): **214.3**
Structural Grade: **0**
O&M Grade: **0**
Clock Start/From: **12**
Clock To:
1st Value: **4.000**
2nd Value:
Value Percent:
Continuous Index:
Within 8" of Joint:
Remarks:

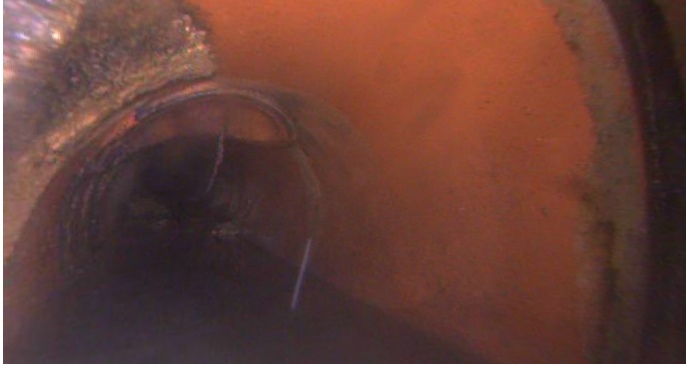
Code:	DAE
Description:	Deposits Attached Encrustation
Distance (ft):	218.1
Structural Grade:	0
O&M Grade:	2
Clock Start/From:	7
Clock To:	5
1st Value:	
2nd Value:	
Value Percent:	5.000
Continuous Index:	F03
Within 8" of Joint:	YES
Remarks:

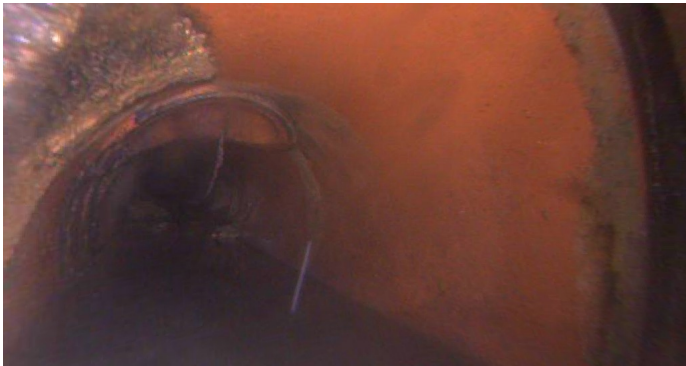
Code:	MSA
Description:	Abandoned Survey
Distance (ft):	218.1
Structural Grade:	0
O&M Grade:	0
Clock Start/From:	
Clock To:	
1st Value:	
2nd Value:	
Value Percent:	
Continuous Index:	
Within 8" of Joint:	NO
Remarks:	Debris
