Profile/Photo Observation Report

Street:	FOXCROFT STREET	Flow Control:	Not Controlled
City:	Hobart, IN	Year Renewed:	
Location:	Yard	Tape/Media #:	
Purpose:	Routine Assessment	Dia/Height:	10"
Use:	Sanitary	Material:	VCP
Drain Area:	NA	Lining:	
Category:	NA		
Comment:

Location Details:		Direction of Survey:	Upstream
US MH:	M-606-064	DS MH:	M-606-065
		Total Length Surveyed (ft):	5.6

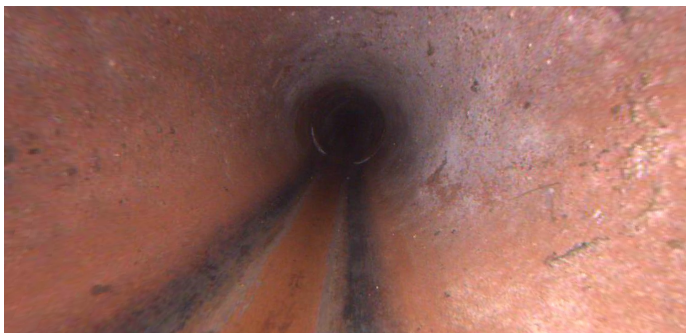
Code: **AMH**
Description: **Manhole**

Distance (ft): **.0**
Structural Grade: **0**
O&M Grade: **0**
Clock Start/From:
Clock To:
1st Value:
2nd Value:
Value Percent:
Continuous Index:
Within 8" of Joint: **NO**
Remarks: **M-606-065**

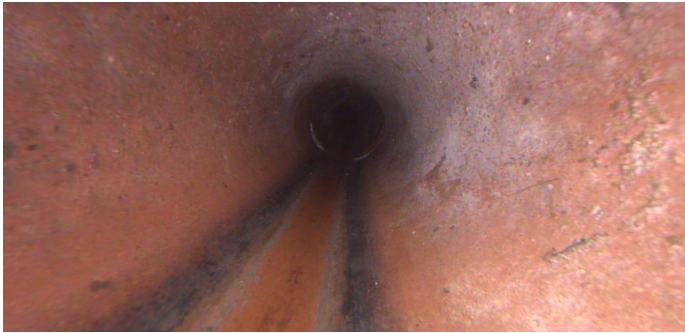
Code:	MWL
Description:	Water Level

Distance (ft):	.0
Structural Grade:	0
O&M Grade:	0
Clock Start/From:	
Clock To:	
1st Value:	
2nd Value:	
Value Percent:	5.000
Continuous Index:	
Within 8" of Joint:	NO
Remarks:

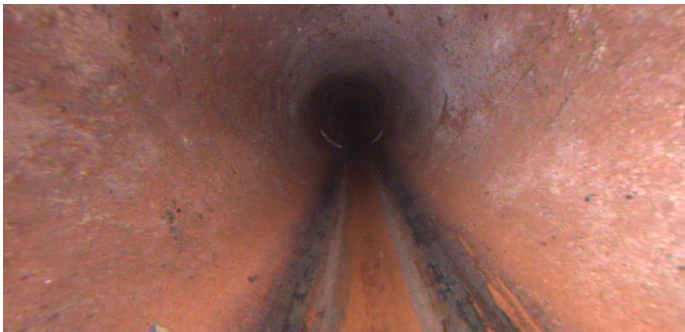
Code:	MSA
Description:	Abandoned Survey

Distance (ft):	5.6
Structural Grade:	0
O&M Grade:	0
Clock Start/From:	
Clock To:	
1st Value:	
2nd Value:	
Value Percent:	
Continuous Index:	
Within 8" of Joint:	NO
Remarks:	UNKNOWN
