Profile/Photo Observation Report

Street:	ALLEY BETWEEN W 7TH ST & W 7TH	Flow Control:	Not Controlled
City:	Hobart, IN	Year Renewed:	
Location:	Yard	Tape/Media #:	
Purpose:	Routine Assessment	Dia/Height:	10"
Use:	Sanitary	Material:	VCP
Drain Area:	NA	Lining:	
Category:	NA		
Comment:	Flow direction is marked wrong.		
Location Details:		Direction of Survey:	Upstream
US MH:	M-606-064	DS MH:	M-606-065
		Total Length Surveyed (ft):	6.3

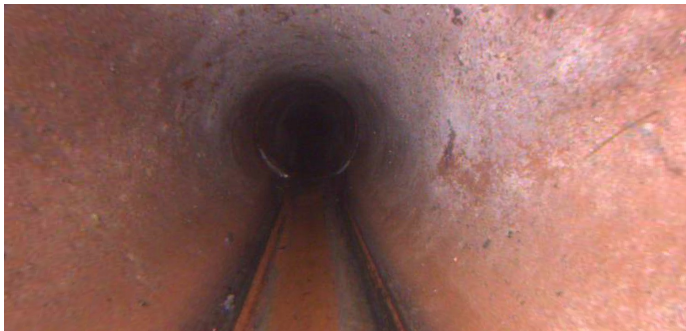
Code: **AMH**
Description: **Manhole**

Distance (ft): **.0**
Structural Grade: **0**
O&M Grade: **0**
Clock Start/From:
Clock To:
1st Value:
2nd Value:
Value Percent:
Continuous Index:
Within 8" of Joint: **NO**
Remarks: **M-606-065**

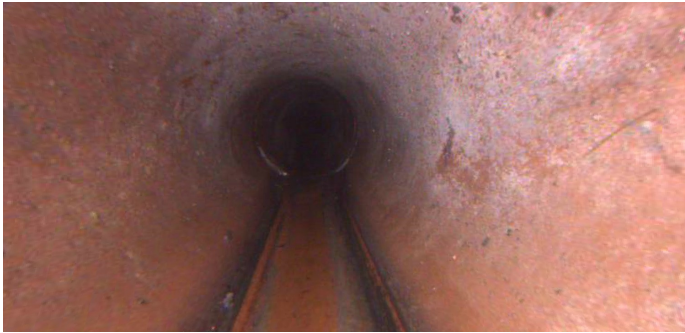
Code:	MWL
Description:	Water Level

Distance (ft):	.0
Structural Grade:	0
O&M Grade:	0
Clock Start/From:	
Clock To:	
1st Value:	
2nd Value:	
Value Percent:	5.000
Continuous Index:	
Within 8" of Joint:	NO
Remarks:

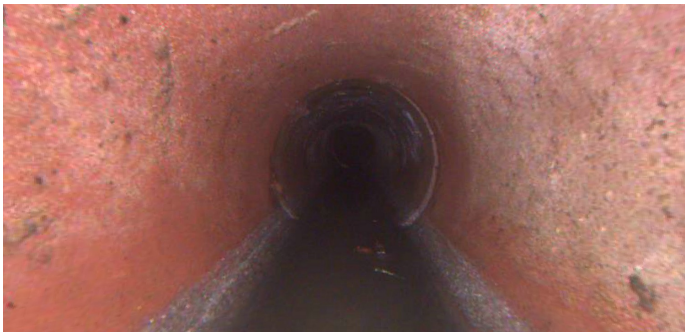
Code:	MSA
Description:	Abandoned Survey

Distance (ft):	6.3
Structural Grade:	0
O&M Grade:	0
Clock Start/From:	
Clock To:	
1st Value:	
2nd Value:	
Value Percent:	
Continuous Index:	
Within 8" of Joint:	NO
Remarks:	unknown
