Profile/Photo Observation Report

Date:	04/08/2018	Weather:		Coding:	PACP 6.0
Pipe Length (ft):	169.8	Owner:	NA	Pre Clean:	No Pre-Cleaning
P.O.#:		Surveyor:	Jen Costello	PSR:	P-606-065-064
Customer:		Clean Date:	01/01/1900	Shape:	C

Street:	FOXCROFT STREET	Flow Control:	Not Controlled
City:	Hobart, IN	Year Renewed:	
Location:	Yard	Tape/Media #:	
Purpose:	Routine Assessment	Dia/Height:	10"
Use:	Sanitary	Material:	VCP
Drain Area:	NA	Lining:	
Category:	NA		
Comment:	Flow direction is marked wrong.		
Location Details:		Direction of Survey:	Upstream
US MH:	M-606-064	DS MH:	M-606-065
		Total Length Surveyed (ft):	6.3

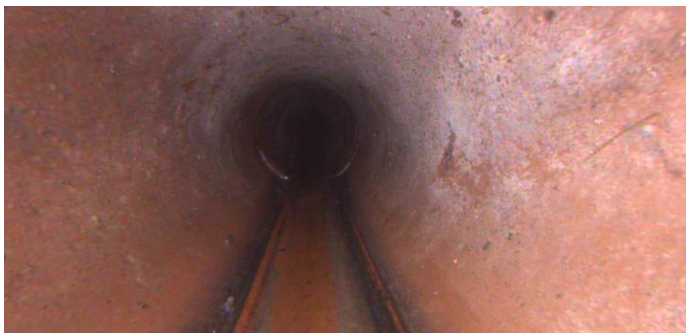
Code: **AMH**
Description: **Manhole**

Distance (ft): **.0**
Structural Grade: **0**
O&M Grade: **0**
Clock Start/From:
Clock To:
1st Value:
2nd Value:
Value Percent:
Continuous Index:
Within 8" of Joint: **NO**
Remarks: **M-606-065**

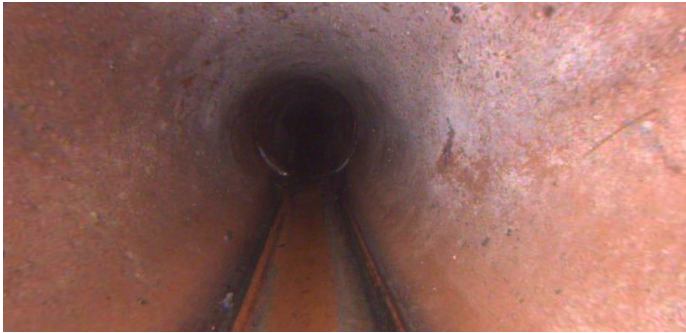
Code:	MWL
Description:	Water Level

Distance (ft):	.0
Structural Grade:	0
O&M Grade:	0
Clock Start/From:	
Clock To:	
1st Value:	
2nd Value:	
Value Percent:	5.000
Continuous Index:	
Within 8" of Joint:	NO
Remarks:

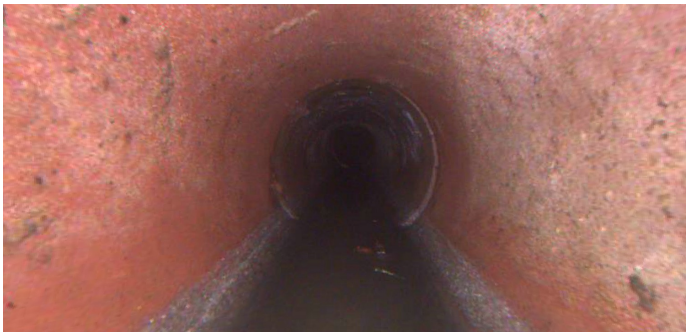
Code:	MSA
Description:	Abandoned Survey

Distance (ft):	6.3
Structural Grade:	0
O&M Grade:	0
Clock Start/From:	
Clock To:	
1st Value:	
2nd Value:	
Value Percent:	
Continuous Index:	
Within 8" of Joint:	NO
Remarks:	unknown
