Profile/Photo Observation Report

Street:	FOXCROFT STREET	Flow Control:	Not Controlled
City:	Hobart, IN	Year Renewed:	
Location:	Yard	Tape/Media #:	
Purpose:	Routine Assessment	Dia/Height:	12"
Use:	Sanitary	Material:	VCP
Drain Area:	NA	Lining:	
Category:	NA		
Comment:	False O_C, flow direction is marked wrong.		
Location Details:		Direction of Survey:	Downstream
US MH:	M-606-064	DS MH:	M-606-067
		Total Length Surveyed (ft):	7.8

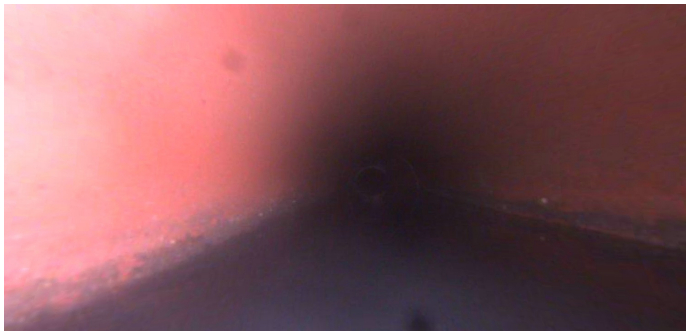
Code: **AMH**
Description: **Manhole**

Distance (ft): **.0**
Structural Grade: **0**
O&M Grade: **0**
Clock Start/From:
Clock To:
1st Value:
2nd Value:
Value Percent:
Continuous Index:
Within 8" of Joint: **NO**
Remarks: **M-606-064**

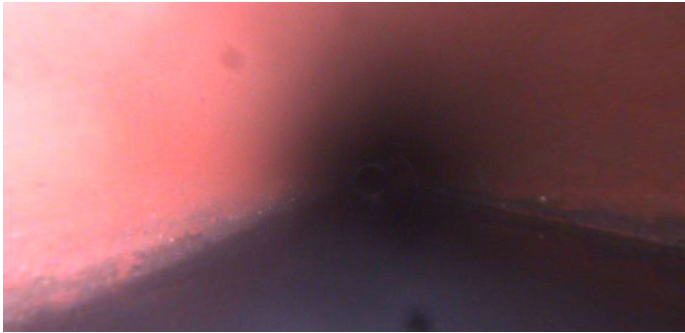
Code:	MWL
Description:	Water Level

Distance (ft):	.0
Structural Grade:	0
O&M Grade:	0
Clock Start/From:	
Clock To:	
1st Value:	
2nd Value:	
Value Percent:	40.000
Continuous Index:	
Within 8" of Joint:	NO
Remarks:

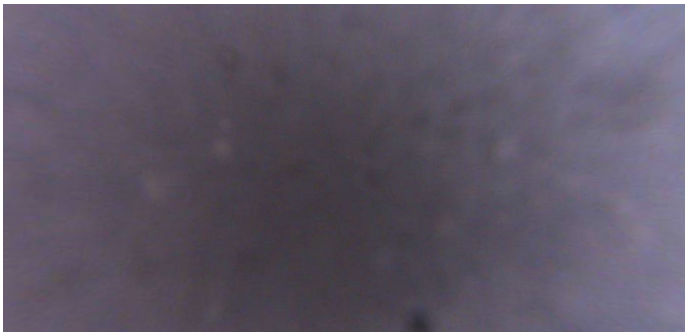
Code:	MWL
Description:	Water Level

Distance (ft):	3.2
Structural Grade:	0
O&M Grade:	0
Clock Start/From:	
Clock To:	
1st Value:	
2nd Value:	
Value Percent:	100.000
Continuous Index:	
Within 8" of Joint:	NO
Remarks:

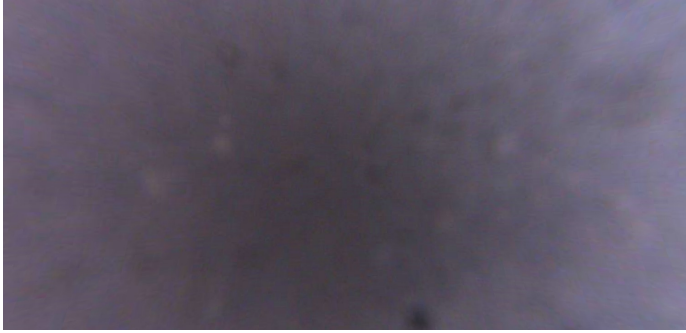
Code: **MCU**
Description: **Camera Underwater**

Distance (ft): **3.2**
Structural Grade: **0**
O&M Grade: **4**
Clock Start/From:
Clock To:
1st Value:
2nd Value:
Value Percent:
Continuous Index:
Within 8" of Joint: **NO**
Remarks:

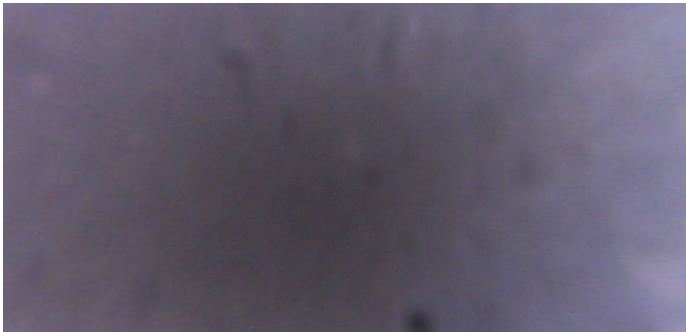
Code: **MSA**
Description: **Abandoned Survey**

Distance (ft): **7.8**
Structural Grade: **0**
O&M Grade: **0**
Clock Start/From:
Clock To:
1st Value:
2nd Value:
Value Percent:
Continuous Index:
Within 8" of Joint: **NO**
Remarks: **MCU**
