Profile/Photo Observation Report

Date:	04/09/2018	Weather:		Coding:	PACP 6.0
Pipe Length (ft):	186.1	Owner:	NA	Pre Clean:	No Pre-Cleaning
P.O.#:		Surveyor:	Mark Ruby	PSR:	P-606-074-067
Customer:		Clean Date:	01/01/1900	Shape:	C

Street:	FOXCROFT STREET	Flow Control:	Not Controlled
City:	Hobart, IN	Year Renewed:	
Location:	Yard	Tape/Media #:	
Purpose:	Routine Assessment	Dia/Height:	12"
Use:	Sanitary	Material:	VCP
Drain Area:	NA	Lining:	
Category:	NA		
Comment:	Flow direction is marked wrong.		
Location Details:		Direction of Survey:	Downstream
US MH:	M-606-067	DS MH:	M-606-074
		Total Length Surveyed (ft):	160.1

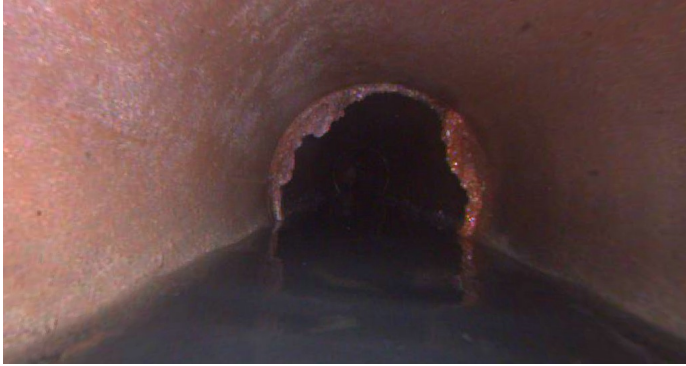
Code: **AMH**
Description: **Manhole**

Distance (ft): **.0**
Structural Grade: **0**
O&M Grade: **0**
Clock Start/From:
Clock To:
1st Value:
2nd Value:
Value Percent:
Continuous Index:
Within 8" of Joint: **NO**
Remarks: **M-606-067**

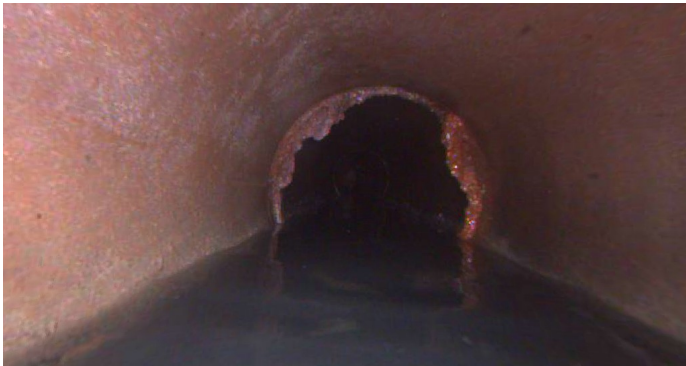
Code: **MWL**
Description: **Water Level**

Distance (ft): **.0**
Structural Grade: **0**
O&M Grade: **0**
Clock Start/From:
Clock To:
1st Value:
2nd Value:
Value Percent: **10.000**
Continuous Index:
Within 8" of Joint: **NO**
Remarks:

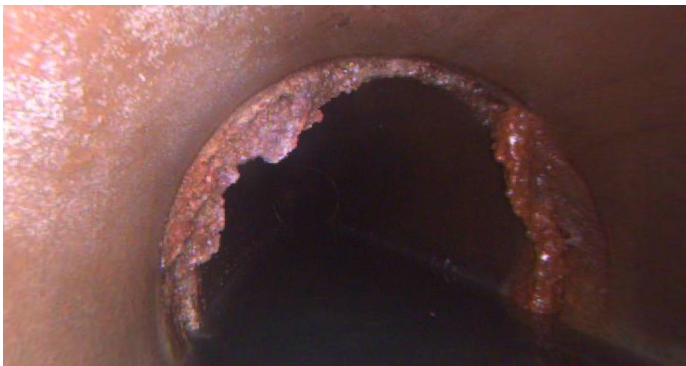
Code: **DAZ**
Description: **Deposits Attached Other**

Distance (ft): **1.3**
Structural Grade: **0**
O&M Grade: **2**
Clock Start/From: **7**
Clock To: **5**
1st Value:
2nd Value:
Value Percent: **5.000**
Continuous Index:
Within 8" of Joint: **YES**
Remarks:

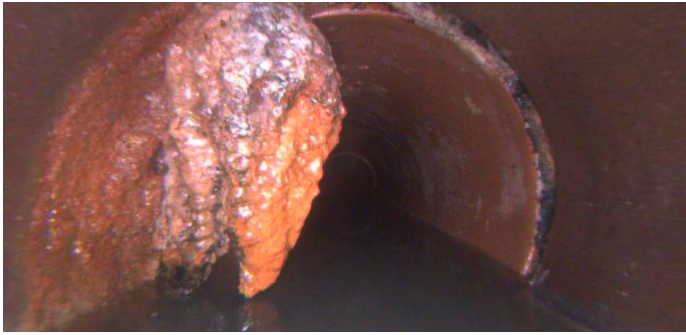
Code: ID
Description: Infil Dripper

Distance (ft): 9.3
Structural Grade: 0
O&M Grade: 3
Clock Start/From: 11
Clock To:
1st Value:
2nd Value:
Value Percent:
Continuous Index:
Within 8" of Joint: YES
Remarks:

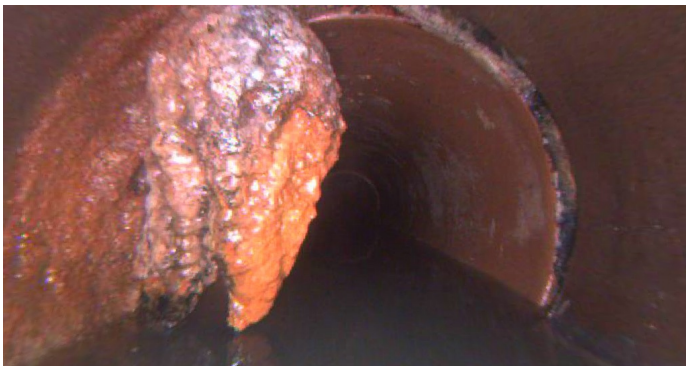
Code: DAGS
Description: Deposits Attached Grease

Distance (ft): 9.3
Structural Grade: 0
O&M Grade: 2
Clock Start/From: 7
Clock To: 12
1st Value:
2nd Value:
Value Percent: 10.000
Continuous Index:
Within 8" of Joint: YES
Remarks:

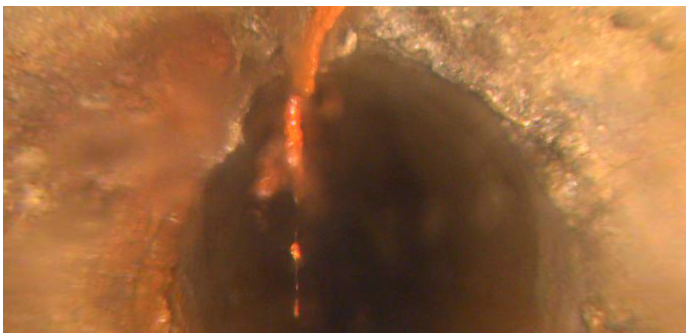
Code: RFJ
Description: Roots Fine Joint

Distance (ft): 81.7
Structural Grade: 0
O&M Grade: 1
Clock Start/From: 12
Clock To:
1st Value:
2nd Value:
Value Percent:
Continuous Index:
Within 8" of Joint: YES
Remarks:

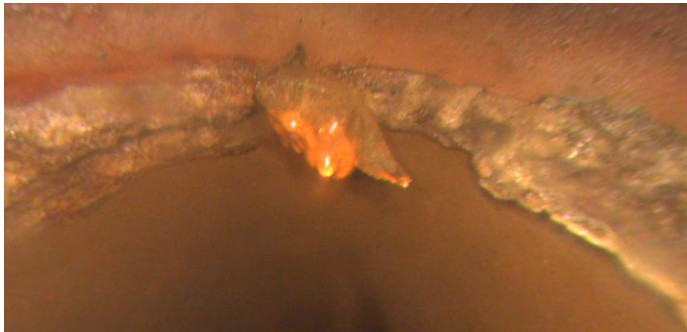
Code:	ID
Description:	Infil Dripper
Distance (ft):	111.1
Structural Grade:	0
O&M Grade:	3
Clock Start/From:	12
Clock To:	
1st Value:	
2nd Value:	
Value Percent:	
Continuous Index:	
Within 8" of Joint:	YES
Remarks:

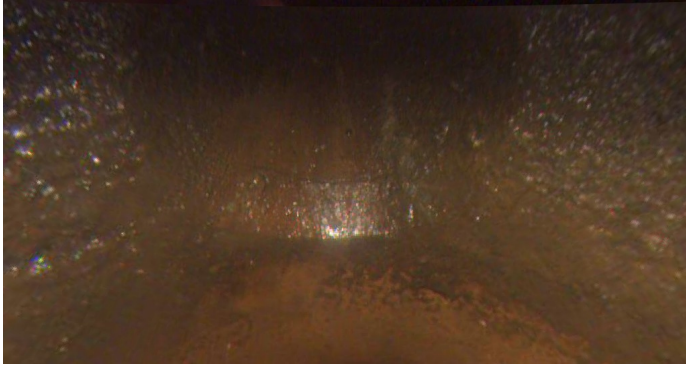
Code: **TFA**
Description: **Tap Factory Active**

Distance (ft): **116.0**
Structural Grade: **0**
O&M Grade: **0**
Clock Start/From: **12**
Clock To:
1st Value: **4.000**
2nd Value:
Value Percent:
Continuous Index:
Within 8" of Joint:
Remarks:

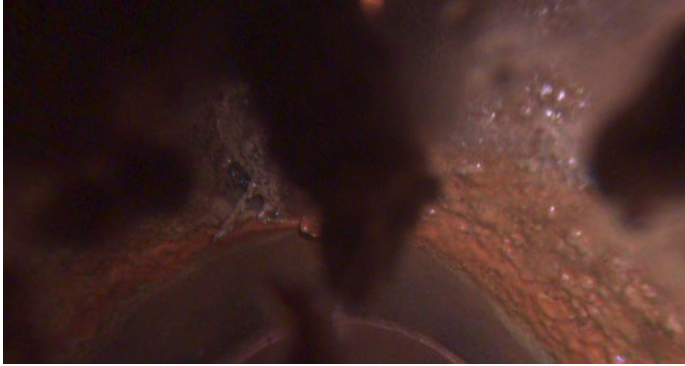
Code: **TF**
Description: **Tap Factory**

Distance (ft): **141.6**
Structural Grade: **0**
O&M Grade: **0**
Clock Start/From: **12**
Clock To:
1st Value: **4.000**
2nd Value:
Value Percent:
Continuous Index:
Within 8" of Joint:
Remarks:

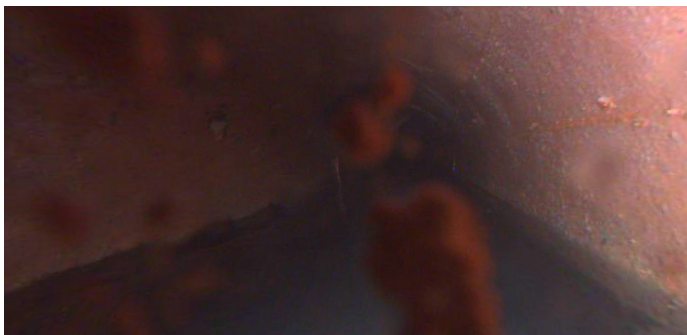
Code:	IW
Description:	Infil Weeper
Distance (ft):	160.0
Structural Grade:	0
O&M Grade:	2
Clock Start/From:	8
Clock To:	4
1st Value:	
2nd Value:	
Value Percent:	
Continuous Index:	F03
Within 8" of Joint:	YES
Remarks:

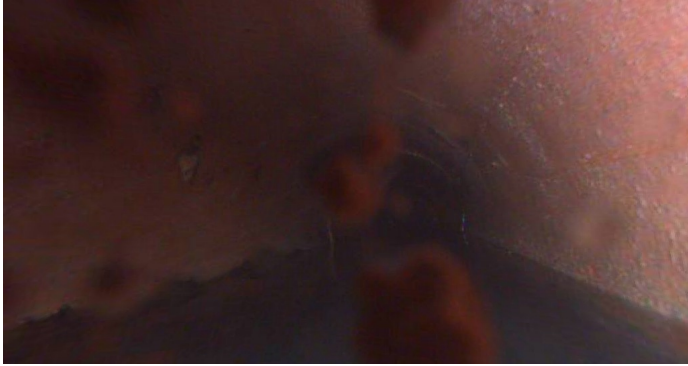
Code:	MSA
Description:	Abandoned Survey
Distance (ft):	160.1
Structural Grade:	0
O&M Grade:	0
Clock Start/From:	
Clock To:	
1st Value:	
2nd Value:	
Value Percent:	
Continuous Index:	
Within 8" of Joint:	NO
Remarks:	Debris
