Profile/Photo Observation Report

Street:	ALLEY BETWEEN S PENNSYLVANIA S	Flow Control:	Not Controlled
City:	Hobart, IN	Year Renewed:	
Location:	Yard	Tape/Media #:	
Purpose:	Routine Assessment	Dia/Height:	10"
Use:	Sanitary	Material:	VCP
Drain Area:	NA	Lining:	
Category:	NA		
Comment:	Flow direction is marked wrong.		
Location Details:		Direction of Survey:	Downstream
US MH:	M-606-068	DS MH:	M-606-069
		Total Length Surveyed (ft):	19.1

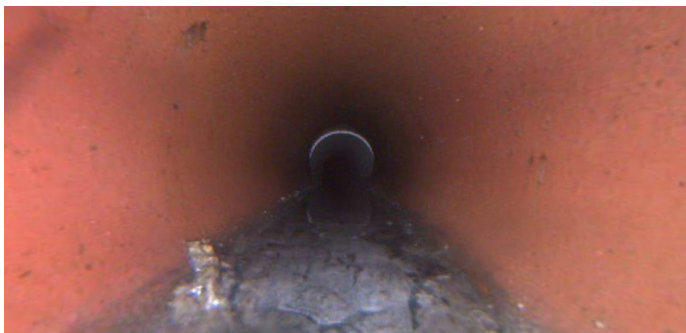
Code: **AMH**
Description: **Manhole**

Distance (ft): **.0**
Structural Grade: **0**
O&M Grade: **0**
Clock Start/From:
Clock To:
1st Value:
2nd Value:
Value Percent:
Continuous Index:
Within 8" of Joint: **NO**
Remarks: **M-606-068**

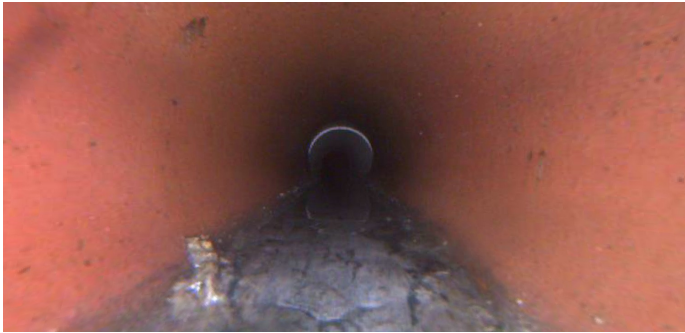
Code:	MWL
Description:	Water Level

Distance (ft):	.0
Structural Grade:	0
O&M Grade:	0
Clock Start/From:	
Clock To:	
1st Value:	
2nd Value:	
Value Percent:	10.000
Continuous Index:	
Within 8" of Joint:	NO
Remarks:

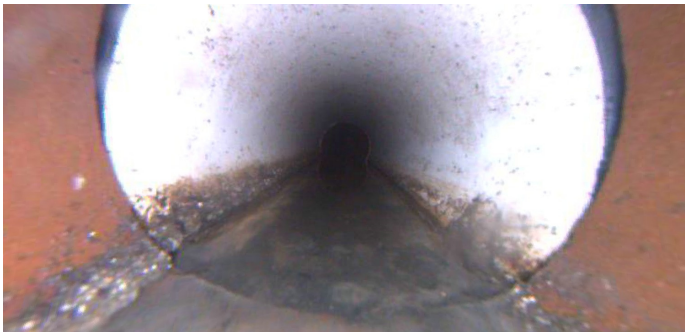
Code:	MMC
Description:	Material Change

Distance (ft):	3.9
Structural Grade:	0
O&M Grade:	0
Clock Start/From:	
Clock To:	
1st Value:	
2nd Value:	
Value Percent:	
Continuous Index:	
Within 8" of Joint:	NO
Remarks:	pvc

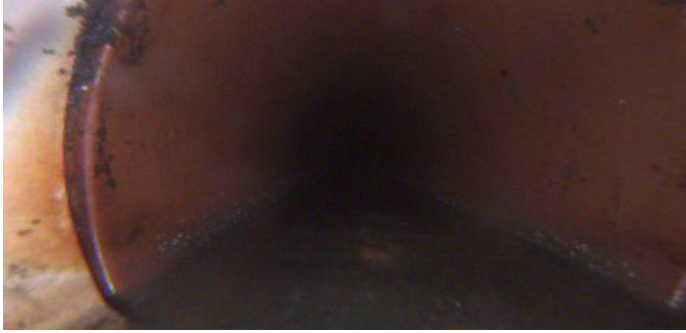
Code: **MMC**
Description: **Material Change**

Distance (ft): **8.2**
Structural Grade: **0**
O&M Grade: **0**
Clock Start/From:
Clock To:
1st Value:
2nd Value:
Value Percent:
Continuous Index:
Within 8" of Joint: **NO**
Remarks: **vcp**

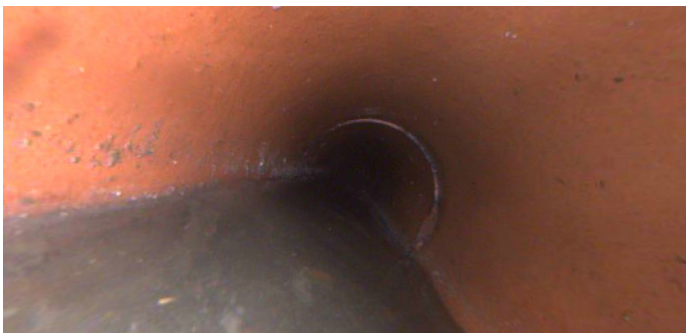
Code: **MSA**
Description: **Abandoned Survey**

Distance (ft): **19.1**
Structural Grade: **0**
O&M Grade: **0**
Clock Start/From:
Clock To:
1st Value:
2nd Value:
Value Percent:
Continuous Index:
Within 8" of Joint: **NO**
Remarks: **overturned**
