## Profile/Photo Observation Report

Date:	<b>04/07/2018</b>	Weather:		Coding:	<b>PACP 6.0</b>
Pipe Length (ft):	<b>182.0</b>	Owner:	<b>NA</b>	Pre Clean:	<b>No Pre-Cleaning</b>
P.O.#:		Surveyor:	<b>Mark Ruby</b>	PSR:	<b>P-606-073-072</b>
Customer:		Clean Date:	<b>01/01/1900</b>	Shape:	<b>C</b>

Street:	<b>FOXCROFT STREET</b>	Flow Control:	<b>Not Controlled</b>
City:	<b>Hobart, IN</b>	Year Renewed:	
Location:	<b>Yard</b>	Tape/Media #:	
Purpose:	<b>Routine Assessment</b>	Dia/Height:	<b>10"</b>
Use:	<b>Sanitary</b>	Material:	<b>VCP</b>
Drain Area:	<b>NA</b>	Lining:	
Category:	<b>NA</b>		
Comment:	<b>P_C blockage, flow direction is marked wrong.</b>		
Location Details:		Direction of Survey:	<b>Upstream</b>
US MH:	<b>M-606-072</b>	DS MH:	<b>M-606-073</b>
		Total Length Surveyed (ft):	<b>81.3</b>

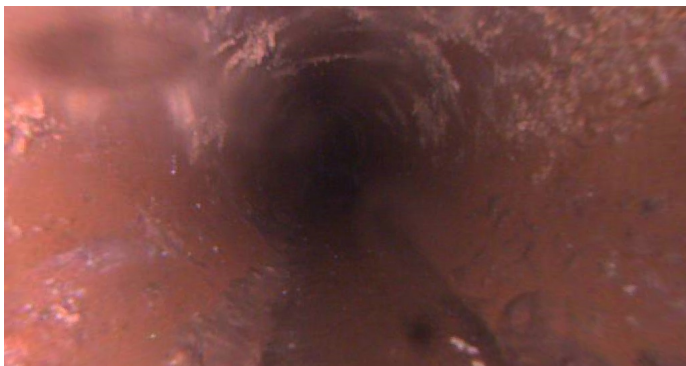
Code: **AMH**  
Description: **Manhole**

Distance (ft): **.0**  
Structural Grade: **0**  
O&M Grade: **0**  
Clock Start/From:  
Clock To:  
1st Value:  
2nd Value:  
Value Percent:  
Continuous Index:  
Within 8" of Joint: **NO**  
Remarks: **M-606-073**

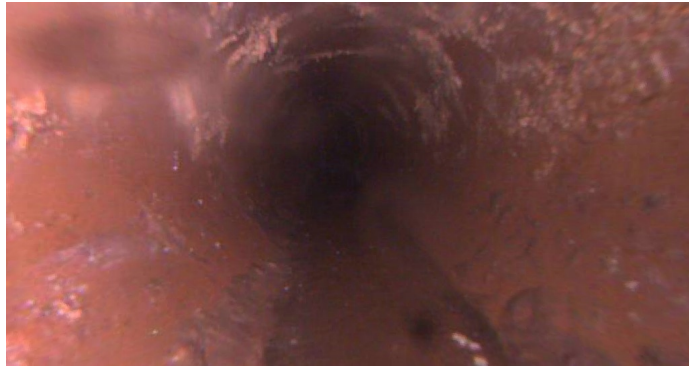
Code:	<b>MWL</b>
Description:	<b>Water Level</b>
Distance (ft):	<b>.0</b>
Structural Grade:	<b>0</b>
O&M Grade:	<b>0</b>
Clock Start/From:	
Clock To:	
1st Value:	
2nd Value:	
Value Percent:	<b>10.000</b>
Continuous Index:	
Within 8" of Joint:	<b>NO</b>
Remarks:

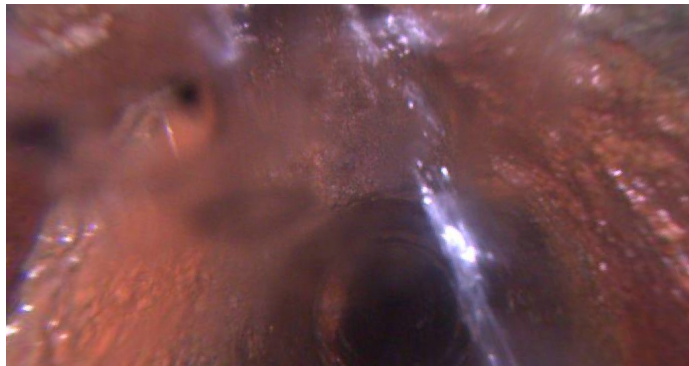
Code:	<b>IR</b>
Description:	<b>Infil Runner</b>
Distance (ft):	<b>4.8</b>
Structural Grade:	<b>0</b>
O&M Grade:	<b>4</b>
Clock Start/From:	<b>12</b>
Clock To:	
1st Value:	
2nd Value:	
Value Percent:	
Continuous Index:	
Within 8" of Joint:	<b>YES</b>
Remarks:

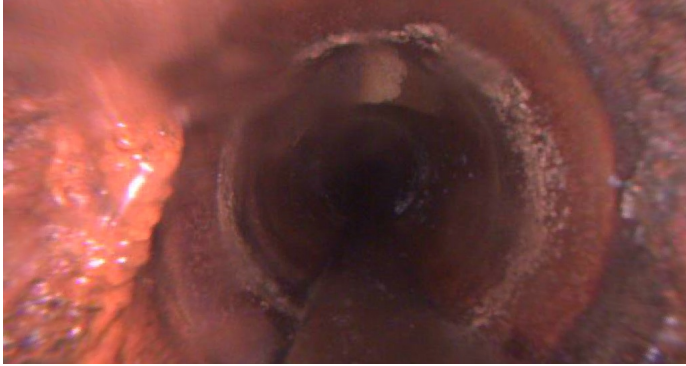
Code: **DAE**  
Description: **Deposits Attached Encrustation**

Distance (ft): **6.2**  
Structural Grade: **0**  
O&M Grade: **2**  
Clock Start/From: **7**  
Clock To: **12**  
1st Value:  
2nd Value:  
Value Percent: **10.000**  
Continuous Index:  
Within 8" of Joint: **NO**  
Remarks:

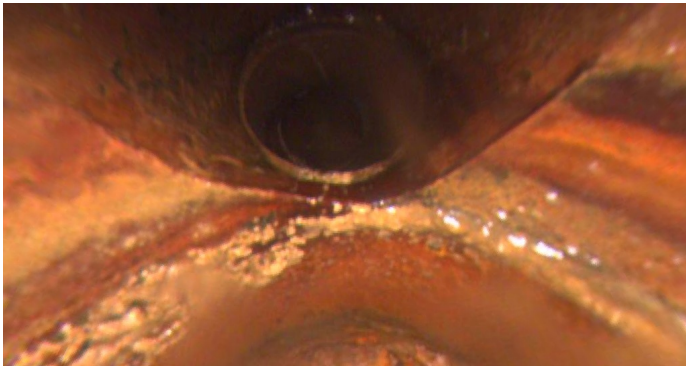
Code: **TF**  
Description: **Tap Factory**

Distance (ft): **7.4**  
Structural Grade: **0**  
O&M Grade: **0**  
Clock Start/From: **12**  
Clock To:  
1st Value: **4.000**  
2nd Value:  
Value Percent:  
Continuous Index:  
Within 8" of Joint:  
Remarks:

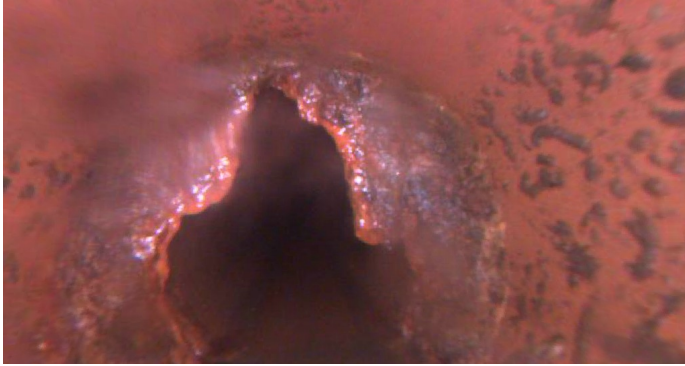
Code: **DAE**  
Description: **Deposits Attached Encrustation**

Distance (ft): **23.8**  
Structural Grade: **0**  
O&M Grade: **2**  
Clock Start/From: **7**  
Clock To: **5**  
1st Value:  
2nd Value:  
Value Percent: **10.000**  
Continuous Index:  
Within 8" of Joint: **YES**  
Remarks:

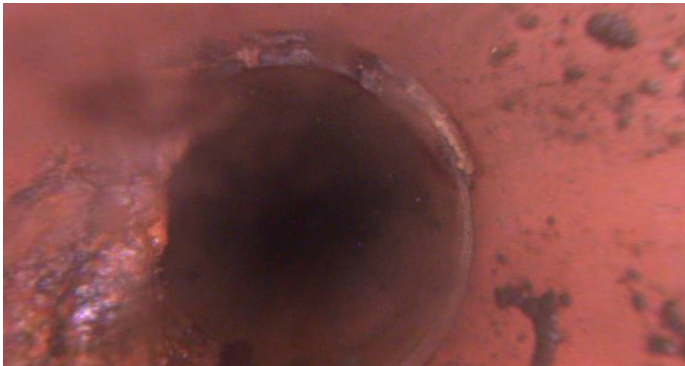
Code: **DAE**  
Description: **Deposits Attached Encrustation**

Distance (ft): **31.9**  
Structural Grade: **0**  
O&M Grade: **2**  
Clock Start/From: **7**  
Clock To: **2**  
1st Value:  
2nd Value:  
Value Percent: **10.000**  
Continuous Index:  
Within 8" of Joint: **YES**  
Remarks:

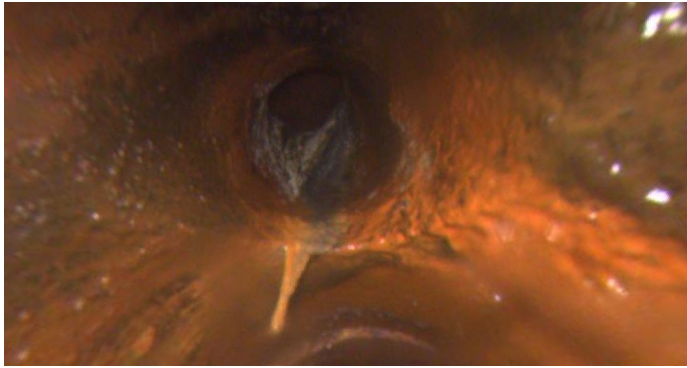
Code: **TF**  
Description: **Tap Factory**

Distance (ft): **41.7**  
Structural Grade: **0**  
O&M Grade: **0**  
Clock Start/From: **12**  
Clock To:  
1st Value: **4.000**  
2nd Value:  
Value Percent:  
Continuous Index:  
Within 8" of Joint:  
Remarks:

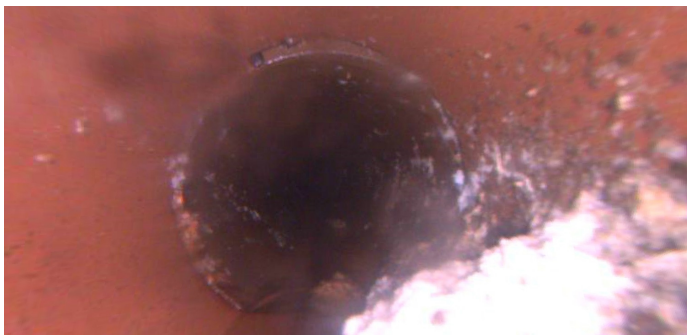
Code: **DAGS**  
Description: **Deposits Attached Grease**

Distance (ft): **51.8**  
Structural Grade: **0**  
O&M Grade: **2**  
Clock Start/From: **3**  
Clock To: **5**  
1st Value:  
2nd Value:  
Value Percent: **10.000**  
Continuous Index:  
Within 8" of Joint: **YES**  
Remarks:

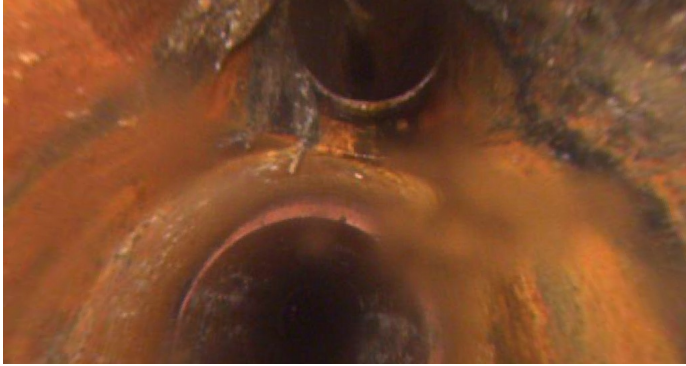
Code: **TF**  
Description: **Tap Factory**

Distance (ft): **51.8**  
Structural Grade: **0**  
O&M Grade: **0**  
Clock Start/From: **11**  
Clock To:  
1st Value: **4.000**  
2nd Value:  
Value Percent:  
Continuous Index:  
Within 8" of Joint:  
Remarks:

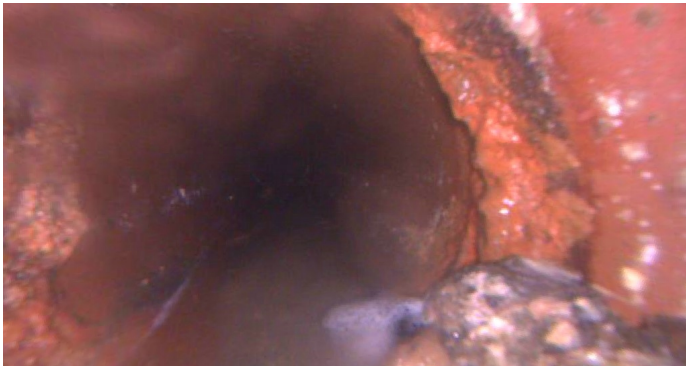
Code: **DAE**  
Description: **Deposits Attached Encrustation**

Distance (ft): **60.2**  
Structural Grade: **0**  
O&M Grade: **2**  
Clock Start/From: **7**  
Clock To: **5**  
1st Value:  
2nd Value:  
Value Percent: **5.000**  
Continuous Index:  
Within 8" of Joint: **YES**  
Remarks:

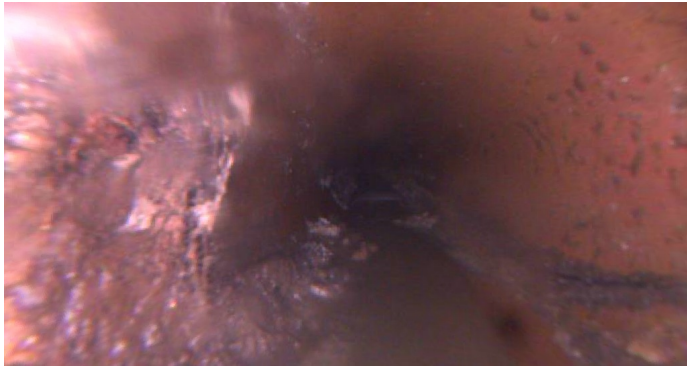
Code: **RMJ**  
Description: **Roots Medium Joint**

Distance (ft): **68.3**  
Structural Grade: **0**  
O&M Grade: **3**  
Clock Start/From: **7**  
Clock To: **11**  
1st Value:  
2nd Value:  
Value Percent: **10.000**  
Continuous Index:  
Within 8" of Joint: **YES**  
Remarks:

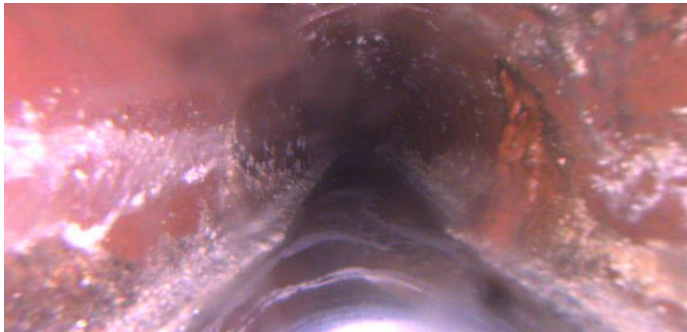
Code: **DAE**  
Description: **Deposits Attached Encrustation**

Distance (ft): **71.9**  
Structural Grade: **0**  
O&M Grade: **2**  
Clock Start/From: **1**  
Clock To: **4**  
1st Value:  
2nd Value:  
Value Percent: **5.000**  
Continuous Index:  
Within 8" of Joint: **YES**  
Remarks:

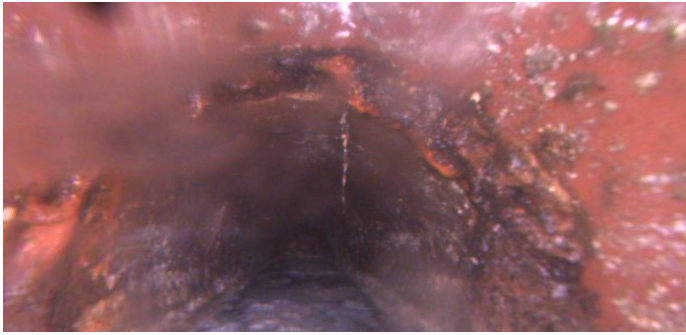
Code: **DAE**  
Description: **Deposits Attached Encrustation**

Distance (ft): **76.3**  
Structural Grade: **0**  
O&M Grade: **2**  
Clock Start/From: **8**  
Clock To: **4**  
1st Value:  
2nd Value:  
Value Percent: **10.000**  
Continuous Index:  
Within 8" of Joint: **YES**  
Remarks:

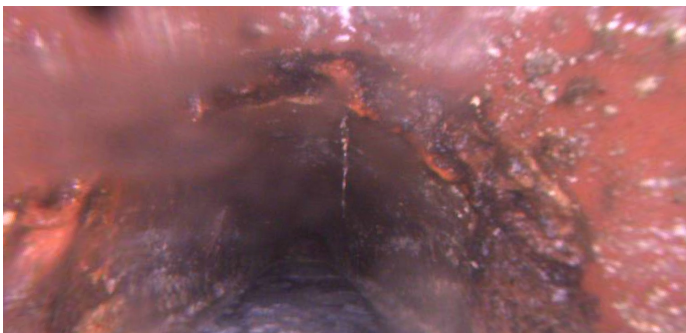
Code: **RFJ**  
Description: **Roots Fine Joint**

Distance (ft): **76.3**  
Structural Grade: **0**  
O&M Grade: **1**  
Clock Start/From: **12**  
Clock To:  
1st Value:  
2nd Value:  
Value Percent:  
Continuous Index:  
Within 8" of Joint: **YES**  
Remarks:

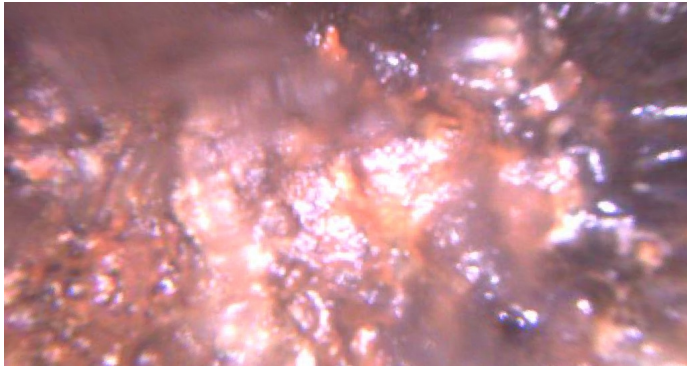
Code:	<b>DAZ</b>
Description:	<b>Deposits Attached Other</b>
Distance (ft):	<b>81.3</b>
Structural Grade:	<b>0</b>
O&M Grade:	<b>5</b>
Clock Start/From:	<b>12</b>
Clock To:	<b>12</b>
1st Value:	
2nd Value:	
Value Percent:	<b>70.000</b>
Continuous Index:	
Within 8" of Joint:	<b>NO</b>
Remarks:

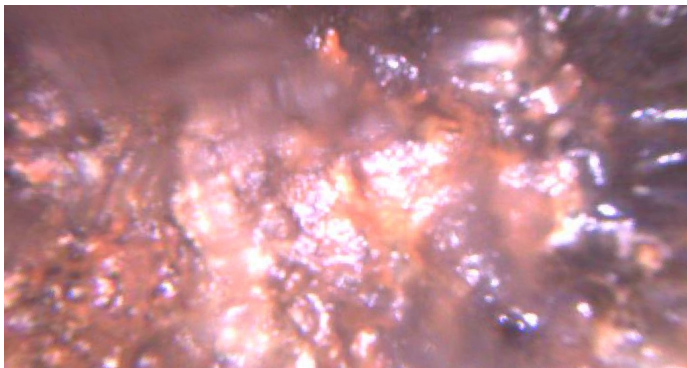
Code:	<b>MSA</b>
Description:	<b>Abandoned Survey</b>
Distance (ft):	<b>81.3</b>
Structural Grade:	<b>0</b>
O&M Grade:	<b>0</b>
Clock Start/From:	
Clock To:	
1st Value:	
2nd Value:	
Value Percent:	
Continuous Index:	
Within 8" of Joint:	<b>NO</b>
Remarks:	<b>DAZ</b>
