## Profile/Photo Observation Report

Street:	<b>FOXCROFT STREET</b>	Flow Control:	<b>Not Controlled</b>
City:	<b>Hobart, IN</b>	Year Renewed:	
Location:	<b>Yard</b>	Tape/Media #:	
Purpose:	<b>Routine Assessment</b>	Dia/Height:	<b>12"</b>
Use:	<b>Sanitary</b>	Material:	<b>VCP</b>
Drain Area:	<b>NA</b>	Lining:	
Category:	<b>NA</b>		
Comment:

Location Details:		Direction of Survey:	<b>Upstream</b>
US MH:	<b>M-606-074</b>	DS MH:	<b>M-606-075</b>
		Total Length Surveyed (ft):	<b>6.3</b>

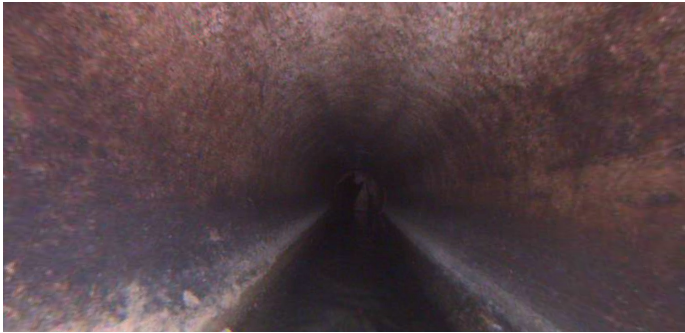
Code:	<b>MWL</b>
Description:	<b>Water Level</b>

Distance (ft):	<b>.0</b>
Structural Grade:	<b>0</b>
O&M Grade:	<b>0</b>
Clock Start/From:	
Clock To:	
1st Value:	
2nd Value:	
Value Percent:	<b>5.000</b>
Continuous Index:	
Within 8" of Joint:	<b>NO</b>
Remarks:

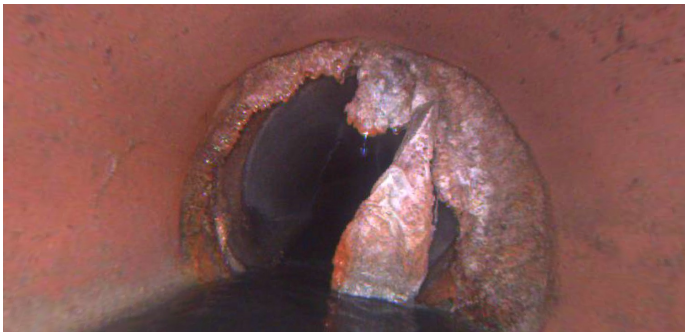
Code:	<b>DAE</b>
Description:	<b>Deposits Attached Encrustation</b>

Distance (ft):	<b>6.0</b>
Structural Grade:	<b>0</b>
O&M Grade:	<b>5</b>
Clock Start/From:	<b>8</b>
Clock To:	<b>4</b>
1st Value:	
2nd Value:	
Value Percent:	<b>40.000</b>
Continuous Index:	
Within 8" of Joint:	<b>YES</b>
Remarks:

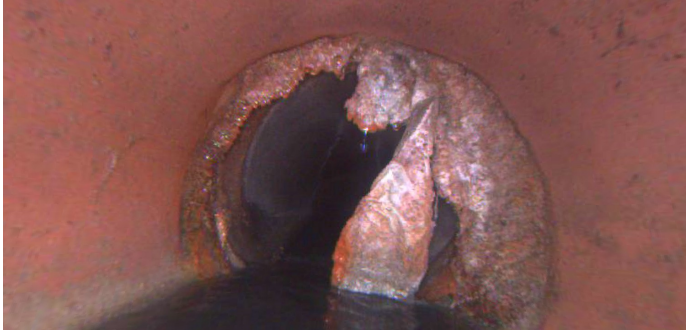
Code: **IR**  
Description: **Infil Runner**

Distance (ft): **6.0**  
Structural Grade: **0**  
O&M Grade: **4**  
Clock Start/From: **12**  
Clock To:  
1st Value:  
2nd Value:  
Value Percent:  
Continuous Index:  
Within 8" of Joint: **YES**  
Remarks:

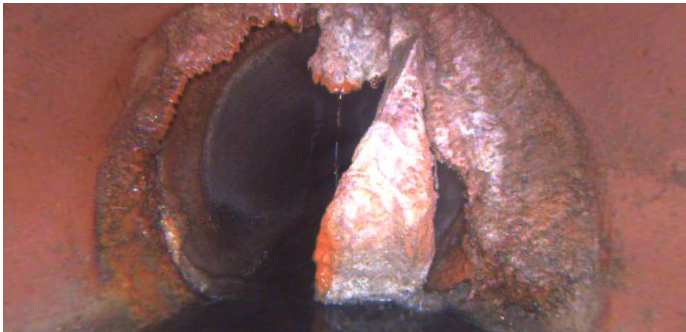
Code: **MSA**  
Description: **Abandoned Survey**

Distance (ft): **6.3**  
Structural Grade: **0**  
O&M Grade: **0**  
Clock Start/From:  
Clock To:  
1st Value:  
2nd Value:  
Value Percent:  
Continuous Index:  
Within 8" of Joint: **NO**  
Remarks: **unknown**
