Profile/Photo Observation Report

Street:	FOXCROFT STREET	Flow Control:	Not Controlled
City:	Hobart, IN	Year Renewed:	
Location:	Yard	Tape/Media #:	
Purpose:	Routine Assessment	Dia/Height:	12"
Use:	Sanitary	Material:	VCP
Drain Area:	NA	Lining:	
Category:	NA		
Comment:			
Location Details:		Direction of Survey:	Upstream
US MH:	M-606-075	DS MH:	M-606-076
		Total Length Surveyed (ft):	22.8

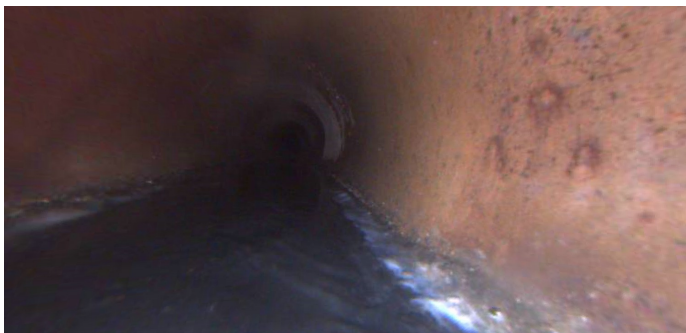
Code: **AMH**
Description: **Manhole**

Distance (ft): **.0**
Structural Grade: **0**
O&M Grade: **0**
Clock Start/From:
Clock To:
1st Value:
2nd Value:
Value Percent:
Continuous Index:
Within 8" of Joint: **NO**
Remarks: **M-606-076**

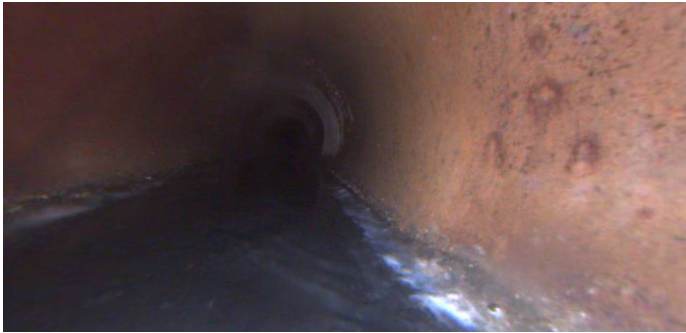
Code:	MWL
Description:	Water Level

Distance (ft):	.0
Structural Grade:	0
O&M Grade:	0
Clock Start/From:	
Clock To:	
1st Value:	
2nd Value:	
Value Percent:	20.000
Continuous Index:	
Within 8" of Joint:	NO
Remarks:

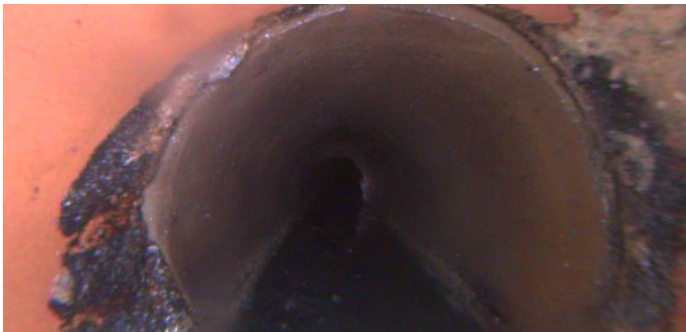
Code:	DAE
Description:	Deposits Attached Encrustation

Distance (ft):	7.6
Structural Grade:	0
O&M Grade:	2
Clock Start/From:	8
Clock To:	4
1st Value:	
2nd Value:	
Value Percent:	5.000
Continuous Index:	S01
Within 8" of Joint:	YES
Remarks:

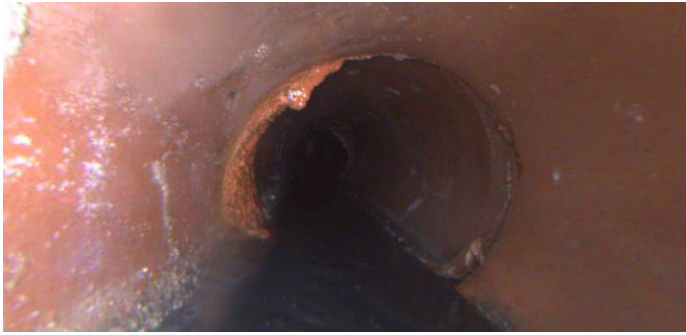
Code: **DAE**
Description: **Deposits Attached Encrustation**

Distance (ft): **22.8**
Structural Grade: **0**
O&M Grade: **2**
Clock Start/From: **8**
Clock To: **4**
1st Value:
2nd Value:
Value Percent: **5.000**
Continuous Index: **F01**
Within 8" of Joint: **YES**
Remarks:

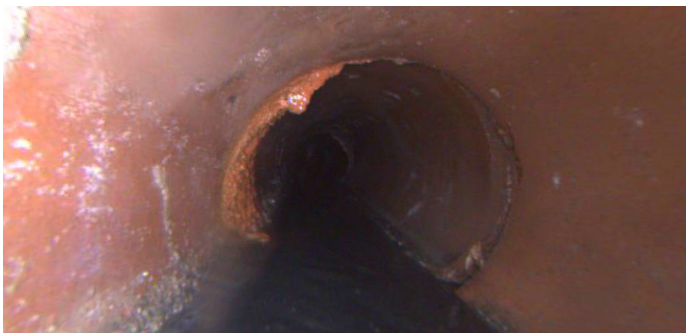
Code: **MSA**
Description: **Abandoned Survey**

Distance (ft): **22.8**
Structural Grade: **0**
O&M Grade: **0**
Clock Start/From:
Clock To:
1st Value:
2nd Value:
Value Percent:
Continuous Index:
Within 8" of Joint: **NO**
Remarks: **DAE**
