Profile/Photo Observation Report

Street:	FOXCROFT STREET	Flow Control:	Not Controlled
City:	Hobart, IN	Year Renewed:	
Location:	Yard	Tape/Media #:	
Purpose:	Routine Assessment	Dia/Height:	10"
Use:	Sanitary	Material:	VCP
Drain Area:	NA	Lining:	
Category:	NA		
Comment:	flow direction is marked wrong.

Location Details:		Direction of Survey:	Upstream
US MH:	M-606-081	DS MH:	M-606-082
		Total Length Surveyed (ft):	161.9

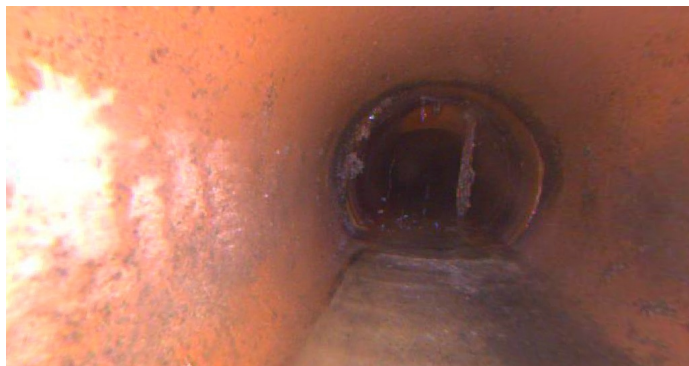
Code: **AMH**
 Description: **Manhole**

Distance (ft): **.0**
 Structural Grade: **0**
 O&M Grade: **0**
 Clock Start/From:
 Clock To:
 1st Value:
 2nd Value:
 Value Percent:
 Continuous Index:
 Within 8" of Joint: **NO**
 Remarks: **M-606-082**

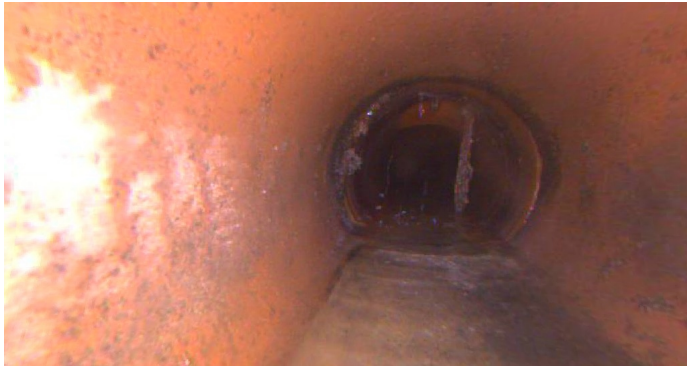
Code: **MWL**
Description: **Water Level**

Distance (ft): **.0**
Structural Grade: **0**
O&M Grade: **0**
Clock Start/From:
Clock To:
1st Value:
2nd Value:
Value Percent: **10.000**
Continuous Index:
Within 8" of Joint: **NO**
Remarks:

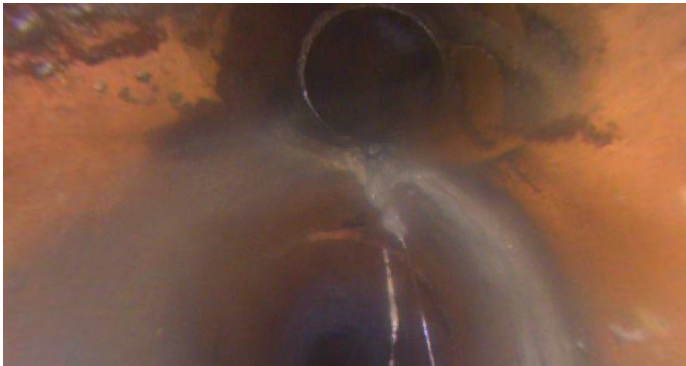
Code: **TF**
Description: **Tap Factory**

Distance (ft): **29.0**
Structural Grade: **0**
O&M Grade: **0**
Clock Start/From: **11**
Clock To:
1st Value: **4.000**
2nd Value:
Value Percent:
Continuous Index:
Within 8" of Joint:
Remarks:

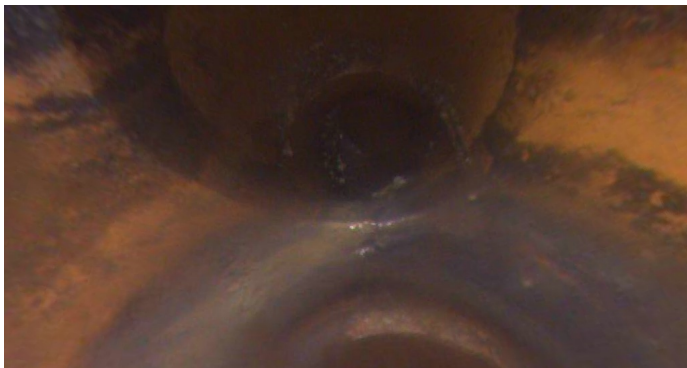
Code:	TF
Description:	Tap Factory
Distance (ft):	46.7
Structural Grade:	0
O&M Grade:	0
Clock Start/From:	12
Clock To:	
1st Value:	4.000
2nd Value:	
Value Percent:	
Continuous Index:	
Within 8" of Joint:	
Remarks:

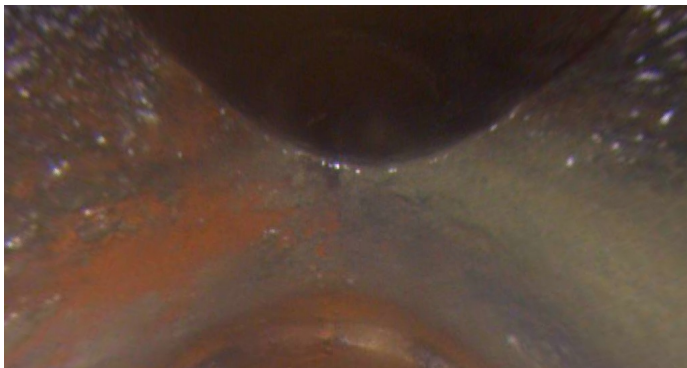
Code: **TF**
Description: **Tap Factory**

Distance (ft): **72.2**
Structural Grade: **0**
O&M Grade: **0**
Clock Start/From: **12**
Clock To:
1st Value: **4.000**
2nd Value:
Value Percent:
Continuous Index:
Within 8" of Joint:
Remarks:

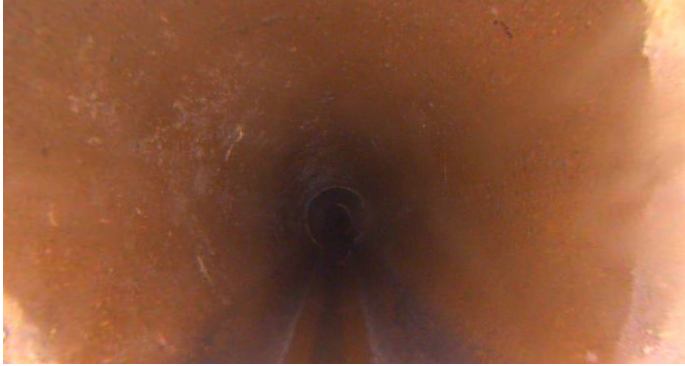
Code: **DAZ**
Description: **Deposits Attached Other**

Distance (ft): **161.9**
Structural Grade: **0**
O&M Grade: **2**
Clock Start/From: **7**
Clock To: **5**
1st Value:
2nd Value:
Value Percent: **5.000**
Continuous Index: **F01**
Within 8" of Joint: **YES**
Remarks:

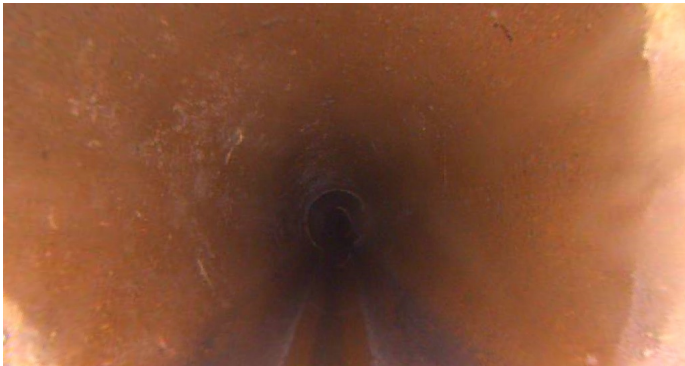
Code: **MSA**
Description: **Abandoned Survey**

Distance (ft): **161.9**
Structural Grade: **0**
O&M Grade: **0**
Clock Start/From:
Clock To:
1st Value:
2nd Value:
Value Percent:
Continuous Index:
Within 8" of Joint: **NO**
Remarks: **DAZ**
