Profile/Photo Observation Report

Date:	04/08/2018	Weather:		Coding:	PACP 6.0
Pipe Length (ft):	175.3	Owner:	NA	Pre Clean:	No Pre-Cleaning
P.O.#:		Surveyor:	Mark Ruby	PSR:	P-606-084-085
Customer:		Clean Date:	01/01/1900	Shape:	C

Street:	N LAKE SHORE DR & S CONNECTICU	Flow Control:	Not Controlled
City:	Hobart, IN	Year Renewed:	
Location:	Yard	Tape/Media #:	
Purpose:	Routine Assessment	Dia/Height:	12"
Use:	Sanitary	Material:	VCP
Drain Area:	NA	Lining:	
Category:	NA		
Comment:	Flow direction is marked wrong.		
Location Details:		Direction of Survey:	Upstream
US MH:	M-606-085	DS MH:	M-606-084
		Total Length Surveyed (ft):	73.0

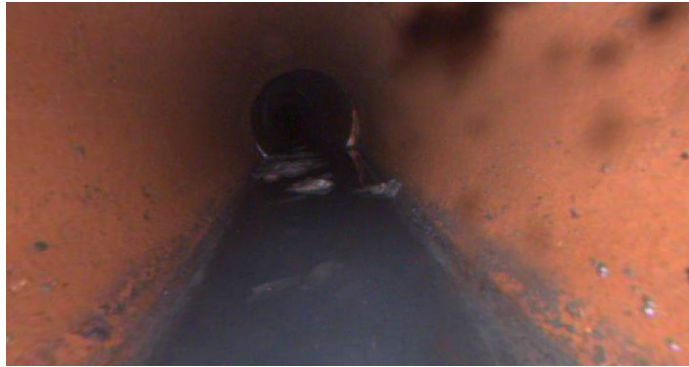
Code: **MWL**
Description: **Water Level**

Distance (ft): **.0**
Structural Grade: **0**
O&M Grade: **0**
Clock Start/From:
Clock To:
1st Value:
2nd Value:
Value Percent: **10.000**
Continuous Index:
Within 8" of Joint: **NO**
Remarks:

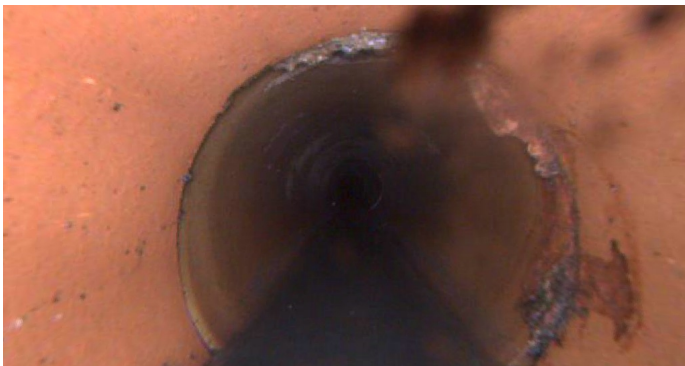
Code: **DAE**
Description: **Deposits Attached Encrustation**

Distance (ft): **18.4**
Structural Grade: **0**
O&M Grade: **2**
Clock Start/From: **7**
Clock To: **5**
1st Value:
2nd Value:
Value Percent: **5.000**
Continuous Index: **S01**
Within 8" of Joint: **YES**
Remarks:

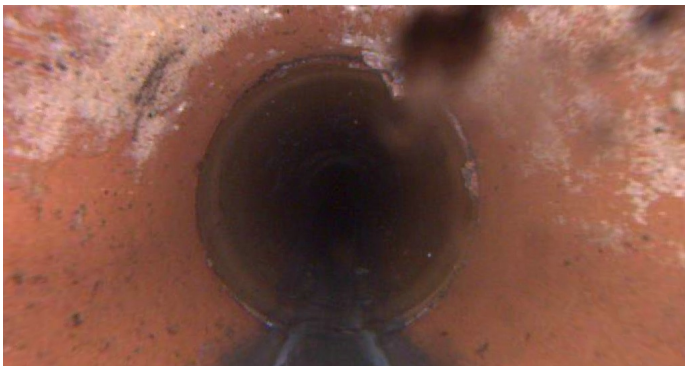
Code: **DAE**
Description: **Deposits Attached Encrustation**

Distance (ft): **41.1**
Structural Grade: **0**
O&M Grade: **2**
Clock Start/From: **7**
Clock To: **5**
1st Value:
2nd Value:
Value Percent: **5.000**
Continuous Index: **F01**
Within 8" of Joint: **YES**
Remarks:

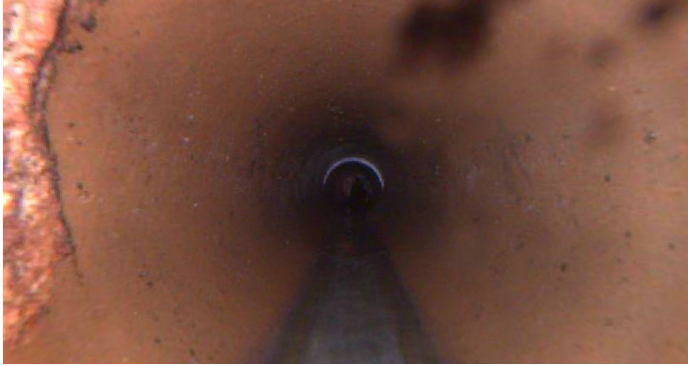
Code:	DAE
Description:	Deposits Attached Encrustation
Distance (ft):	64.7
Structural Grade:	0
O&M Grade:	2
Clock Start/From:	8
Clock To:	11
1st Value:	
2nd Value:	
Value Percent:	5.000
Continuous Index:	
Within 8" of Joint:	YES
Remarks:

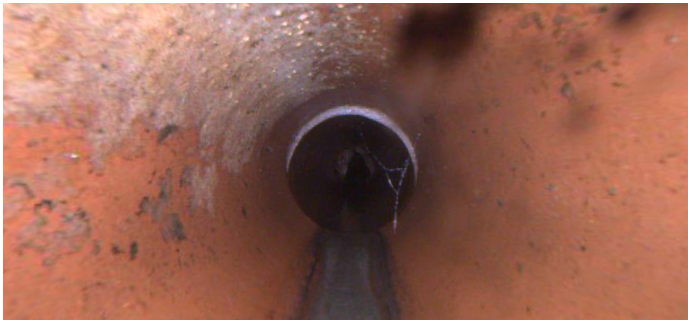
Code:	IW
Description:	Infil Weeper
Distance (ft):	67.2
Structural Grade:	0
O&M Grade:	2
Clock Start/From:	8
Clock To:	4
1st Value:	
2nd Value:	
Value Percent:	
Continuous Index:	F02
Within 8" of Joint:	YES
Remarks:

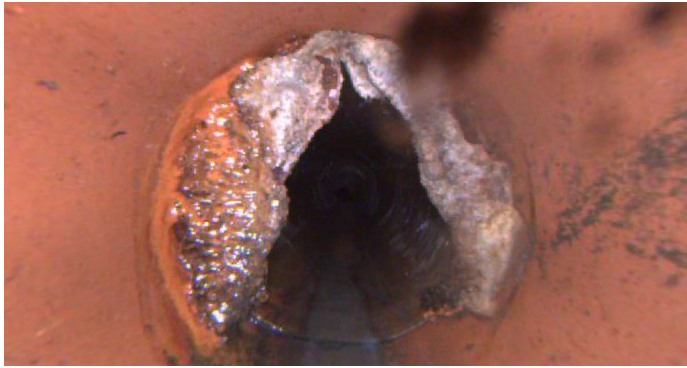
Code:	DAZ
Description:	Deposits Attached Other
Distance (ft):	72.0
Structural Grade:	0
O&M Grade:	2
Clock Start/From:	7
Clock To:	5
1st Value:	
2nd Value:	
Value Percent:	10.000
Continuous Index:	
Within 8" of Joint:	YES
Remarks:

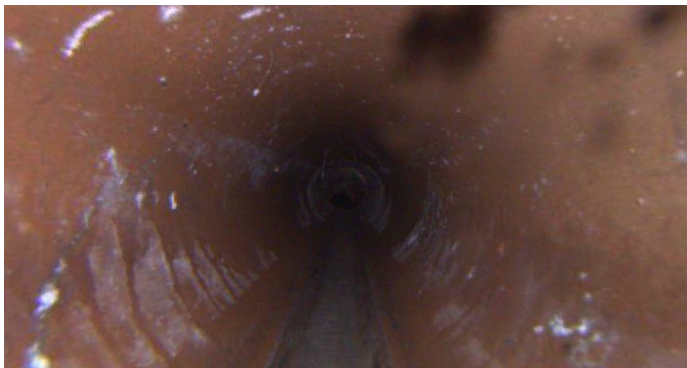
Code:	MSA
Description:	Abandoned Survey
Distance (ft):	73.0
Structural Grade:	0
O&M Grade:	0
Clock Start/From:	
Clock To:	
1st Value:	
2nd Value:	
Value Percent:	
Continuous Index:	
Within 8" of Joint:	NO
Remarks:	DAZ
