Profile/Photo Observation Report

Street:	FOXCROFT STREET	Flow Control:	Not Controlled
City:	Hobart, IN	Year Renewed:	
Location:	Yard	Tape/Media #:	
Purpose:	Routine Assessment	Dia/Height:	12"
Use:	Sanitary	Material:	VCP
Drain Area:	NA	Lining:	
Category:	NA		
Comment:	Flow direction is marked wrong.		
Location Details:		Direction of Survey:	Upstream
US MH:	M-606-085	DS MH:	M-606-084
		Total Length Surveyed (ft):	73.0

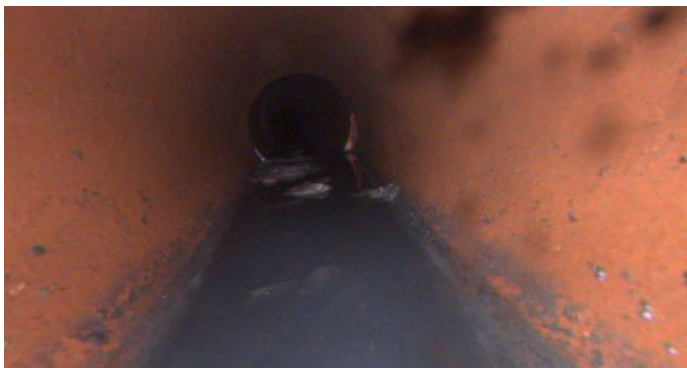
Position	Code	Observation	Video (sec)	Grade
M-606-084				
.0	AMH	Manhole	10	NA
.0	MWL	Water Level	21	NA
3.2	DAE	Deposits Attached Encrustation	39	M 2
3.2	IW	Infil Weeper	50	M 2
18.4	DAE(S01)	Deposits Attached Encrustation	92	M 2
18.5	IW(S02)	Infil Weeper	103	M 2
41.1	DAE(F01)	Deposits Attached Encrustation	160	M 2
64.7	DAE	Deposits Attached Encrustation	218	M 2
67.2	IW(F02)	Infil Weeper	234	M 2
72.0	DAZ	Deposits Attached Other	255	M 2
73.0	MSA	Abandoned Survey	268	NA
M-606-085

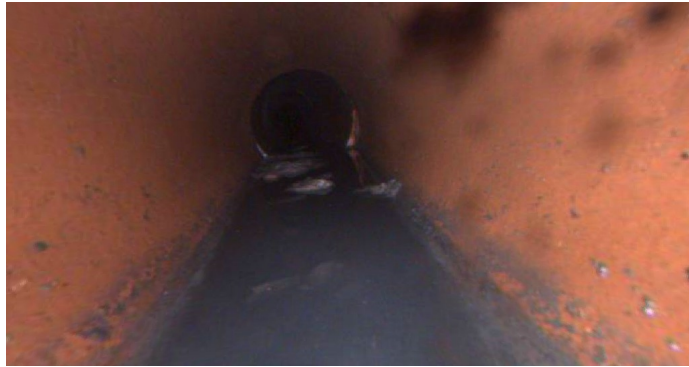
Code: **MWL**
Description: **Water Level**

Distance (ft): **.0**
Structural Grade: **0**
O&M Grade: **0**
Clock Start/From:
Clock To:
1st Value:
2nd Value:
Value Percent: **10.000**
Continuous Index:
Within 8" of Joint: **NO**
Remarks:

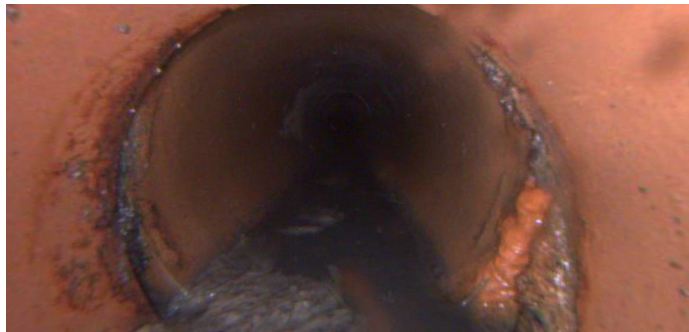
Code: **DAE**
Description: **Deposits Attached Encrustation**

Distance (ft): **3.2**
Structural Grade: **0**
O&M Grade: **2**
Clock Start/From: **8**
Clock To: **4**
1st Value:
2nd Value:
Value Percent: **5.000**
Continuous Index:
Within 8" of Joint: **YES**
Remarks:

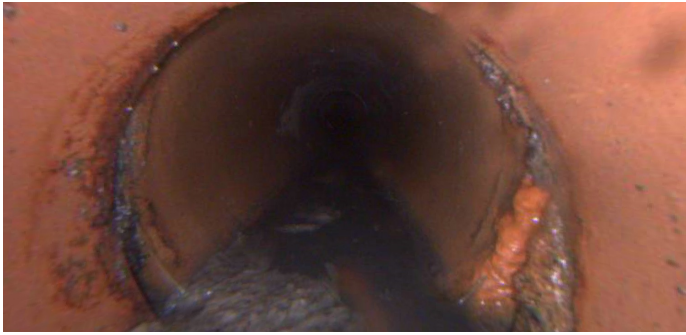
Code: **IW**
Description: **Infil Weeper**

Distance (ft): **3.2**
Structural Grade: **0**
O&M Grade: **2**
Clock Start/From: **8**
Clock To: **4**
1st Value:
2nd Value:
Value Percent:
Continuous Index:
Within 8" of Joint: **YES**
Remarks:

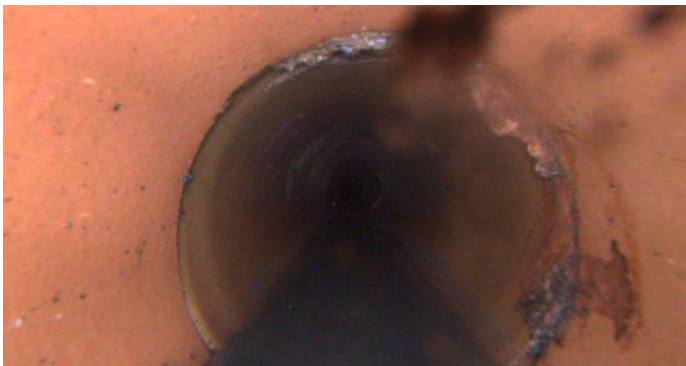
Code: **DAE**
Description: **Deposits Attached Encrustation**

Distance (ft): **18.4**
Structural Grade: **0**
O&M Grade: **2**
Clock Start/From: **7**
Clock To: **5**
1st Value:
2nd Value:
Value Percent: **5.000**
Continuous Index: **S01**
Within 8" of Joint: **YES**
Remarks:

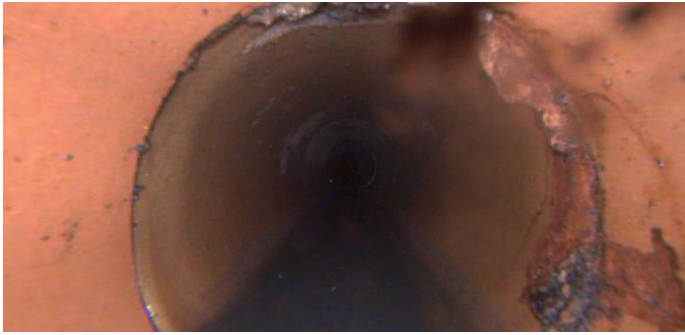
Code: **IW**
Description: **Infil Weeper**

Distance (ft): **18.5**
Structural Grade: **0**
O&M Grade: **2**
Clock Start/From: **8**
Clock To: **4**
1st Value:
2nd Value:
Value Percent:
Continuous Index: **S02**
Within 8" of Joint: **YES**
Remarks:

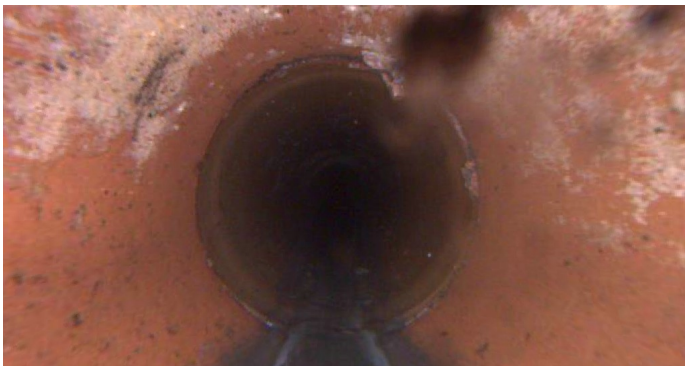
Code: **DAE**
Description: **Deposits Attached Encrustation**

Distance (ft): **41.1**
Structural Grade: **0**
O&M Grade: **2**
Clock Start/From: **7**
Clock To: **5**
1st Value:
2nd Value:
Value Percent: **5.000**
Continuous Index: **F01**
Within 8" of Joint: **YES**
Remarks:

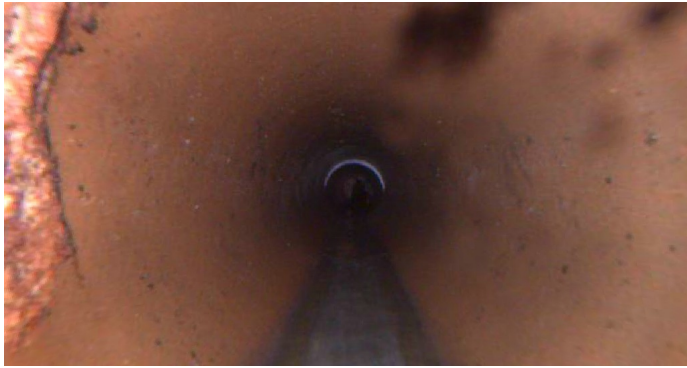
Code:	DAE
Description:	Deposits Attached Encrustation
Distance (ft):	64.7
Structural Grade:	0
O&M Grade:	2
Clock Start/From:	8
Clock To:	11
1st Value:	
2nd Value:	
Value Percent:	5.000
Continuous Index:	
Within 8" of Joint:	YES
Remarks:

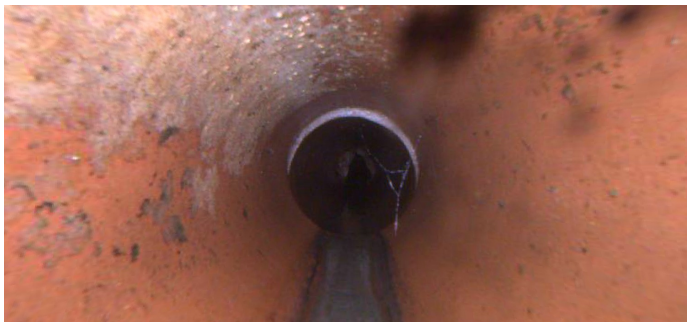
Code:	IW
Description:	Infil Weeper
Distance (ft):	67.2
Structural Grade:	0
O&M Grade:	2
Clock Start/From:	8
Clock To:	4
1st Value:	
2nd Value:	
Value Percent:	
Continuous Index:	F02
Within 8" of Joint:	YES
Remarks:

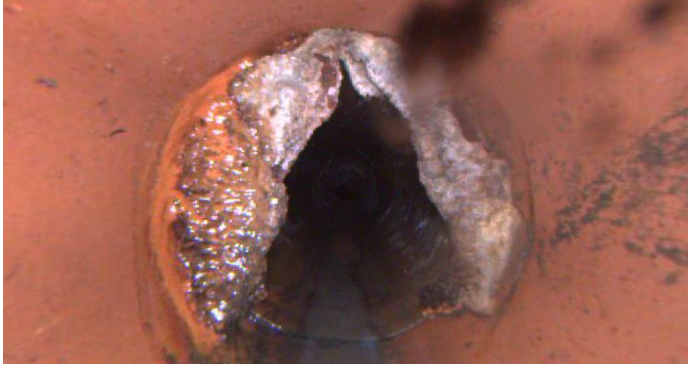
Code:	DAZ
Description:	Deposits Attached Other
Distance (ft):	72.0
Structural Grade:	0
O&M Grade:	2
Clock Start/From:	7
Clock To:	5
1st Value:	
2nd Value:	
Value Percent:	10.000
Continuous Index:	
Within 8" of Joint:	YES
Remarks:

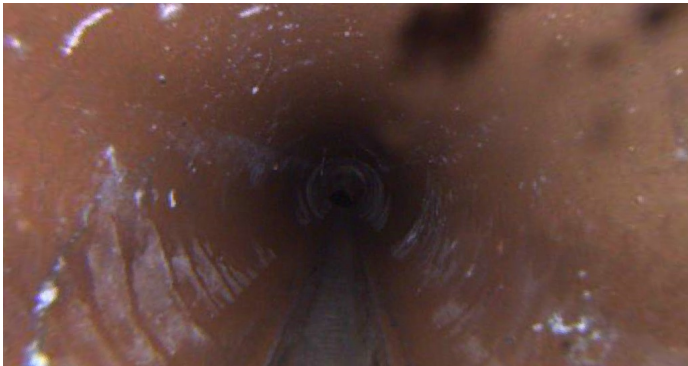
Code:	MSA
Description:	Abandoned Survey
Distance (ft):	73.0
Structural Grade:	0
O&M Grade:	0
Clock Start/From:	
Clock To:	
1st Value:	
2nd Value:	
Value Percent:	
Continuous Index:	
Within 8" of Joint:	NO
Remarks:	DAZ
