Profile/Photo Observation Report

Street:	FOXCROFT STREET	Flow Control:	Not Controlled
City:	Hobart, IN	Year Renewed:	
Location:	Yard	Tape/Media #:	
Purpose:	Routine Assessment	Dia/Height:	10"
Use:	Sanitary	Material:	VCP
Drain Area:	NA	Lining:	
Category:	NA		
Comment:

Location Details:		Direction of Survey:	Downstream
US MH:	M-606-089	DS MH:	M-606-090
		Total Length Surveyed (ft):	7.3

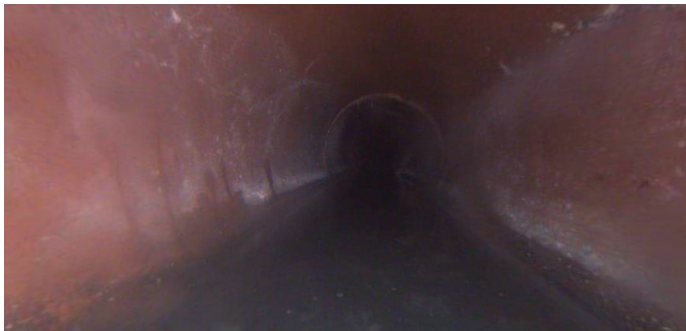
Code: **AMH**
Description: **Manhole**

Distance (ft): **.0**
Structural Grade: **0**
O&M Grade: **0**
Clock Start/From:
Clock To:
1st Value:
2nd Value:
Value Percent:
Continuous Index:
Within 8" of Joint: **NO**
Remarks: **M-606-089**

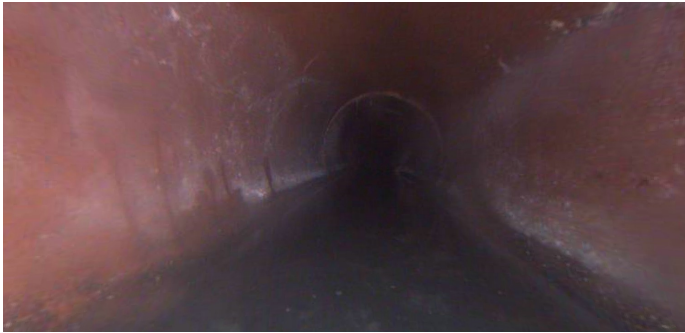
Code:	MWL
Description:	Water Level

Distance (ft):	.0
Structural Grade:	0
O&M Grade:	0
Clock Start/From:	
Clock To:	
1st Value:	
2nd Value:	
Value Percent:	10.000
Continuous Index:	
Within 8" of Joint:	NO
Remarks:

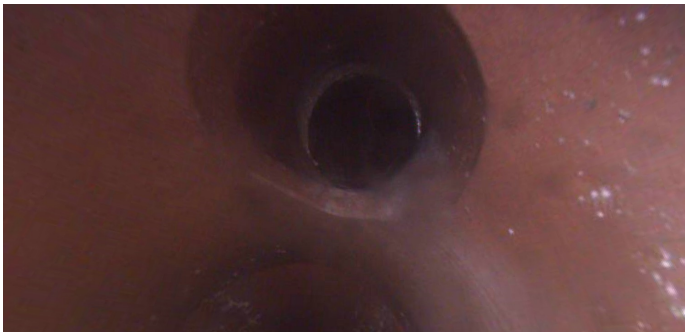
Code:	TF
Description:	Tap Factory

Distance (ft):	4.1
Structural Grade:	0
O&M Grade:	0
Clock Start/From:	12
Clock To:	
1st Value:	4.000
2nd Value:	
Value Percent:	
Continuous Index:	
Within 8" of Joint:	
Remarks:

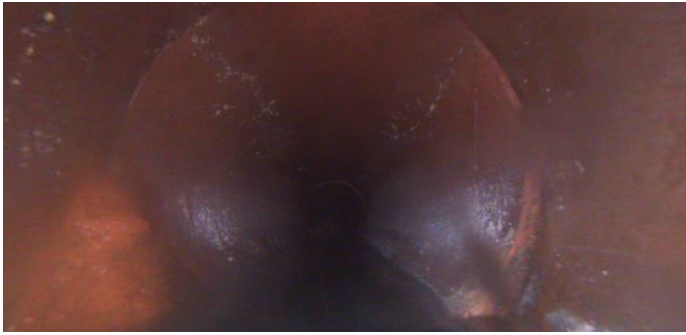
Code: **DAE**
Description: **Deposits Attached Encrustation**

Distance (ft): **4.8**
Structural Grade: **0**
O&M Grade: **2**
Clock Start/From: **8**
Clock To: **9**
1st Value:
2nd Value:
Value Percent: **5.000**
Continuous Index:
Within 8" of Joint: **YES**
Remarks:

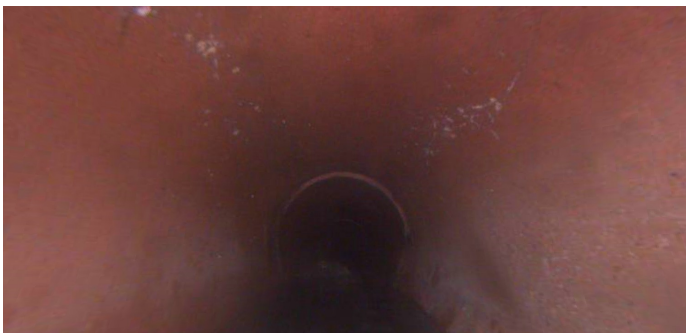
Code: **MSA**
Description: **Abandoned Survey**

Distance (ft): **7.3**
Structural Grade: **0**
O&M Grade: **0**
Clock Start/From:
Clock To:
1st Value:
2nd Value:
Value Percent:
Continuous Index:
Within 8" of Joint: **NO**
Remarks: **DAE**
