## Profile/Photo Observation Report

Date:	<b>04/07/2018</b>	Weather:		Coding:	<b>PACP 6.0</b>
Pipe Length (ft):	<b>105.9</b>	Owner:	<b>NA</b>	Pre Clean:	<b>No Pre-Cleaning</b>
P.O.#:		Surveyor:	<b>Jen Costello</b>	PSR:	<b>P-606-092-091</b>
Customer:		Clean Date:	<b>01/01/1900</b>	Shape:	<b>C</b>

Street:	<b>OFF N LAKE SHORE DR</b>	Flow Control:	<b>Not Controlled</b>
City:	<b>Hobart, IN</b>	Year Renewed:	
Location:	<b>Yard</b>	Tape/Media #:	
Purpose:	<b>Routine Assessment</b>	Dia/Height:	<b>10"</b>
Use:	<b>Sanitary</b>	Material:	<b>VCP</b>
Drain Area:	<b>NA</b>	Lining:	
Category:	<b>NA</b>		
Comment:			
Location Details:		Direction of Survey:	<b>Downstream</b>
US MH:	<b>M-606-092</b>	DS MH:	<b>M-606-091</b>
		Total Length Surveyed (ft):	<b>5.9</b>

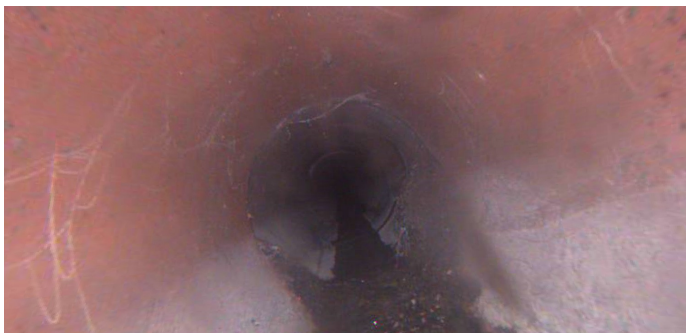
Code: **AMH**  
Description: **Manhole**

Distance (ft): **.0**  
Structural Grade: **0**  
O&M Grade: **0**  
Clock Start/From:  
Clock To:  
1st Value:  
2nd Value:  
Value Percent:  
Continuous Index:  
Within 8" of Joint: **NO**  
Remarks: **M-606-092**

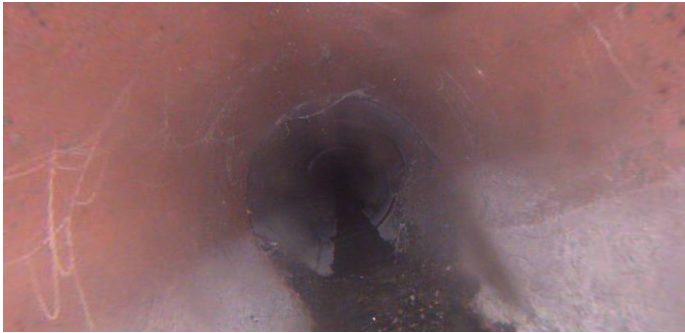
Code:	<b>MWL</b>
Description:	<b>Water Level</b>

Distance (ft):	<b>.0</b>
Structural Grade:	<b>0</b>
O&M Grade:	<b>0</b>
Clock Start/From:	
Clock To:	
1st Value:	
2nd Value:	
Value Percent:	<b>5.000</b>
Continuous Index:	
Within 8" of Joint:	<b>NO</b>
Remarks:

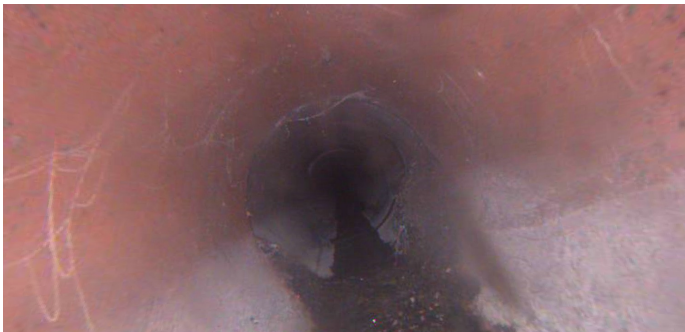
Code:	<b>DSF</b>
Description:	<b>Deposits Settled Fine</b>

Distance (ft):	<b>.0</b>
Structural Grade:	<b>0</b>
O&M Grade:	<b>2</b>
Clock Start/From:	<b>6</b>
Clock To:	
1st Value:	
2nd Value:	
Value Percent:	<b>5.000</b>
Continuous Index:	
Within 8" of Joint:	<b>NO</b>
Remarks:

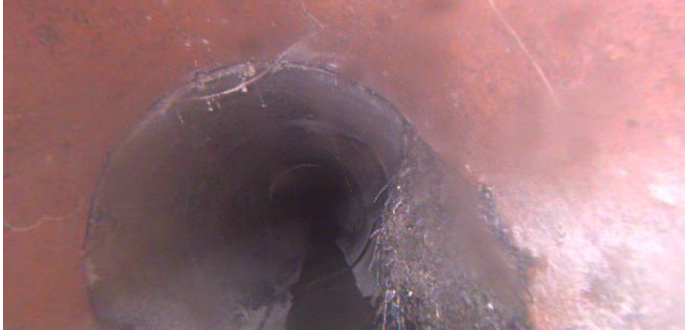
Code: **RMJ**  
Description: **Roots Medium Joint**

Distance (ft): **1.1**  
Structural Grade: **0**  
O&M Grade: **3**  
Clock Start/From: **1**  
Clock To: **4**  
1st Value:  
2nd Value:  
Value Percent: **10.000**  
Continuous Index:  
Within 8" of Joint: **YES**  
Remarks:

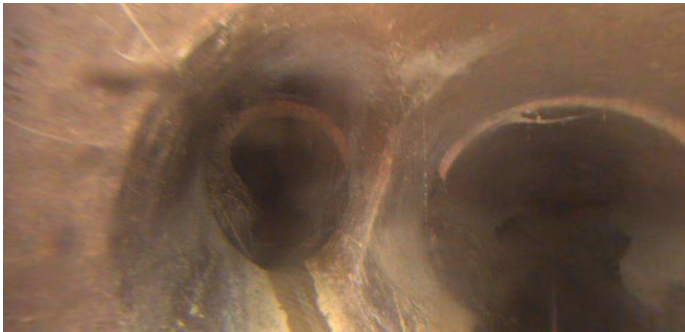
Code: **TF**  
Description: **Tap Factory**

Distance (ft): **3.5**  
Structural Grade: **0**  
O&M Grade: **0**  
Clock Start/From: **3**  
Clock To:  
1st Value: **4.000**  
2nd Value:  
Value Percent:  
Continuous Index:  
Within 8" of Joint:  
Remarks:

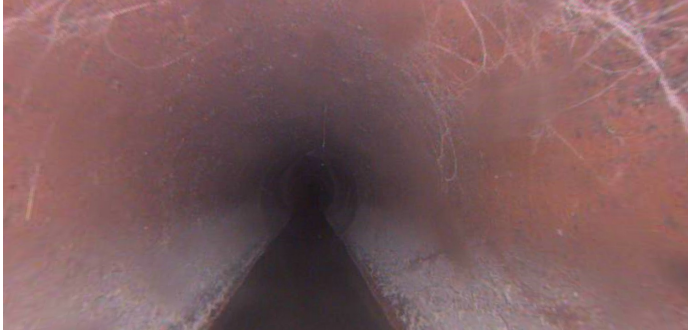
Code:	<b>MSA</b>
Description:	<b>Abandoned Survey</b>
Distance (ft):	<b>5.9</b>
Structural Grade:	<b>0</b>
O&M Grade:	<b>0</b>
Clock Start/From:	
Clock To:	
1st Value:	
2nd Value:	
Value Percent:	
Continuous Index:	
Within 8" of Joint:	<b>NO</b>
Remarks:	<b>unknown</b>
