## Profile/Photo Observation Report

Street:	<b>FOXCROFT STREET</b>	Flow Control:	<b>Not Controlled</b>
City:	<b>Hobart, IN</b>	Year Renewed:	
Location:	<b>Yard</b>	Tape/Media #:	
Purpose:	<b>Routine Assessment</b>	Dia/Height:	<b>10"</b>
Use:	<b>Sanitary</b>	Material:	<b>VCP</b>
Drain Area:	<b>NA</b>	Lining:	
Category:	<b>NA</b>		
Comment:

Location Details:		Direction of Survey:	<b>Downstream</b>
US MH:	<b>M-606-092</b>	DS MH:	<b>M-606-091</b>
		Total Length Surveyed (ft):	<b>5.9</b>

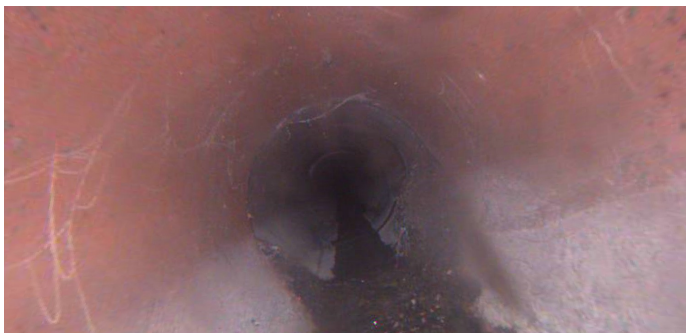
Code: **AMH**  
Description: **Manhole**

Distance (ft): **.0**  
Structural Grade: **0**  
O&M Grade: **0**  
Clock Start/From:  
Clock To:  
1st Value:  
2nd Value:  
Value Percent:  
Continuous Index:  
Within 8" of Joint: **NO**  
Remarks: **M-606-092**

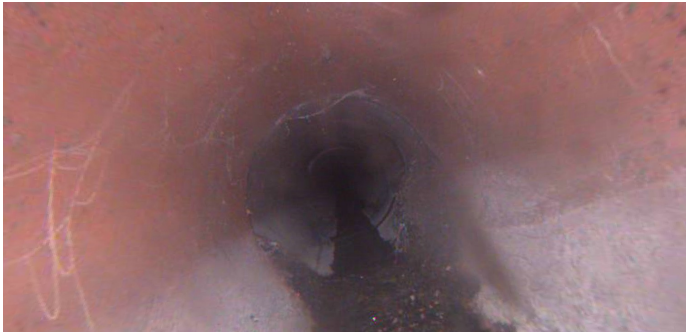
Code:	<b>MWL</b>
Description:	<b>Water Level</b>

Distance (ft):	<b>.0</b>
Structural Grade:	<b>0</b>
O&M Grade:	<b>0</b>
Clock Start/From:	
Clock To:	
1st Value:	
2nd Value:	
Value Percent:	<b>5.000</b>
Continuous Index:	
Within 8" of Joint:	<b>NO</b>
Remarks:

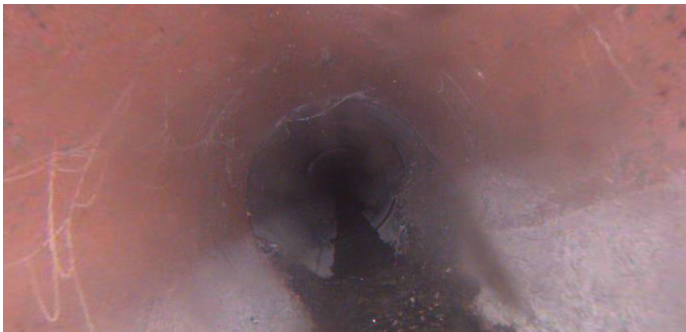
Code:	<b>DSF</b>
Description:	<b>Deposits Settled Fine</b>

Distance (ft):	<b>.0</b>
Structural Grade:	<b>0</b>
O&M Grade:	<b>2</b>
Clock Start/From:	<b>6</b>
Clock To:	
1st Value:	
2nd Value:	
Value Percent:	<b>5.000</b>
Continuous Index:	
Within 8" of Joint:	<b>NO</b>
Remarks:

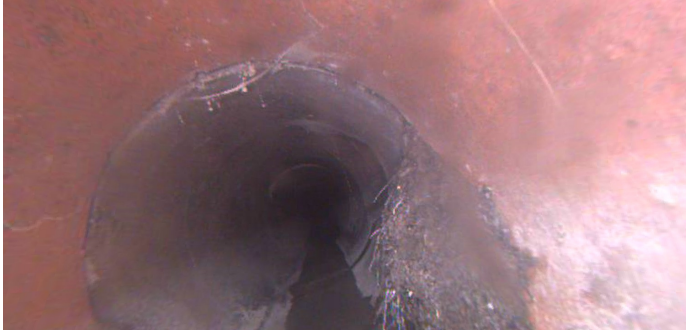
Code: **RMJ**  
Description: **Roots Medium Joint**

Distance (ft): **1.1**  
Structural Grade: **0**  
O&M Grade: **3**  
Clock Start/From: **1**  
Clock To: **4**  
1st Value:  
2nd Value:  
Value Percent: **10.000**  
Continuous Index:  
Within 8" of Joint: **YES**  
Remarks:

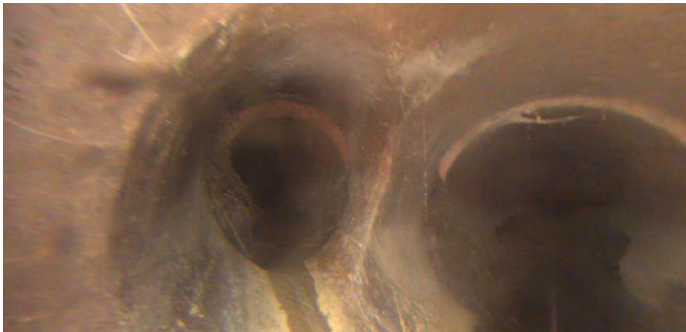
Code: **TF**  
Description: **Tap Factory**

Distance (ft): **3.5**  
Structural Grade: **0**  
O&M Grade: **0**  
Clock Start/From: **3**  
Clock To:  
1st Value: **4.000**  
2nd Value:  
Value Percent:  
Continuous Index:  
Within 8" of Joint:  
Remarks:

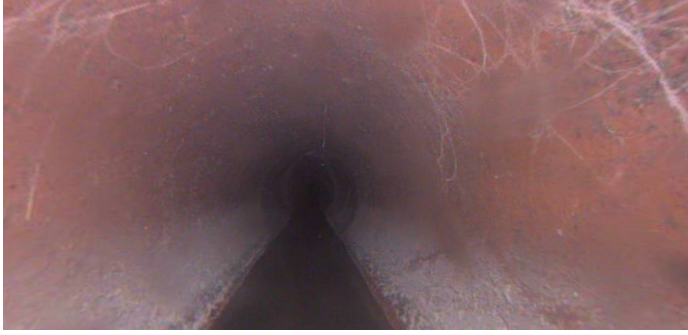
Code:	<b>MSA</b>
Description:	<b>Abandoned Survey</b>
Distance (ft):	<b>5.9</b>
Structural Grade:	<b>0</b>
O&M Grade:	<b>0</b>
Clock Start/From:	
Clock To:	
1st Value:	
2nd Value:	
Value Percent:	
Continuous Index:	
Within 8" of Joint:	<b>NO</b>
Remarks:	<b>unknown</b>
