## Profile/Photo Observation Report

Street:	<b>FOXCROFT STREET</b>	Flow Control:	<b>Not Controlled</b>
City:	<b>Hobart, IN</b>	Year Renewed:	
Location:	<b>Yard</b>	Tape/Media #:	
Purpose:	<b>Routine Assessment</b>	Dia/Height:	<b>10"</b>
Use:	<b>Sanitary</b>	Material:	<b>VCP</b>
Drain Area:	<b>NA</b>	Lining:	
Category:	<b>NA</b>		
Comment:	<b>P_C unknown obstruction, flow direction is marked wrong.</b>		
Location Details:		Direction of Survey:	<b>Downstream</b>
US MH:	<b>M-606-095</b>	DS MH:	<b>M-606-096</b>
		Total Length Surveyed (ft):	<b>125.2</b>

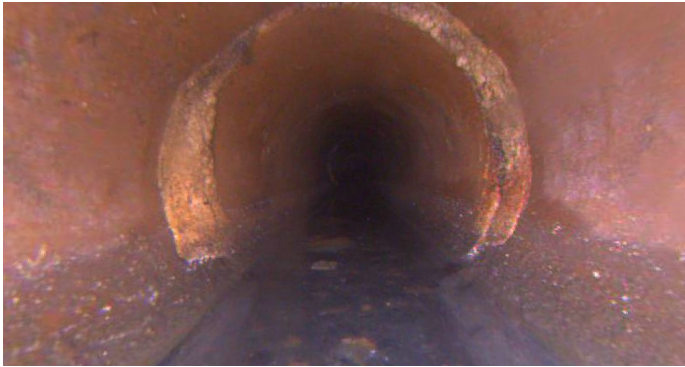
Code:	<b>MWL</b>
Description:	<b>Water Level</b>

Distance (ft):	<b>.0</b>
Structural Grade:	<b>0</b>
O&M Grade:	<b>0</b>
Clock Start/From:	
Clock To:	
1st Value:	
2nd Value:	
Value Percent:	<b>10.000</b>
Continuous Index:	
Within 8" of Joint:	<b>NO</b>
Remarks:

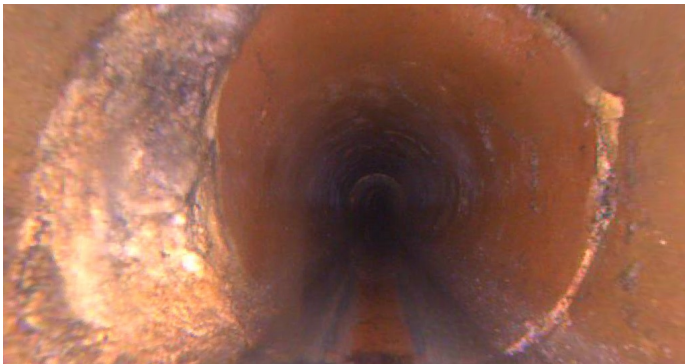
Code:	<b>DAE</b>
Description:	<b>Deposits Attached Encrustation</b>

Distance (ft):	<b>5.2</b>
Structural Grade:	<b>0</b>
O&M Grade:	<b>2</b>
Clock Start/From:	<b>7</b>
Clock To:	<b>12</b>
1st Value:	
2nd Value:	
Value Percent:	<b>5.000</b>
Continuous Index:	
Within 8" of Joint:	<b>YES</b>
Remarks:

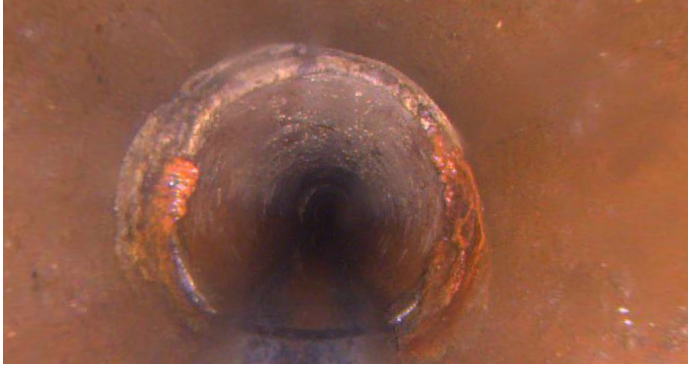
Code:	<b>DAE</b>
Description:	<b>Deposits Attached Encrustation</b>
Distance (ft):	<b>8.9</b>
Structural Grade:	<b>0</b>
O&M Grade:	<b>2</b>
Clock Start/From:	<b>7</b>
Clock To:	<b>5</b>
1st Value:	
2nd Value:	
Value Percent:	<b>5.000</b>
Continuous Index:	<b>S01</b>
Within 8" of Joint:	<b>YES</b>
Remarks:

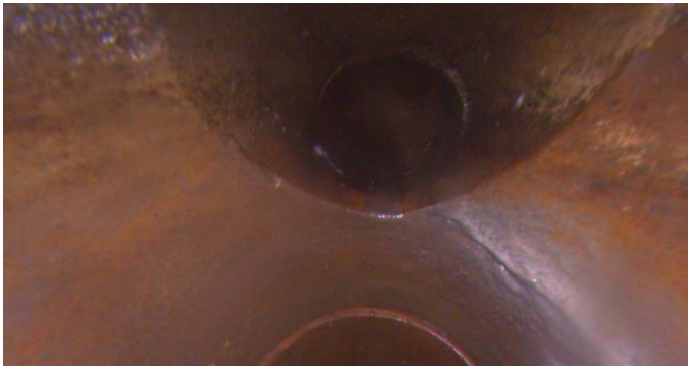
Code:	<b>TF</b>
Description:	<b>Tap Factory</b>
Distance (ft):	<b>42.6</b>
Structural Grade:	<b>0</b>
O&M Grade:	<b>0</b>
Clock Start/From:	<b>1</b>
Clock To:	
1st Value:	<b>4.000</b>
2nd Value:	
Value Percent:	
Continuous Index:	
Within 8" of Joint:	
Remarks:

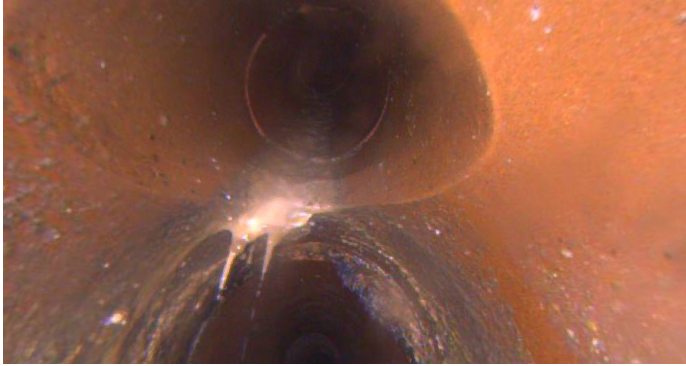
Code: **TF**  
Description: **Tap Factory**

Distance (ft): **44.5**  
Structural Grade: **0**  
O&M Grade: **0**  
Clock Start/From: **12**  
Clock To:  
1st Value: **4.000**  
2nd Value:  
Value Percent:  
Continuous Index:  
Within 8" of Joint:  
Remarks:

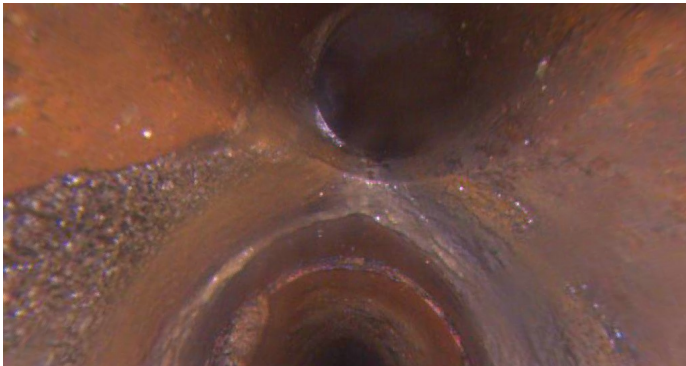
Code: **TF**  
Description: **Tap Factory**

Distance (ft): **66.5**  
Structural Grade: **0**  
O&M Grade: **0**  
Clock Start/From: **12**  
Clock To:  
1st Value: **4.000**  
2nd Value:  
Value Percent:  
Continuous Index:  
Within 8" of Joint:  
Remarks:

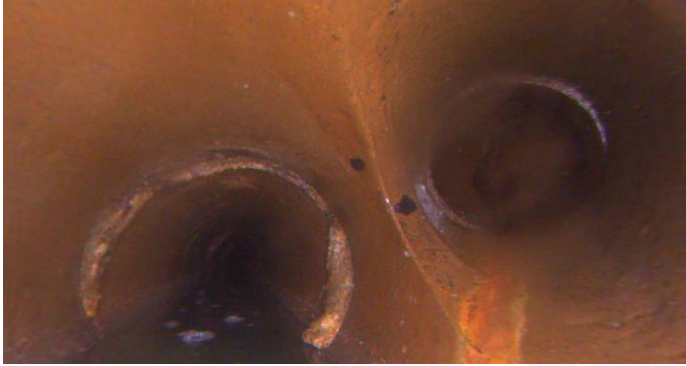
Code: **TF**  
Description: **Tap Factory**

Distance (ft): **72.4**  
Structural Grade: **0**  
O&M Grade: **0**  
Clock Start/From: **3**  
Clock To:  
1st Value: **4.000**  
2nd Value:  
Value Percent:  
Continuous Index:  
Within 8" of Joint:  
Remarks:

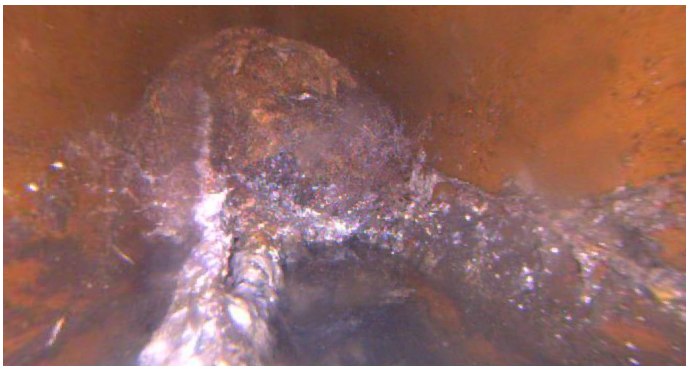
Code: **DAE**  
Description: **Deposits Attached Encrustation**

Distance (ft): **123.9**  
Structural Grade: **0**  
O&M Grade: **2**  
Clock Start/From: **7**  
Clock To: **5**  
1st Value:  
2nd Value:  
Value Percent: **5.000**  
Continuous Index: **F01**  
Within 8" of Joint: **YES**  
Remarks:

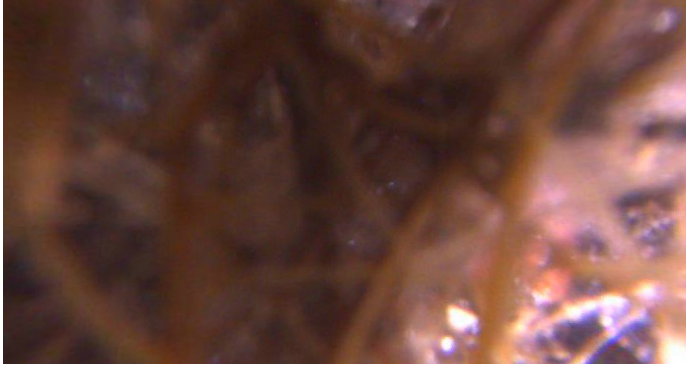
Code: **RBB**  
Description: **Roots Ball Barrel**

Distance (ft): **125.2**  
Structural Grade: **0**  
O&M Grade: **5**  
Clock Start/From: **12**  
Clock To: **12**  
1st Value:  
2nd Value:  
Value Percent: **90.000**  
Continuous Index:  
Within 8" of Joint: **NO**  
Remarks:

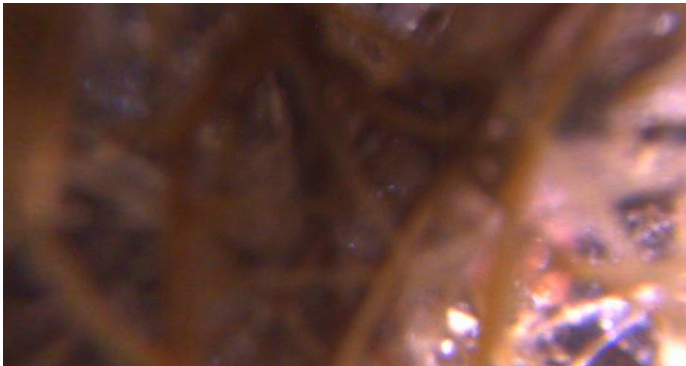
Code: **MSA**  
Description: **Abandoned Survey**

Distance (ft): **125.2**  
Structural Grade: **0**  
O&M Grade: **0**  
Clock Start/From:  
Clock To:  
1st Value:  
2nd Value:  
Value Percent:  
Continuous Index:  
Within 8" of Joint: **NO**  
Remarks: **RBB**
