| Profile/Ph | oto Observation I | Report | | | | RedZone |
| Street: | W 14TH ST | | Flow Control: | | Not Controlled | |
| US MH: | M-607-001 | DS MH: | M-607-068 | T | otal Length Surveyed (ft): | 31.3 |

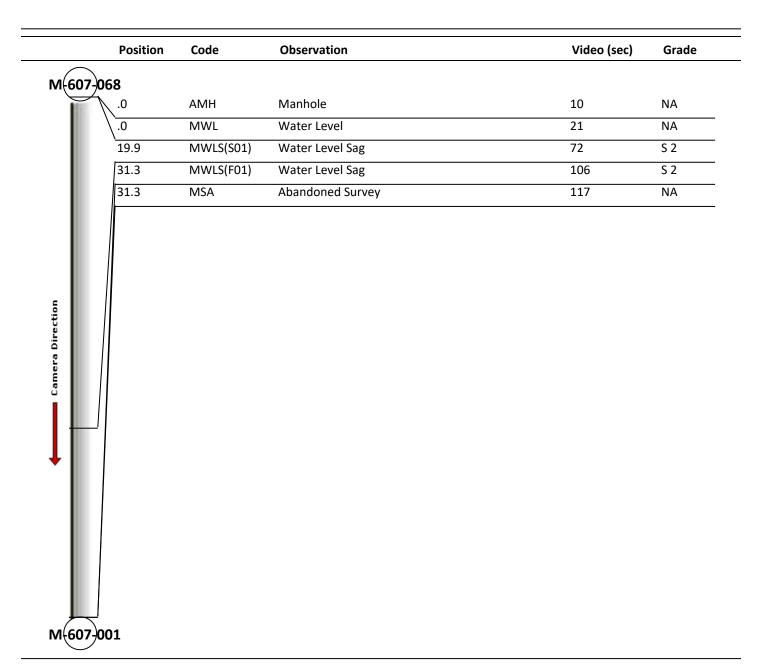
| Code:<br>Description: | AMH<br>Manhole |
| Remarks: | M-607-068 |
