Profile/Photo Observation Report

Date:	04/07/2018	Weather:		Coding:	PACP 6.0
Pipe Length (ft):		Owner:	City of Hobart	Pre Clean:	Not Known
P.O.#:	201	Surveyor:	B. Helbling	PSR:	P-607-006-007
Customer:	City of Hobart	Clean Date:		Shape:	C

Street:	Polly Lane	Flow Control:	Not Controlled
City:	Hobart, IN	Year Renewed:	
Location:	Easement/Right of Way	Tape/Media #:	DEP201
Purpose:	Routine Assessment	Dia/Height:	18"
Use:	Sanitary	Material:	VCP
Drain Area:		Lining:	
Category:	NA		
Comment:	YES501824 Submittal 2		
Location Details:		Direction of Survey:	Upstream
US MH:	M-607-007	DS MH:	M-607-006
		Total Length Surveyed (ft):	48.8

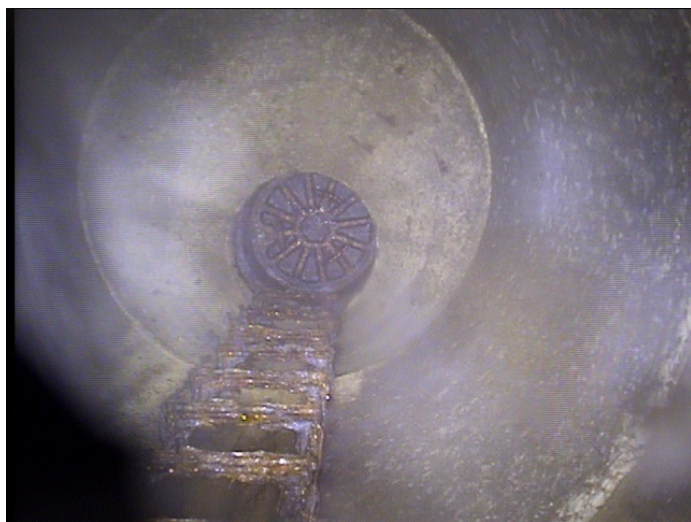
Code: **AMH**
Description: **Manhole**

Distance (ft): **.0**
Structural Grade: **0**
O&M Grade: **0**
Clock Start/From:
Clock To:
1st Value:
2nd Value:
Value Percent:
Continuous Index:
Within 8" of Joint: **NO**
Remarks: **M-607-007**

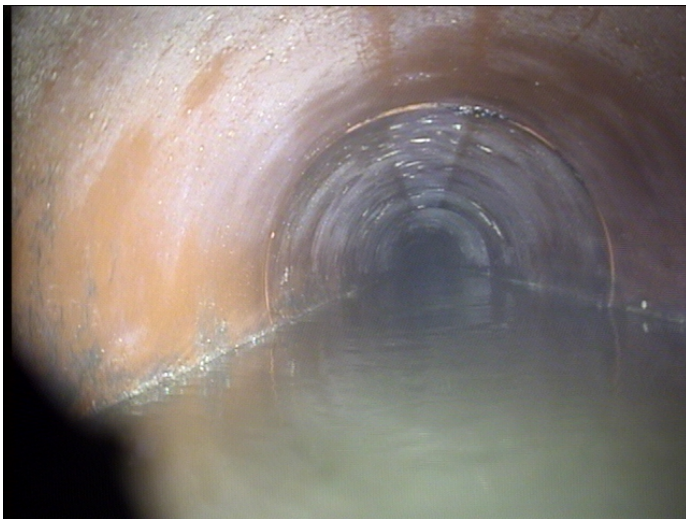
Code: **MSA**
Description: **Abandoned Survey**

Distance (ft): **48.8**
Structural Grade: **0**
O&M Grade: **0**
Clock Start/From:
Clock To:
1st Value:
2nd Value:
Value Percent:
Continuous Index:
Within 8" of Joint: **NO**
Remarks: **Unable to pass unseen obstacle**
