## Profile/Photo Observation Report

Date:	<b>04/07/2018</b>	Weather:		Coding:	<b>PACP 6.0</b>
Pipe Length (ft):		Owner:	<b>City of Hobart</b>	Pre Clean:	<b>Not Known</b>
P.O.#:	<b>203</b>	Surveyor:	<b>B. Helbling</b>	PSR:	<b>P-607-023-008</b>
Customer:	<b>City of Hobart</b>	Clean Date:		Shape:	<b>C</b>

Street:	<b>Polly Lane</b>	Flow Control:	<b>Not Controlled</b>
City:	<b>Hobart, IN</b>	Year Renewed:	
Location:	<b>Easement/Right of Way</b>	Tape/Media #:	<b>DEP203</b>
Purpose:	<b>Routine Assessment</b>	Dia/Height:	<b>18"</b>
Use:	<b>Sanitary</b>	Material:	<b>VCP</b>
Drain Area:		Lining:	
Category:	<b>NA</b>		
Comment:	<b>YES501824 Submittal 2</b>		
Location Details:		Direction of Survey:	<b>Downstream</b>
US MH:	<b>M-607-008</b>	DS MH:	<b>M-607-023</b>
		Total Length Surveyed (ft):	<b>280.1</b>

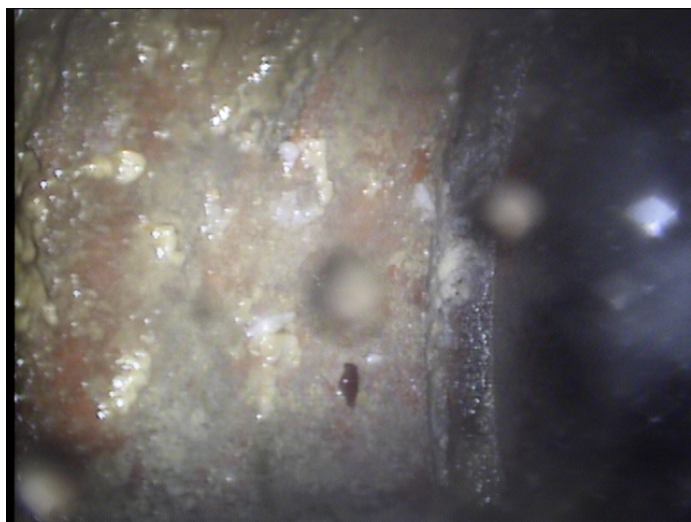
Code: **AMH**  
 Description: **Manhole**

Distance (ft): **.0**  
 Structural Grade: **0**  
 O&M Grade: **0**  
 Clock Start/From:  
 Clock To:  
 1st Value:  
 2nd Value:  
 Value Percent:  
 Continuous Index:  
 Within 8" of Joint: **NO**  
 Remarks: **M-607-008**

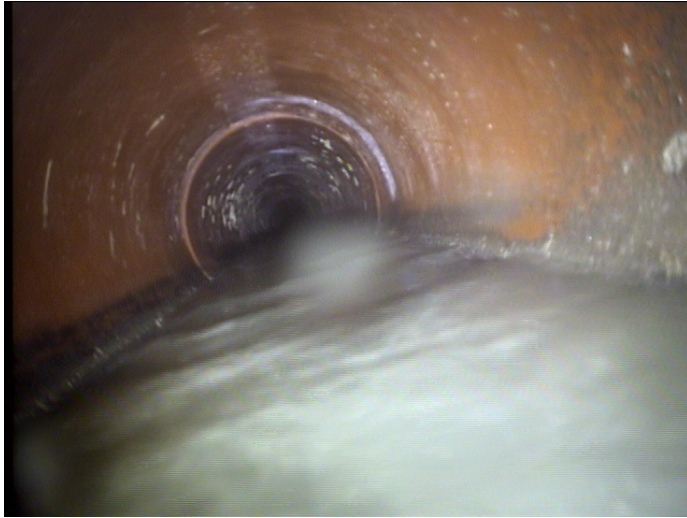
Code:	<b>MWL</b>
Description:	<b>Water Level</b>
Distance (ft):	<b>.0</b>
Structural Grade:	<b>0</b>
O&M Grade:	<b>0</b>
Clock Start/From:	
Clock To:	
1st Value:	
2nd Value:	
Value Percent:	<b>15.000</b>
Continuous Index:	
Within 8" of Joint:	<b>NO</b>
Remarks:

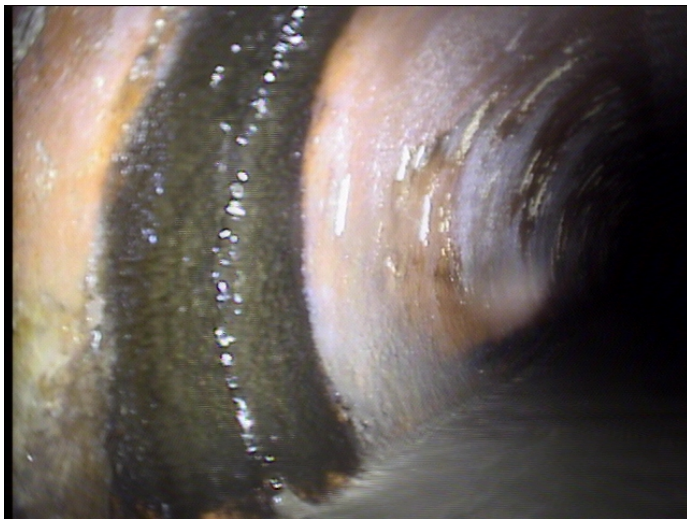
Code:	<b>IR</b>
Description:	<b>Infil Runner</b>
Distance (ft):	<b>138.4</b>
Structural Grade:	<b>0</b>
O&M Grade:	<b>4</b>
Clock Start/From:	<b>7</b>
Clock To:	<b>11</b>
1st Value:	
2nd Value:	
Value Percent:	
Continuous Index:	
Within 8" of Joint:	<b>YES</b>
Remarks:

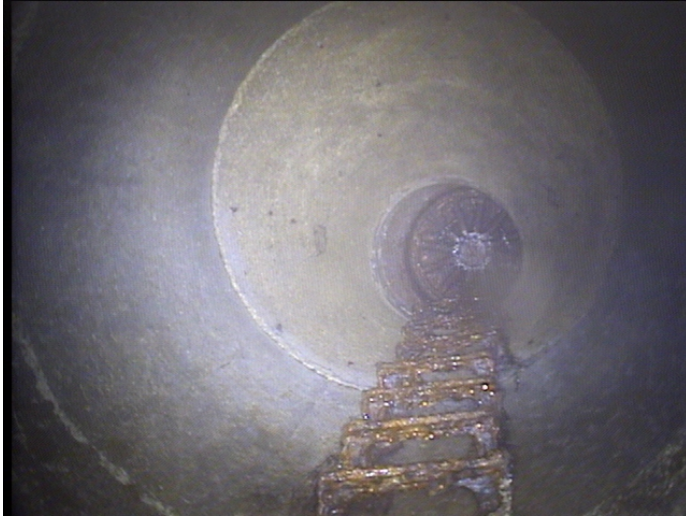
Code:	<b>AMH</b>
Description:	<b>Manhole</b>
Distance (ft):	<b>280.1</b>
Structural Grade:	<b>0</b>
O&M Grade:	<b>0</b>
Clock Start/From:	
Clock To:	
1st Value:	
2nd Value:	
Value Percent:	
Continuous Index:	
Within 8" of Joint:	<b>NO</b>
Remarks:	<b>M-607-023</b>
