Profile/Photo Observation Report

Date:	05/03/2018	Weather:		Coding:	PACP 6.0
Pipe Length (ft):		Owner:	City of Hobart	Pre Clean:	Not Known
P.O.#:	291	Surveyor:	B. Helbling	PSR:	P-607-009-010
Customer:	City of Hobart	Clean Date:		Shape:	C

Street:	South Lake Park	Flow Control:	Not Controlled
City:	Hobart, IN	Year Renewed:	
Location:	Easement/Right of Way	Tape/Media #:	DEP291
Purpose:	Routine Assessment	Dia/Height:	18"
Use:	Sanitary	Material:	VCP
Drain Area:		Lining:	
Category:	NA		
Comment:	5-21-2018		
Location Details:		Direction of Survey:	Downstream
US MH:	M-607-010	DS MH:	M-607-009
		Total Length Surveyed (ft):	290.2

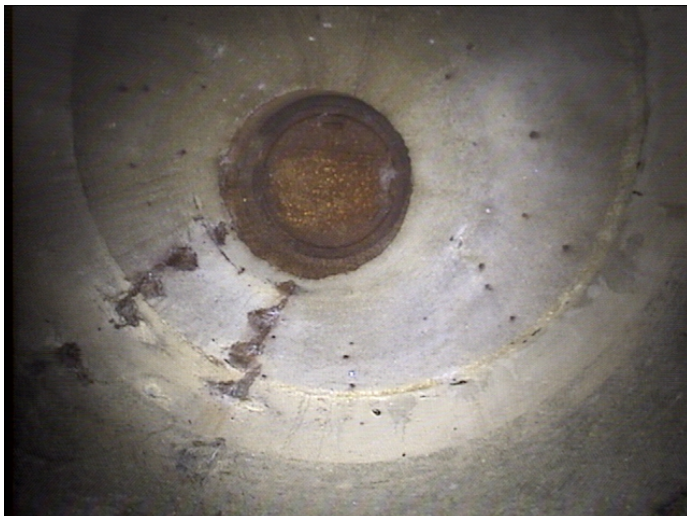
Code: **AMH**
Description: **Manhole**

Distance (ft): **.0**
Structural Grade: **0**
O&M Grade: **0**
Clock Start/From:
Clock To:
1st Value:
2nd Value:
Value Percent:
Continuous Index:
Within 8" of Joint: **NO**
Remarks: **M-607-009**

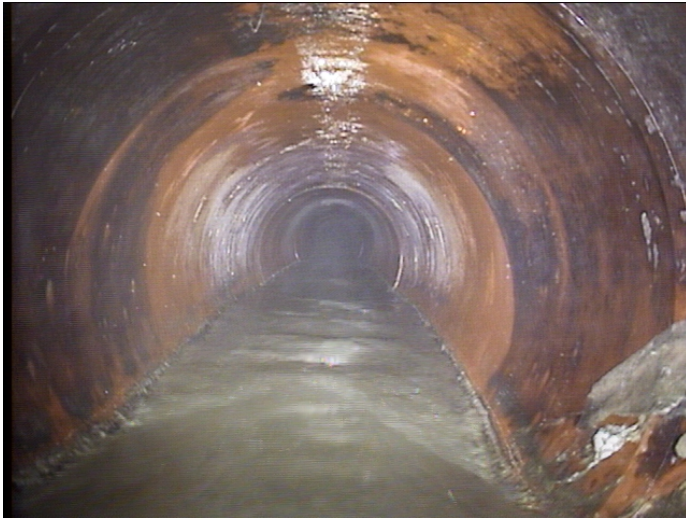
Code: **MWL**
Description: **Water Level**

Distance (ft): **.0**
Structural Grade: **0**
O&M Grade: **0**
Clock Start/From:
Clock To:
1st Value:
2nd Value:
Value Percent: **15.000**
Continuous Index:
Within 8" of Joint: **NO**
Remarks:

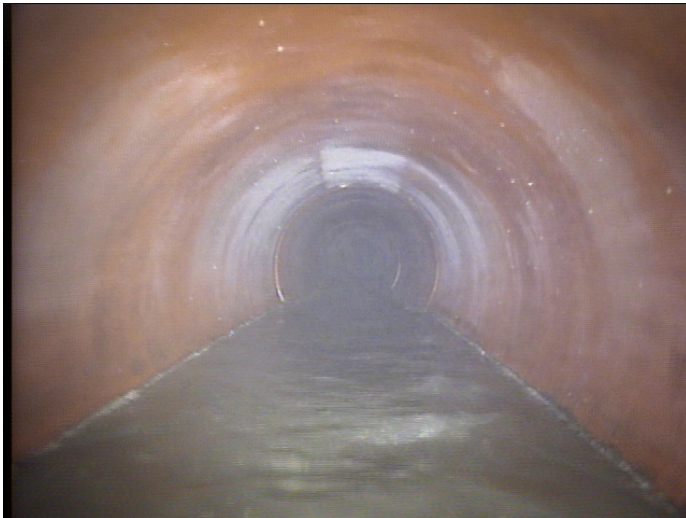
Code: **DSF**
Description: **Deposits Settled Fine**

Distance (ft): **7.8**
Structural Grade: **0**
O&M Grade: **2**
Clock Start/From: **4**
Clock To: **8**
1st Value:
2nd Value:
Value Percent: **5.000**
Continuous Index: **S01**
Within 8" of Joint: **NO**
Remarks:

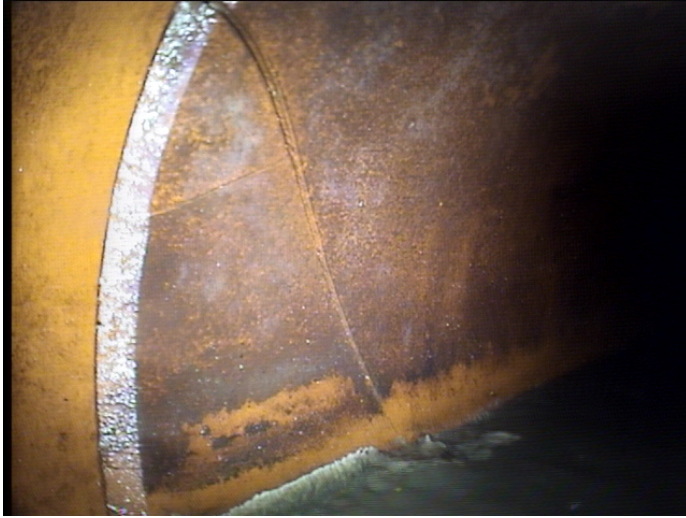
Code: **FS**
Description: **Fracture Spiral**

Distance (ft): **78.1**
Structural Grade: **3**
O&M Grade: **0**
Clock Start/From: **7**
Clock To: **9**
1st Value:
2nd Value:
Value Percent:
Continuous Index:
Within 8" of Joint: **NO**
Remarks:

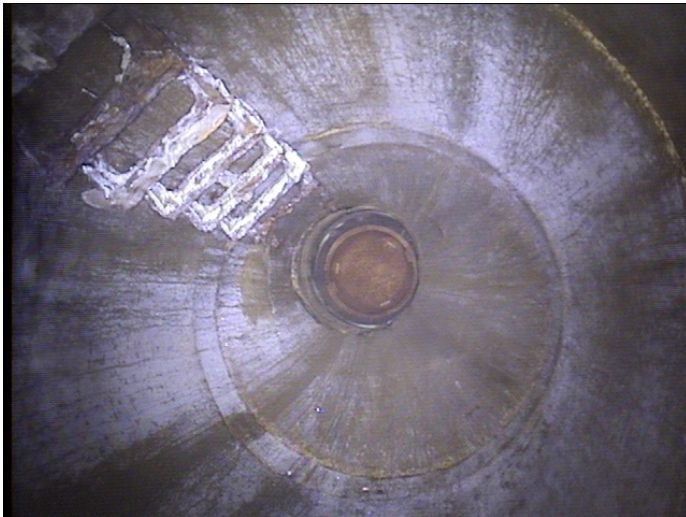
Code: **DSF**
Description: **Deposits Settled Fine**

Distance (ft): **290.2**
Structural Grade: **0**
O&M Grade: **2**
Clock Start/From: **4**
Clock To: **8**
1st Value:
2nd Value:
Value Percent: **5.000**
Continuous Index: **F01**
Within 8" of Joint: **NO**
Remarks:

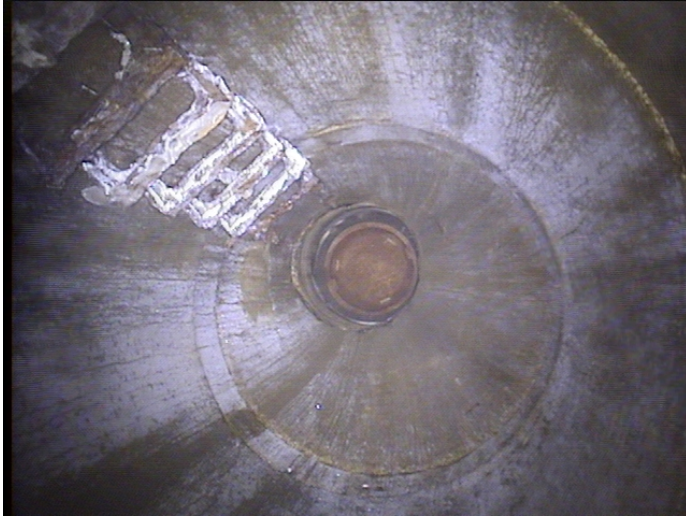
Code:	AMH
Description:	Manhole
Distance (ft):	290.2
Structural Grade:	0
O&M Grade:	0
Clock Start/From:	
Clock To:	
1st Value:	
2nd Value:	
Value Percent:	
Continuous Index:	
Within 8" of Joint:	NO
Remarks:	M-607-010
