Profile/Photo Observation Report

Street:	10th Street	Flow Control:	Not Controlled
City:	Hobart, IN	Year Renewed:	
Location:	Light Highway	Tape/Media #:	DEP 617
Purpose:	Routine Assessment	Dia/Height:	18"
Use:	Sanitary	Material:	PVC
Drain Area:		Lining:	
Category:	NA		
Comment:	5-21-2018		
Location Details:		Direction of Survey:	Upstream
US MH:	M-607-014	DS MH:	M-606-001
		Total Length Surveyed (ft):	16.3

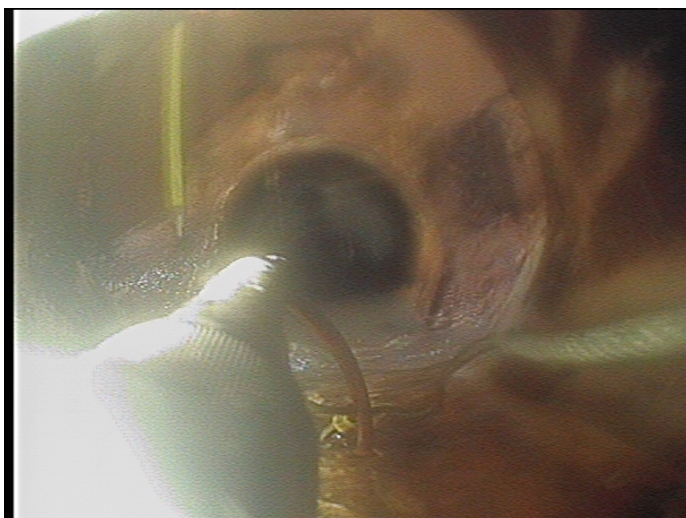
Code: **AMH**
 Description: **Manhole**

Distance (ft): **.0**
 Structural Grade: **0**
 O&M Grade: **0**
 Clock Start/From:
 Clock To:
 1st Value:
 2nd Value:
 Value Percent:
 Continuous Index:
 Within 8" of Joint: **NO**
 Remarks: **M-607-014**

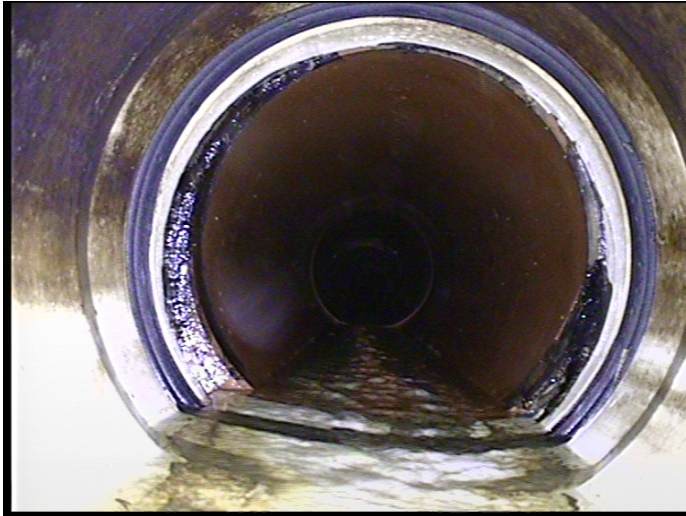
Code:	MWL
Description:	Water Level
Distance (ft):	.0
Structural Grade:	0
O&M Grade:	0
Clock Start/From:	
Clock To:	
1st Value:	
2nd Value:	
Value Percent:	10.000
Continuous Index:	
Within 8" of Joint:	NO
Remarks:

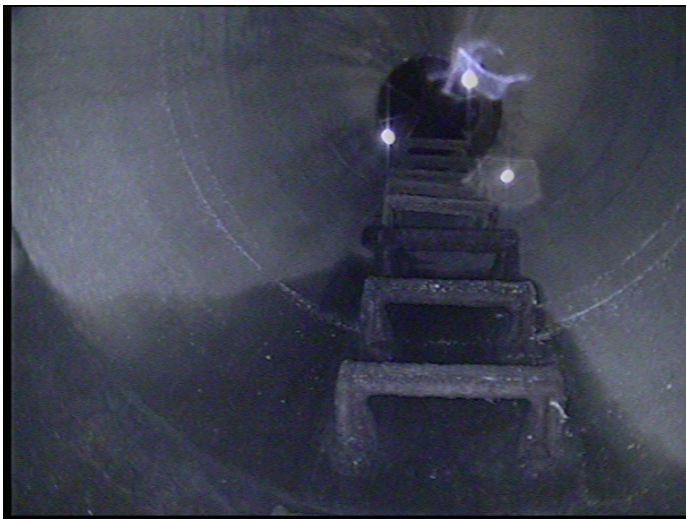
Code:	AMH
Description:	Manhole
Distance (ft):	16.2
Structural Grade:	0
O&M Grade:	0
Clock Start/From:	
Clock To:	
1st Value:	
2nd Value:	
Value Percent:	
Continuous Index:	
Within 8" of Joint:	NO
Remarks:	M-606-001
