Profile/Photo Observation Report

Street:	Polly Lane	Flow Control:	Not Controlled
City:	Hobart, IN	Year Renewed:	
Location:	Easement/Right of Way	Tape/Media #:	DEP201
Purpose:	Routine Assessment	Dia/Height:	18"
Use:	Sanitary	Material:	VCP
Drain Area:		Lining:	
Category:	NA		
Comment:	YES501824 Submittal 2		
Location Details:		Direction of Survey:	Upstream
US MH:	M-607-023	DS MH:	M-607-007
		Total Length Surveyed (ft):	62.2

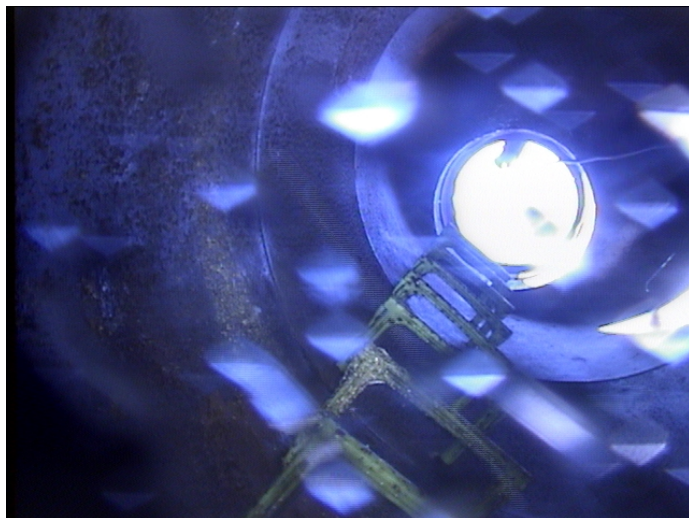
Code: **AMH**
 Description: **Manhole**

Distance (ft): **.0**
 Structural Grade: **0**
 O&M Grade: **0**
 Clock Start/From:
 Clock To:
 1st Value:
 2nd Value:
 Value Percent:
 Continuous Index:
 Within 8" of Joint: **NO**
 Remarks: **M-607-023**

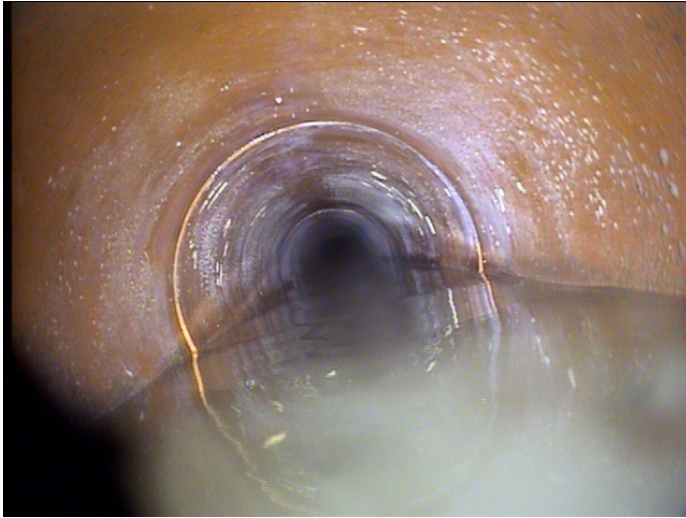
Code:	MWL
Description:	Water Level
Distance (ft):	.0
Structural Grade:	0
O&M Grade:	0
Clock Start/From:	
Clock To:	
1st Value:	
2nd Value:	
Value Percent:	20.000
Continuous Index:	
Within 8" of Joint:	NO
Remarks:

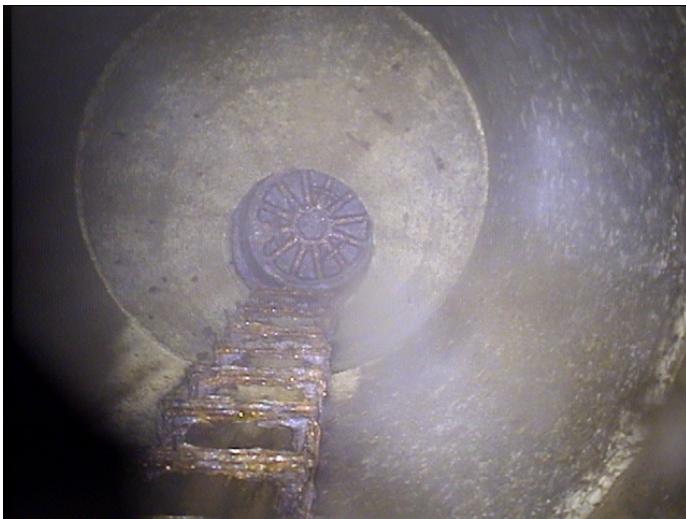
Code:	AMH
Description:	Manhole
Distance (ft):	62.2
Structural Grade:	0
O&M Grade:	0
Clock Start/From:	
Clock To:	
1st Value:	
2nd Value:	
Value Percent:	
Continuous Index:	
Within 8" of Joint:	NO
Remarks:	M-607-007
