## Profile/Photo Observation Report

Street:	<b>POLLY LN</b>	Flow Control:	<b>Not Controlled</b>
City:	<b>Hobart, IN</b>	Year Renewed:	
Location:	<b>Yard</b>	Tape/Media #:	
Purpose:	<b>Routine Assessment</b>	Dia/Height:	<b>8"</b>
Use:	<b>Sanitary</b>	Material:	<b>PVC</b>
Drain Area:	<b>NA</b>	Lining:	
Category:	<b>NA</b>		
Comment:

Location Details:		Direction of Survey:	<b>Upstream</b>
US MH:	<b>M-607-023</b>	DS MH:	<b>M-607-025</b>
		Total Length Surveyed (ft):	<b>27.9</b>

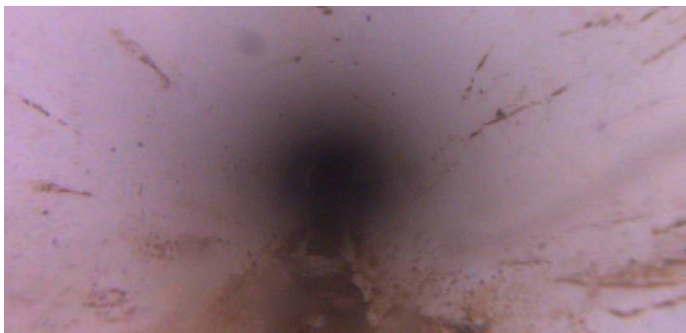
Code: **AMH**  
Description: **Manhole**

Distance (ft): **.0**  
Structural Grade: **0**  
O&M Grade: **0**  
Clock Start/From:  
Clock To:  
1st Value:  
2nd Value:  
Value Percent:  
Continuous Index:  
Within 8" of Joint: **NO**  
Remarks: **M-607-025**

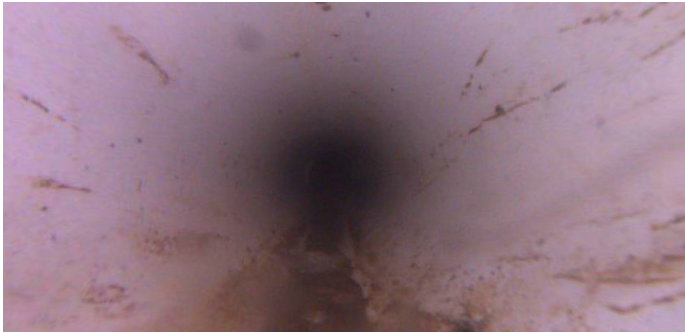
Code:	<b>MWL</b>
Description:	<b>Water Level</b>

Distance (ft):	<b>.0</b>
Structural Grade:	<b>0</b>
O&M Grade:	<b>0</b>
Clock Start/From:	
Clock To:	
1st Value:	
2nd Value:	
Value Percent:	<b>5.000</b>
Continuous Index:	
Within 8" of Joint:	<b>NO</b>
Remarks:

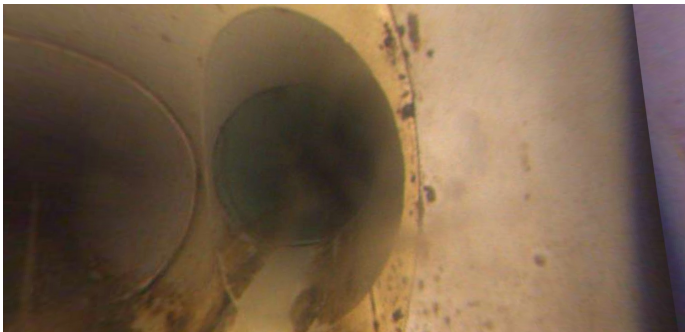
Code:	<b>TFA</b>
Description:	<b>Tap Factory Active</b>

Distance (ft):	<b>5.3</b>
Structural Grade:	<b>0</b>
O&M Grade:	<b>0</b>
Clock Start/From:	<b>9</b>
Clock To:	
1st Value:	<b>4.000</b>
2nd Value:	
Value Percent:	
Continuous Index:	
Within 8" of Joint:	
Remarks:

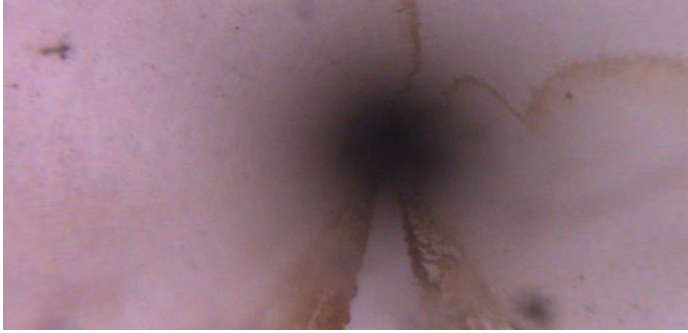
Code:	<b>MSA</b>
Description:	<b>Abandoned Survey</b>
Distance (ft):	<b>27.9</b>
Structural Grade:	<b>0</b>
O&M Grade:	<b>0</b>
Clock Start/From:	
Clock To:	
1st Value:	
2nd Value:	
Value Percent:	
Continuous Index:	
Within 8" of Joint:	<b>NO</b>
Remarks:	<b>unknown</b>
