Profile/Photo Observation Report

Street:	POLLY LN	Flow Control:	Not Controlled
City:	Hobart, IN	Year Renewed:	
Location:	Yard	Tape/Media #:	
Purpose:	Routine Assessment	Dia/Height:	8"
Use:	Sanitary	Material:	PVC
Drain Area:	NA	Lining:	
Category:	NA		
Comment:	Flow direction is marked wrong.		
Location Details:		Direction of Survey:	Upstream
US MH:	M-607-023	DS MH:	M-607-025
		Total Length Surveyed (ft):	125.4

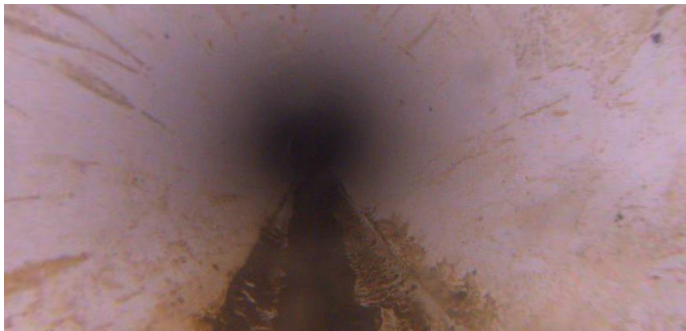
Code: **AMH**
Description: **Manhole**

Distance (ft): **.0**
Structural Grade: **0**
O&M Grade: **0**
Clock Start/From:
Clock To:
1st Value:
2nd Value:
Value Percent:
Continuous Index:
Within 8" of Joint: **NO**
Remarks: **M-607-025**

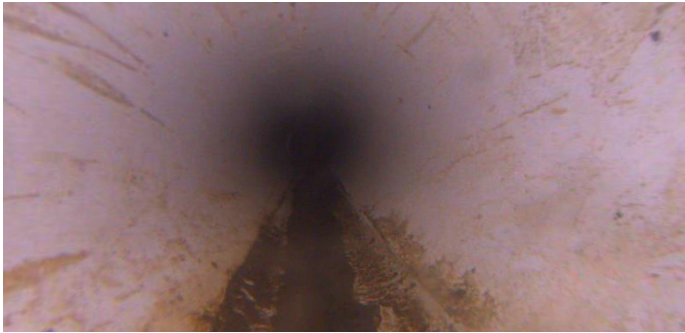
Code:	MWL
Description:	Water Level

Distance (ft):	.0
Structural Grade:	0
O&M Grade:	0
Clock Start/From:	
Clock To:	
1st Value:	
2nd Value:	
Value Percent:	5.000
Continuous Index:	
Within 8" of Joint:	NO
Remarks:

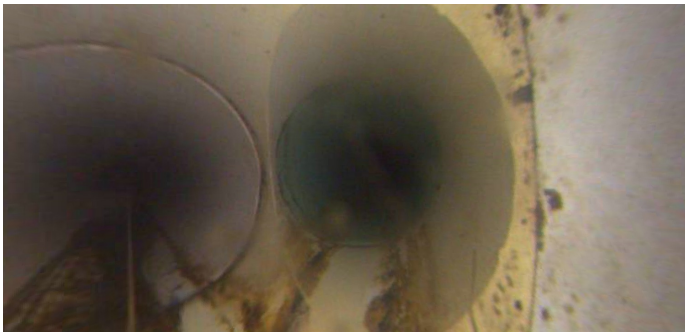
Code:	TF
Description:	Tap Factory

Distance (ft):	5.7
Structural Grade:	0
O&M Grade:	0
Clock Start/From:	9
Clock To:	
1st Value:	4.000
2nd Value:	
Value Percent:	
Continuous Index:	
Within 8" of Joint:	
Remarks:

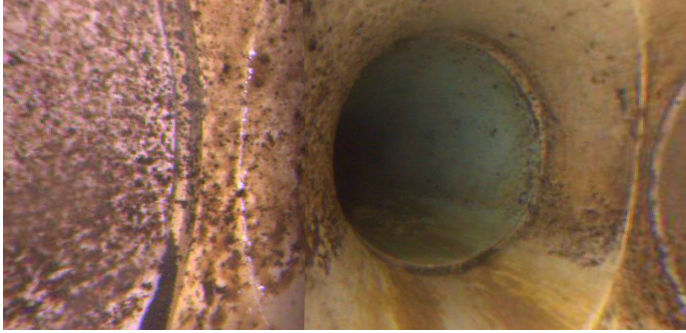
Code: **TF**
Description: **Tap Factory**

Distance (ft): **54.6**
Structural Grade: **0**
O&M Grade: **0**
Clock Start/From: **3**
Clock To:
1st Value: **4.000**
2nd Value:
Value Percent:
Continuous Index:
Within 8" of Joint:
Remarks:

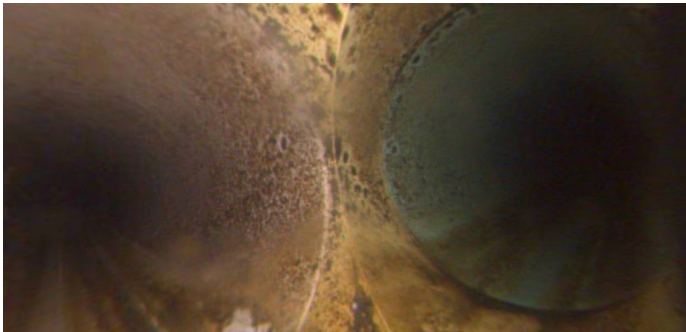
Code: **TFA**
Description: **Tap Factory Active**

Distance (ft): **58.2**
Structural Grade: **0**
O&M Grade: **0**
Clock Start/From: **9**
Clock To:
1st Value: **4.000**
2nd Value:
Value Percent:
Continuous Index:
Within 8" of Joint:
Remarks:

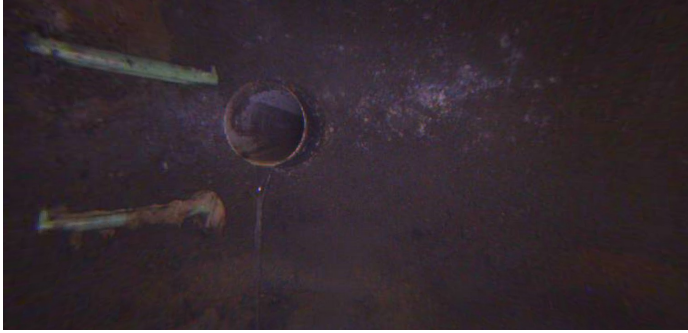
Code:	AMH
Description:	Manhole
Distance (ft):	125.4
Structural Grade:	0
O&M Grade:	0
Clock Start/From:	
Clock To:	
1st Value:	
2nd Value:	
Value Percent:	
Continuous Index:	
Within 8" of Joint:	NO
Remarks:	M-607-023
