Profile/Photo Observation Report

Date:	04/07/2018	Weather:		Coding:	PACP 6.0
Pipe Length (ft):		Owner:	City of Hobart	Pre Clean:	Not Known
P.O.#:	202	Surveyor:	B. Helbling	PSR:	P-607-008-024
Customer:	City of Hobart	Clean Date:		Shape:	C

Street:	Laura Lane	Flow Control:	Not Controlled
City:	Hobart, IN	Year Renewed:	
Location:	Easement/Right of Way	Tape/Media #:	DEP202
Purpose:	Routine Assessment	Dia/Height:	18"
Use:	Sanitary	Material:	VCP
Drain Area:		Lining:	
Category:	NA		
Comment:	YES501824 Submittal 2		
Location Details:		Direction of Survey:	Upstream
US MH:	M-607-024	DS MH:	M-607-008
		Total Length Surveyed (ft):	86.6

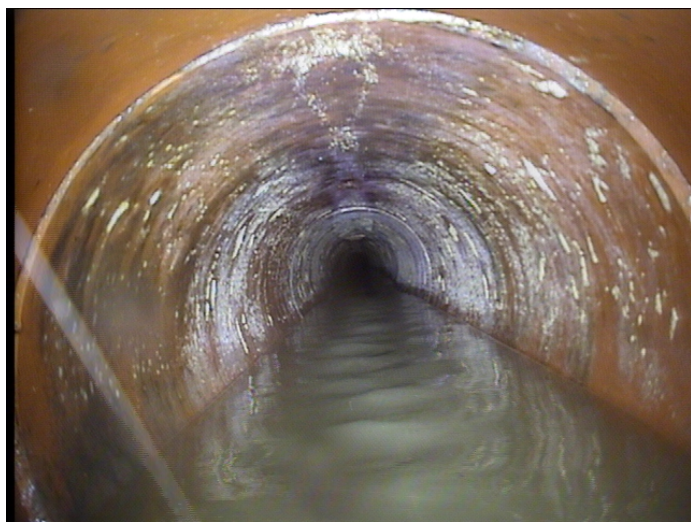
Code: **AMH**
Description: **Manhole**

Distance (ft): **.0**
Structural Grade: **0**
O&M Grade: **0**
Clock Start/From:
Clock To:
1st Value:
2nd Value:
Value Percent:
Continuous Index:
Within 8" of Joint: **NO**
Remarks: **M-607-024**

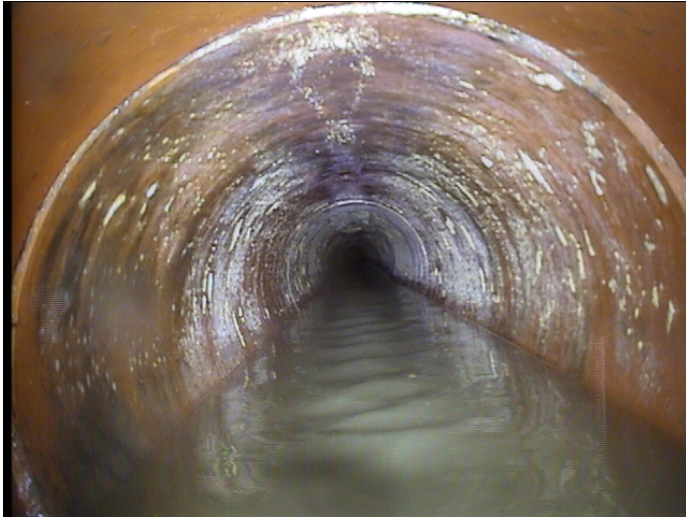
Code: **MWL**
Description: **Water Level**

Distance (ft): **.0**
Structural Grade: **0**
O&M Grade: **0**
Clock Start/From:
Clock To:
1st Value:
2nd Value:
Value Percent: **15.000**
Continuous Index:
Within 8" of Joint: **NO**
Remarks:

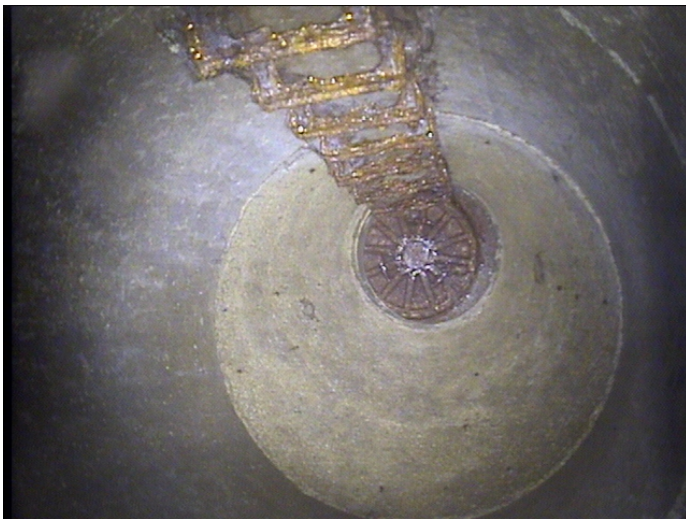
Code: **AMH**
Description: **Manhole**

Distance (ft): **86.6**
Structural Grade: **0**
O&M Grade: **0**
Clock Start/From:
Clock To:
1st Value:
2nd Value:
Value Percent:
Continuous Index:
Within 8" of Joint: **NO**
Remarks: **M-607-008**
