## Profile/Photo Observation Report

Date:	<b>04/04/2018</b>	Weather:		Coding:	<b>PACP 6.0</b>
Pipe Length (ft):	<b>279.5</b>	Owner:	<b>NA</b>	Pre Clean:	<b>No Pre-Cleaning</b>
P.O.#:		Surveyor:	<b>Jen Costello</b>	PSR:	<b>P-607-027-026</b>
Customer:		Clean Date:	<b>01/01/1900</b>	Shape:	<b>C</b>

Street:	<b>POLLY LN</b>	Flow Control:	<b>Not Controlled</b>
City:	<b>Hobart, IN</b>	Year Renewed:	
Location:	<b>Yard</b>	Tape/Media #:	
Purpose:	<b>Routine Assessment</b>	Dia/Height:	<b>8"</b>
Use:	<b>Sanitary</b>	Material:	<b>PVC</b>
Drain Area:	<b>NA</b>	Lining:	
Category:	<b>NA</b>		
Comment:			
Location Details:		Direction of Survey:	<b>Upstream</b>
US MH:	<b>M-607-026</b>	DS MH:	<b>M-607-027</b>
		Total Length Surveyed (ft):	<b>278.5</b>

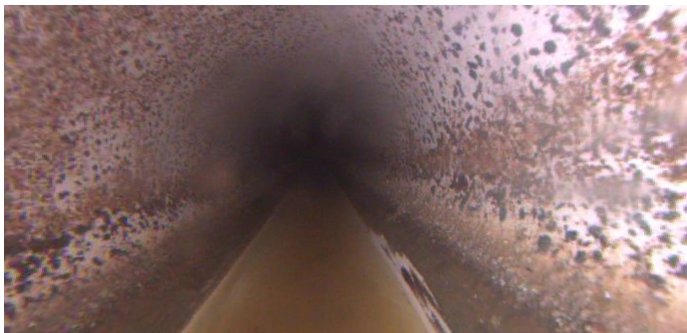
Position	Code	Observation	Video (sec)	Grade
.0	AMH	Manhole	10	NA
.0	MWL	Water Level	21	NA
7.9	TF	Tap Factory	49	NA
83.2	TF	Tap Factory	212	NA
119.1	TFA	Tap Factory Active	296	NA
212.3	TF	Tap Factory	495	NA
215.2	TF	Tap Factory	514	NA
271.2	MWL	Water Level	639	NA
278.5	AMH	Manhole	664	NA

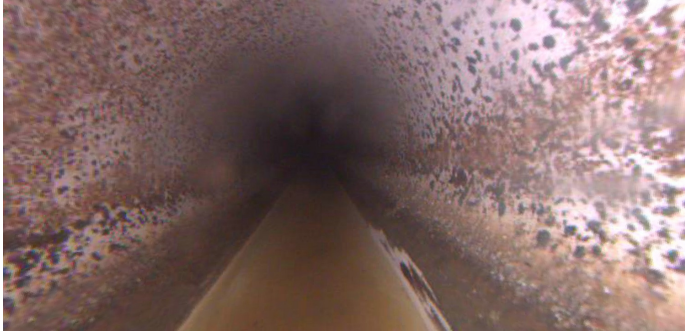
Code:	<b>MWL</b>
Description:	<b>Water Level</b>

Distance (ft):	<b>.0</b>
Structural Grade:	<b>0</b>
O&M Grade:	<b>0</b>
Clock Start/From:	
Clock To:	
1st Value:	
2nd Value:	
Value Percent:	<b>5.000</b>
Continuous Index:	
Within 8" of Joint:	<b>NO</b>
Remarks:

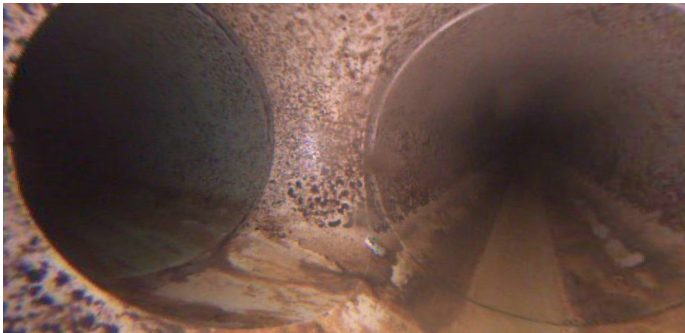
Code:	<b>TF</b>
Description:	<b>Tap Factory</b>

Distance (ft):	<b>7.9</b>
Structural Grade:	<b>0</b>
O&M Grade:	<b>0</b>
Clock Start/From:	<b>9</b>
Clock To:	
1st Value:	<b>4.000</b>
2nd Value:	
Value Percent:	
Continuous Index:	
Within 8" of Joint:	
Remarks:

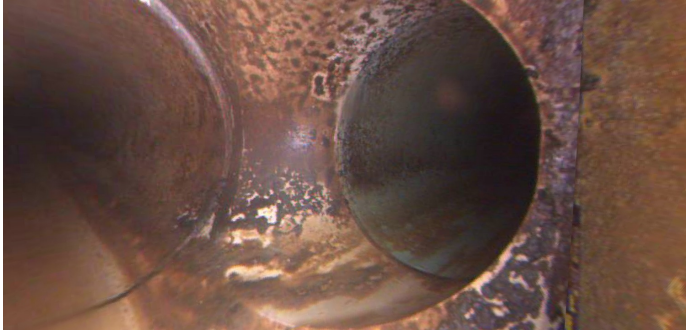
Code: **TF**  
Description: **Tap Factory**

Distance (ft): **83.2**  
Structural Grade: **0**  
O&M Grade: **0**  
Clock Start/From: **3**  
Clock To:  
1st Value: **4.000**  
2nd Value:  
Value Percent:  
Continuous Index:  
Within 8" of Joint:  
Remarks:

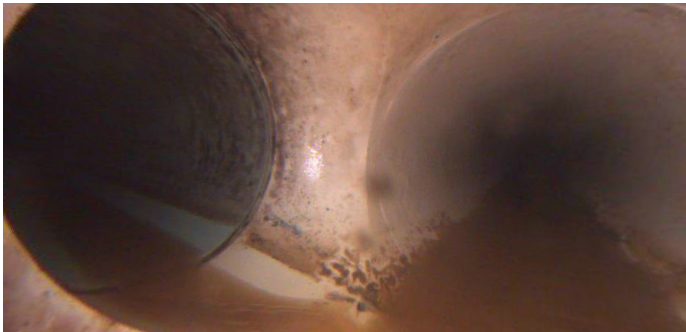
Code: **TFA**  
Description: **Tap Factory Active**

Distance (ft): **119.1**  
Structural Grade: **0**  
O&M Grade: **0**  
Clock Start/From: **9**  
Clock To:  
1st Value: **4.000**  
2nd Value:  
Value Percent:  
Continuous Index:  
Within 8" of Joint:  
Remarks:

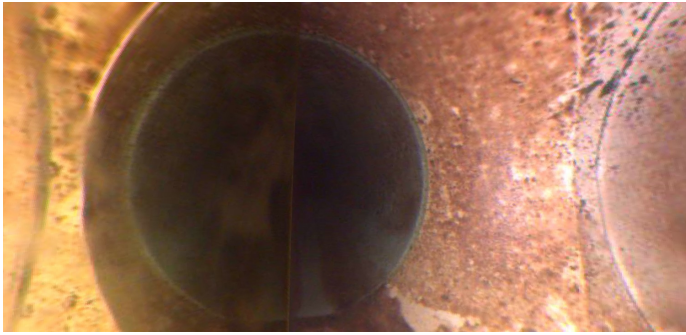
Code: **TF**  
Description: **Tap Factory**

Distance (ft): **212.3**  
Structural Grade: **0**  
O&M Grade: **0**  
Clock Start/From: **9**  
Clock To:  
1st Value: **4.000**  
2nd Value:  
Value Percent:  
Continuous Index:  
Within 8" of Joint:  
Remarks:

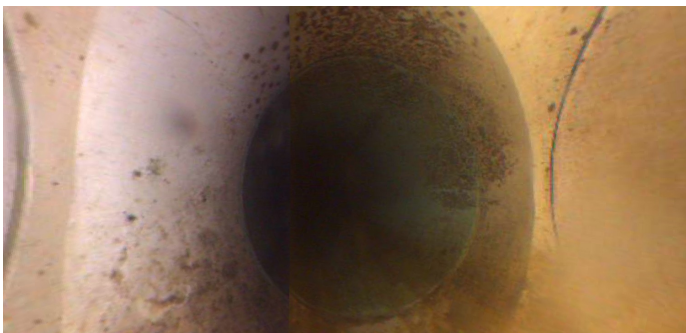
Code: **TF**  
Description: **Tap Factory**

Distance (ft): **215.2**  
Structural Grade: **0**  
O&M Grade: **0**  
Clock Start/From: **3**  
Clock To:  
1st Value: **4.000**  
2nd Value:  
Value Percent:  
Continuous Index:  
Within 8" of Joint:  
Remarks:

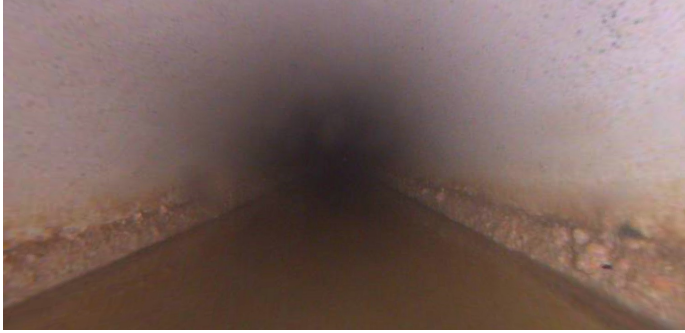
Code: **MWL**  
Description: **Water Level**

Distance (ft): **271.2**  
Structural Grade: **0**  
O&M Grade: **0**  
Clock Start/From:  
Clock To:  
1st Value:  
2nd Value:  
Value Percent: **30.000**  
Continuous Index:  
Within 8" of Joint: **NO**  
Remarks:

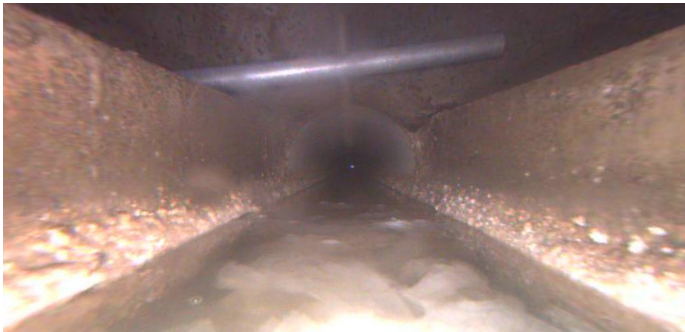
Code: **AMH**  
Description: **Manhole**

Distance (ft): **278.5**  
Structural Grade: **0**  
O&M Grade: **0**  
Clock Start/From:  
Clock To:  
1st Value:  
2nd Value:  
Value Percent:  
Continuous Index:  
Within 8" of Joint: **NO**  
Remarks: **M-607-026**
