Profile/Photo Observation Report

Street:	FOXCROFT STREET	Flow Control:	Not Controlled
City:	Hobart, IN	Year Renewed:	
Location:	Yard	Tape/Media #:	
Purpose:	Routine Assessment	Dia/Height:	8"
Use:	Sanitary	Material:	PVC
Drain Area:	NA	Lining:	
Category:	NA		
Comment:

Location Details:		Direction of Survey:	Upstream
US MH:	M-607-026	DS MH:	M-607-027
		Total Length Surveyed (ft):	278.5

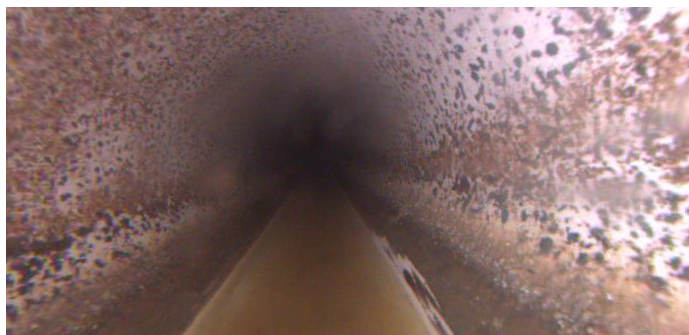
Code: **AMH**
Description: **Manhole**

Distance (ft): **.0**
Structural Grade: **0**
O&M Grade: **0**
Clock Start/From:
Clock To:
1st Value:
2nd Value:
Value Percent:
Continuous Index:
Within 8" of Joint: **NO**
Remarks: **M-607-027**

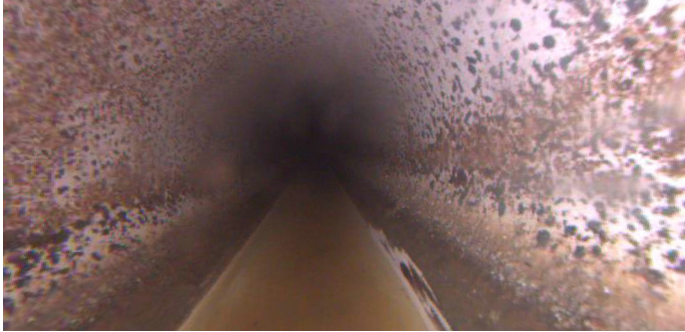
Code:	MWL
Description:	Water Level

Distance (ft):	.0
Structural Grade:	0
O&M Grade:	0
Clock Start/From:	
Clock To:	
1st Value:	
2nd Value:	
Value Percent:	5.000
Continuous Index:	
Within 8" of Joint:	NO
Remarks:

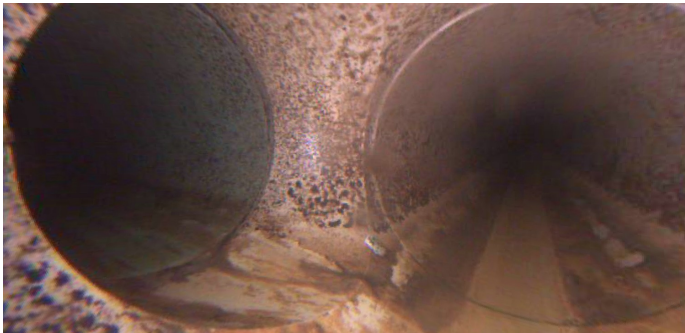
Code:	TF
Description:	Tap Factory

Distance (ft):	7.9
Structural Grade:	0
O&M Grade:	0
Clock Start/From:	9
Clock To:	
1st Value:	4.000
2nd Value:	
Value Percent:	
Continuous Index:	
Within 8" of Joint:	
Remarks:

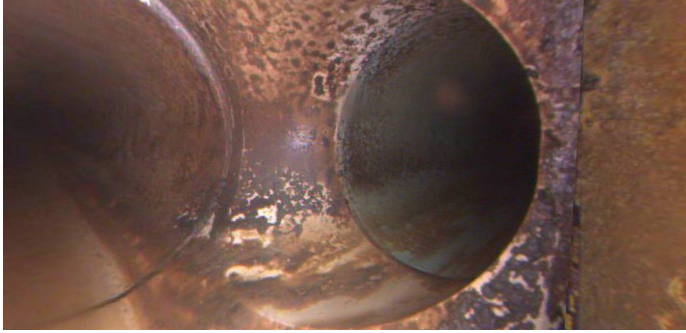
Code: **TF**
Description: **Tap Factory**

Distance (ft): **83.2**
Structural Grade: **0**
O&M Grade: **0**
Clock Start/From: **3**
Clock To:
1st Value: **4.000**
2nd Value:
Value Percent:
Continuous Index:
Within 8" of Joint:
Remarks:

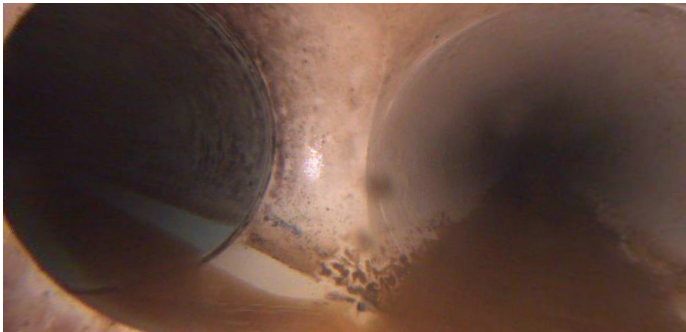
Code: **TFA**
Description: **Tap Factory Active**

Distance (ft): **119.1**
Structural Grade: **0**
O&M Grade: **0**
Clock Start/From: **9**
Clock To:
1st Value: **4.000**
2nd Value:
Value Percent:
Continuous Index:
Within 8" of Joint:
Remarks:

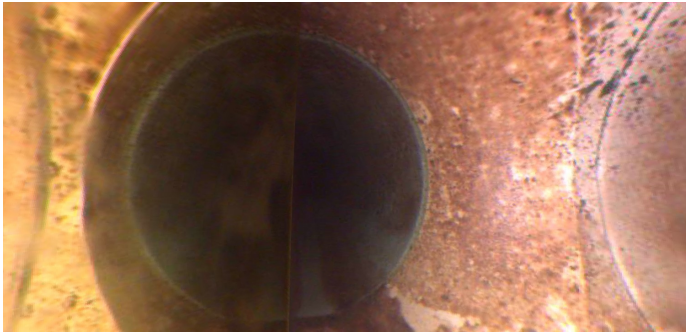
Code: **TF**
Description: **Tap Factory**

Distance (ft): **212.3**
Structural Grade: **0**
O&M Grade: **0**
Clock Start/From: **9**
Clock To:
1st Value: **4.000**
2nd Value:
Value Percent:
Continuous Index:
Within 8" of Joint:
Remarks:

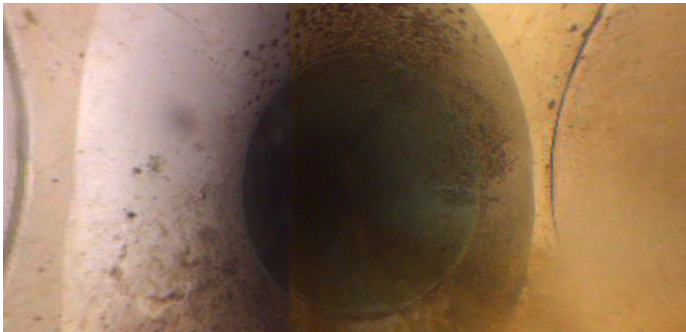
Code: **TF**
Description: **Tap Factory**

Distance (ft): **215.2**
Structural Grade: **0**
O&M Grade: **0**
Clock Start/From: **3**
Clock To:
1st Value: **4.000**
2nd Value:
Value Percent:
Continuous Index:
Within 8" of Joint:
Remarks:

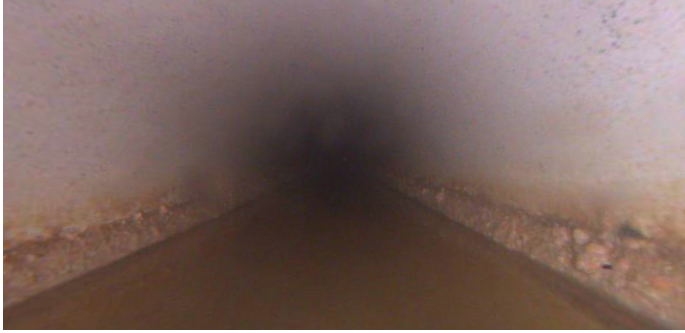
Code: **MWL**
Description: **Water Level**

Distance (ft): **271.2**
Structural Grade: **0**
O&M Grade: **0**
Clock Start/From:
Clock To:
1st Value:
2nd Value:
Value Percent: **30.000**
Continuous Index:
Within 8" of Joint: **NO**
Remarks:

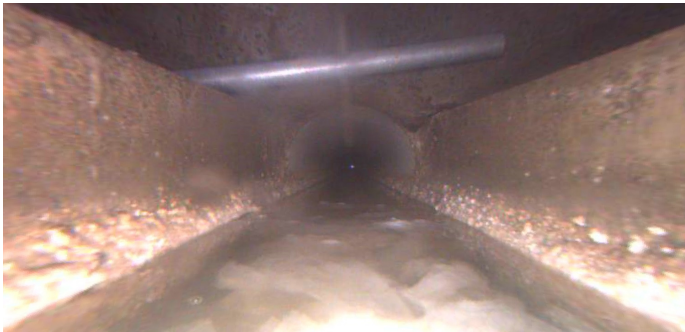
Code: **AMH**
Description: **Manhole**

Distance (ft): **278.5**
Structural Grade: **0**
O&M Grade: **0**
Clock Start/From:
Clock To:
1st Value:
2nd Value:
Value Percent:
Continuous Index:
Within 8" of Joint: **NO**
Remarks: **M-607-026**
