Profile/Photo Observation Report

Street:	FOXCROFT STREET	Flow Control:	Not Controlled
City:	Hobart, IN	Year Renewed:	
Location:	Yard	Tape/Media #:	
Purpose:	Routine Assessment	Dia/Height:	8"
Use:	Sanitary	Material:	PVC
Drain Area:	NA	Lining:	
Category:	NA		
Comment:	Flow direction marked wrong.

Location Details:		Direction of Survey:	Downstream
US MH:	M-607-030	DS MH:	M-607-031
		Total Length Surveyed (ft):	198.7

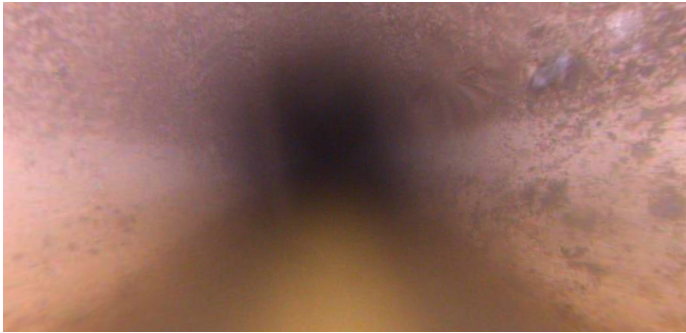
Code:	MWL
Description:	Water Level

Distance (ft):	.0
Structural Grade:	0
O&M Grade:	0
Clock Start/From:	
Clock To:	
1st Value:	
2nd Value:	
Value Percent:	5.000
Continuous Index:	
Within 8" of Joint:	NO
Remarks:

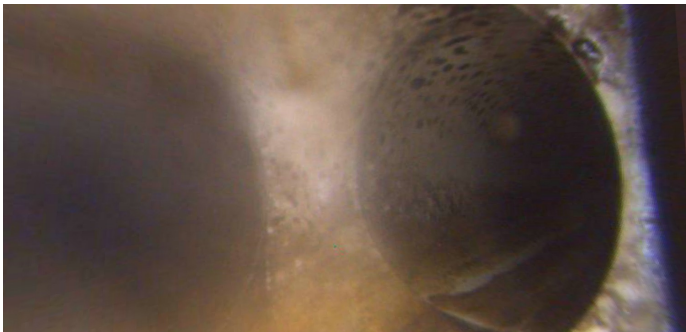
Code:	TF
Description:	Tap Factory

Distance (ft):	78.1
Structural Grade:	0
O&M Grade:	0
Clock Start/From:	9
Clock To:	
1st Value:	4.000
2nd Value:	
Value Percent:	
Continuous Index:	
Within 8" of Joint:	
Remarks:

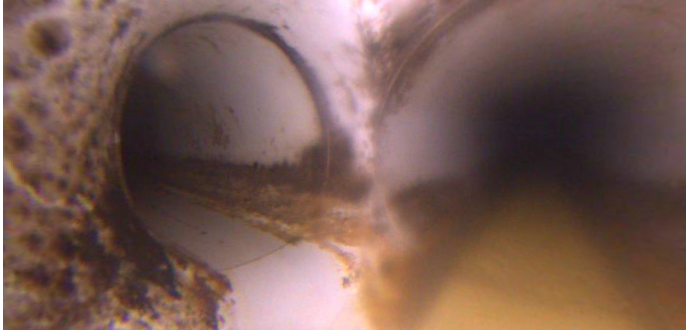
Code: **TFA**
Description: **Tap Factory Active**

Distance (ft): **165.7**
Structural Grade: **0**
O&M Grade: **0**
Clock Start/From: **9**
Clock To:
1st Value: **4.000**
2nd Value:
Value Percent:
Continuous Index:
Within 8" of Joint:
Remarks:
