Profile/Photo Observation Report

Date:	04/08/2018	Weather:		Coding:	PACP 6.0
Pipe Length (ft):		Owner:	City of Hobart	Pre Clean:	Not Known
P.O.#:	211	Surveyor:	B. Helbling	PSR:	P-608-004-033
Customer:	City of Hobart	Clean Date:		Shape:	C

Street:	South Wisconsin Street	Flow Control:	Not Controlled
City:	Hobart, IN	Year Renewed:	
Location:	Sidewalk	Tape/Media #:	DEP211
Purpose:	Routine Assessment	Dia/Height:	15"
Use:	Sanitary	Material:	PVC
Drain Area:		Lining:	
Category:	NA		
Comment:	YES501824 Submittal 2		
Location Details:		Direction of Survey:	Upstream
US MH:	M-607-033	DS MH:	M-608-004
		Total Length Surveyed (ft):	2.4

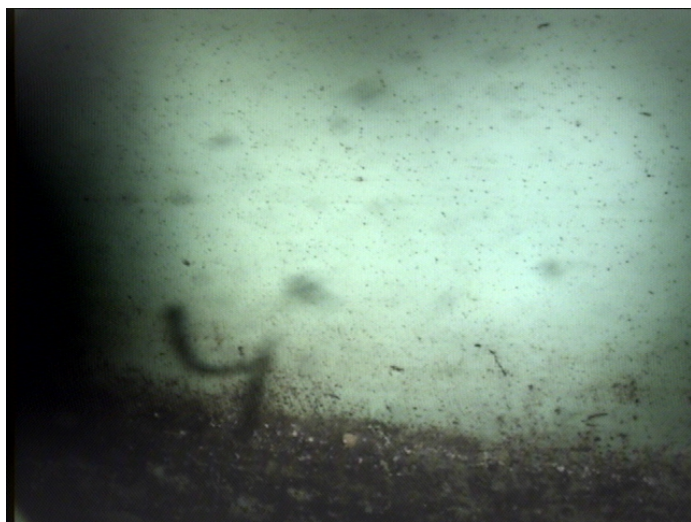
Code: **AMH**
 Description: **Manhole**

Distance (ft): **.0**
 Structural Grade: **0**
 O&M Grade: **0**
 Clock Start/From:
 Clock To:
 1st Value:
 2nd Value:
 Value Percent:
 Continuous Index:
 Within 8" of Joint: **NO**
 Remarks: **M-607-033**
