Profile/Photo Observation Report

Date:	04/09/2018	Weather:		Coding:	PACP 6.0
Pipe Length (ft):		Owner:	City of Hobart	Pre Clean:	Not Known
P.O.#:	213	Surveyor:	B. Helbling	PSR:	P-607-034-042
Customer:	City of Hobart	Clean Date:		Shape:	C

Street:	West 14th Street	Flow Control:	Not Controlled
City:	Hobart, IN	Year Renewed:	
Location:	Light Highway	Tape/Media #:	DEP213
Purpose:	Routine Assessment	Dia/Height:	15"
Use:	Sanitary	Material:	PVC
Drain Area:		Lining:	
Category:	NA		
Comment:	YES501824 Submittal 2		
Location Details:		Direction of Survey:	Downstream
US MH:	M-607-034	DS MH:	M-607-077
		Total Length Surveyed (ft):	36.8

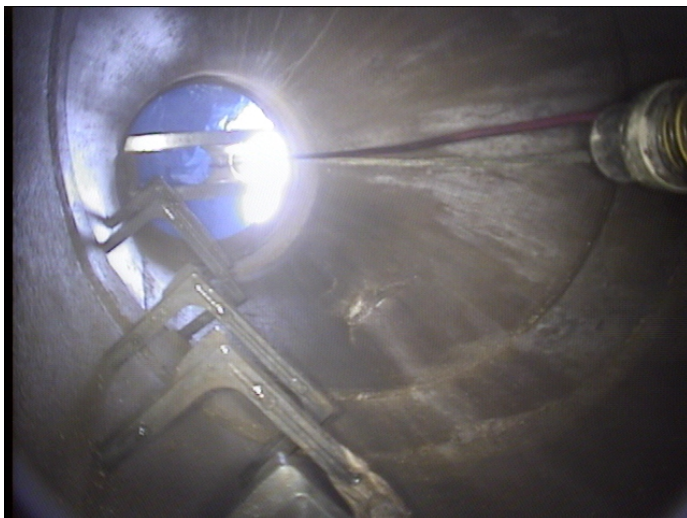
Code: **AMH**
Description: **Manhole**

Distance (ft): **.0**
Structural Grade: **0**
O&M Grade: **0**
Clock Start/From:
Clock To:
1st Value:
2nd Value:
Value Percent:
Continuous Index:
Within 8" of Joint: **NO**
Remarks: **M-607-034**

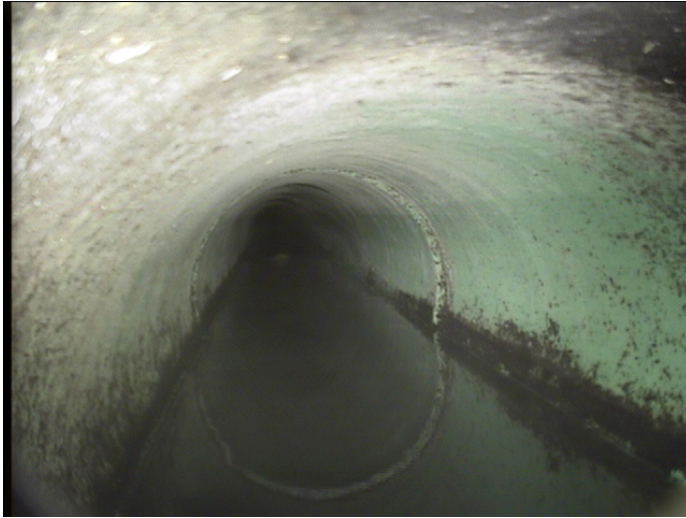
Code: **MWL**
Description: **Water Level**

Distance (ft): **.0**
Structural Grade: **0**
O&M Grade: **0**
Clock Start/From:
Clock To:
1st Value:
2nd Value:
Value Percent: **10.000**
Continuous Index:
Within 8" of Joint: **NO**
Remarks:

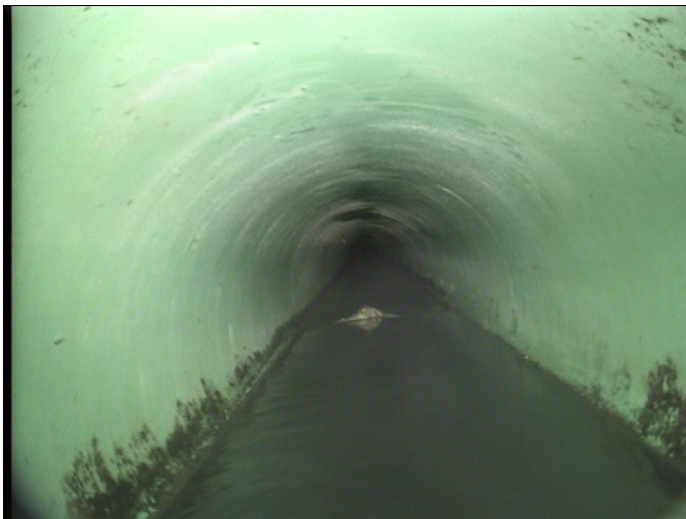
Code: **DSF**
Description: **Deposits Settled Fine**

Distance (ft): **2.3**
Structural Grade: **0**
O&M Grade: **2**
Clock Start/From: **5**
Clock To: **7**
1st Value:
2nd Value:
Value Percent: **10.000**
Continuous Index: **S01**
Within 8" of Joint: **NO**
Remarks:

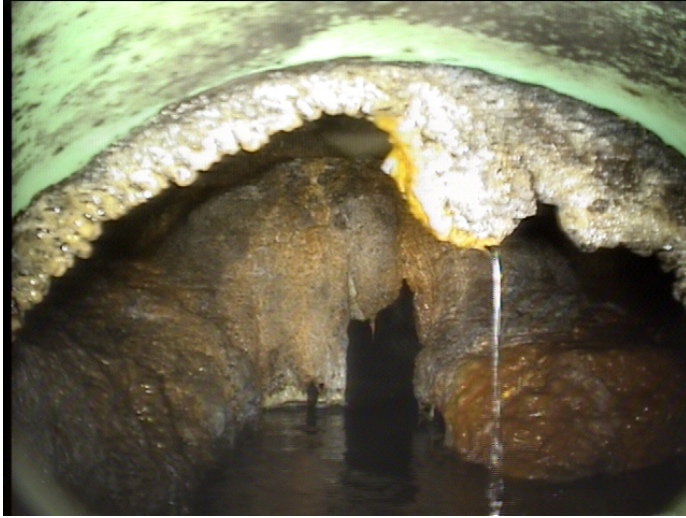
Code: **AMH**
Description: **Manhole**

Distance (ft): **36.8**
Structural Grade: **0**
O&M Grade: **0**
Clock Start/From:
Clock To:
1st Value:
2nd Value:
Value Percent:
Continuous Index:
Within 8" of Joint: **NO**
Remarks: **M607-077**

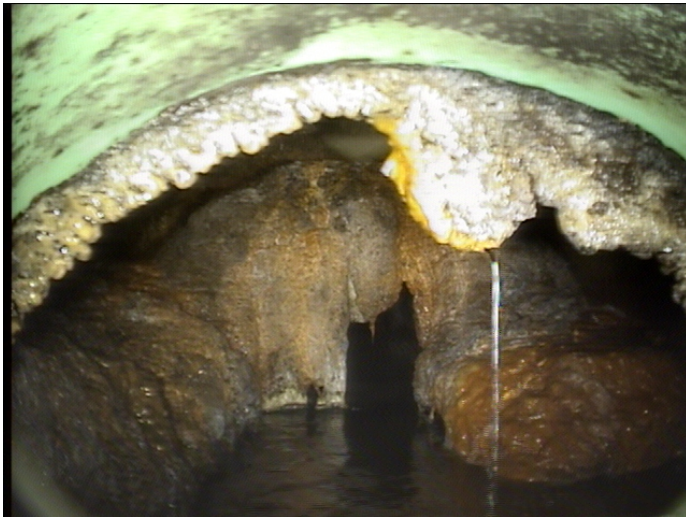
Code: **DSF**
Description: **Deposits Settled Fine**

Distance (ft): **36.8**
Structural Grade: **0**
O&M Grade: **2**
Clock Start/From: **5**
Clock To: **7**
1st Value:
2nd Value:
Value Percent: **10.000**
Continuous Index: **F01**
Within 8" of Joint: **NO**
Remarks:
